Inspections: Damaged Pole Report

Service Request 25-00928377 Sector: \_\_\_\_\_ Gateway \_\_\_\_\_ Primary \_\_\_\_\_

Street: 1483 E. Fayette

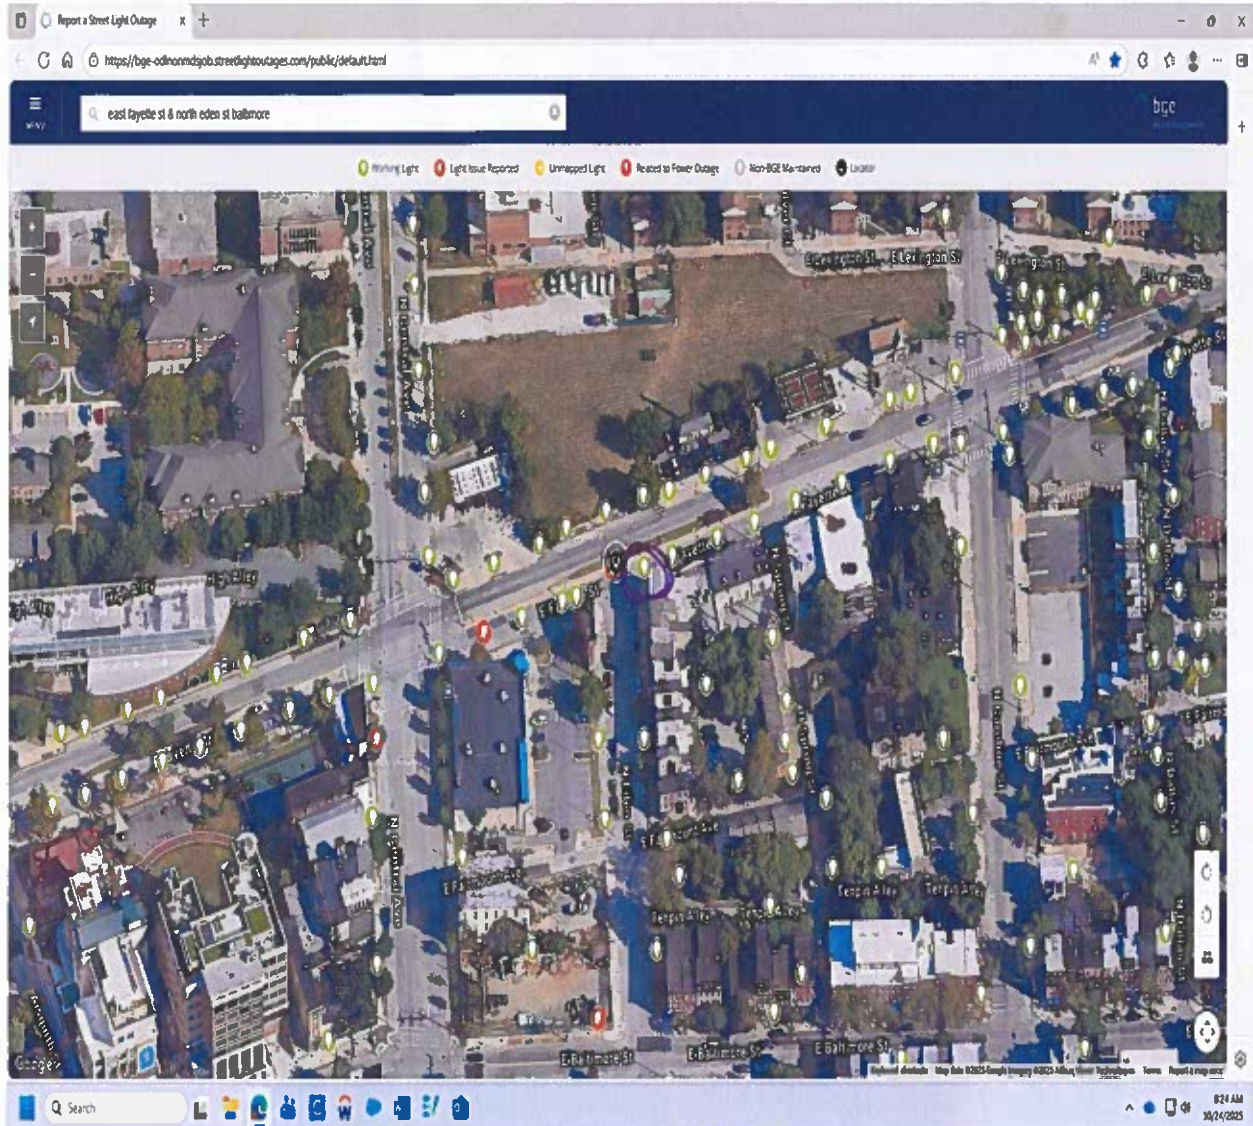
Home Land  
Acorn Fixture
