Inspections: Damaged Pole Report

Service Request 25-00930275 Sector: \_\_\_\_\_ Gateway: \_\_\_\_\_ Primary: \_\_\_\_\_

Location on Service Request: 5710 Eastern Ave

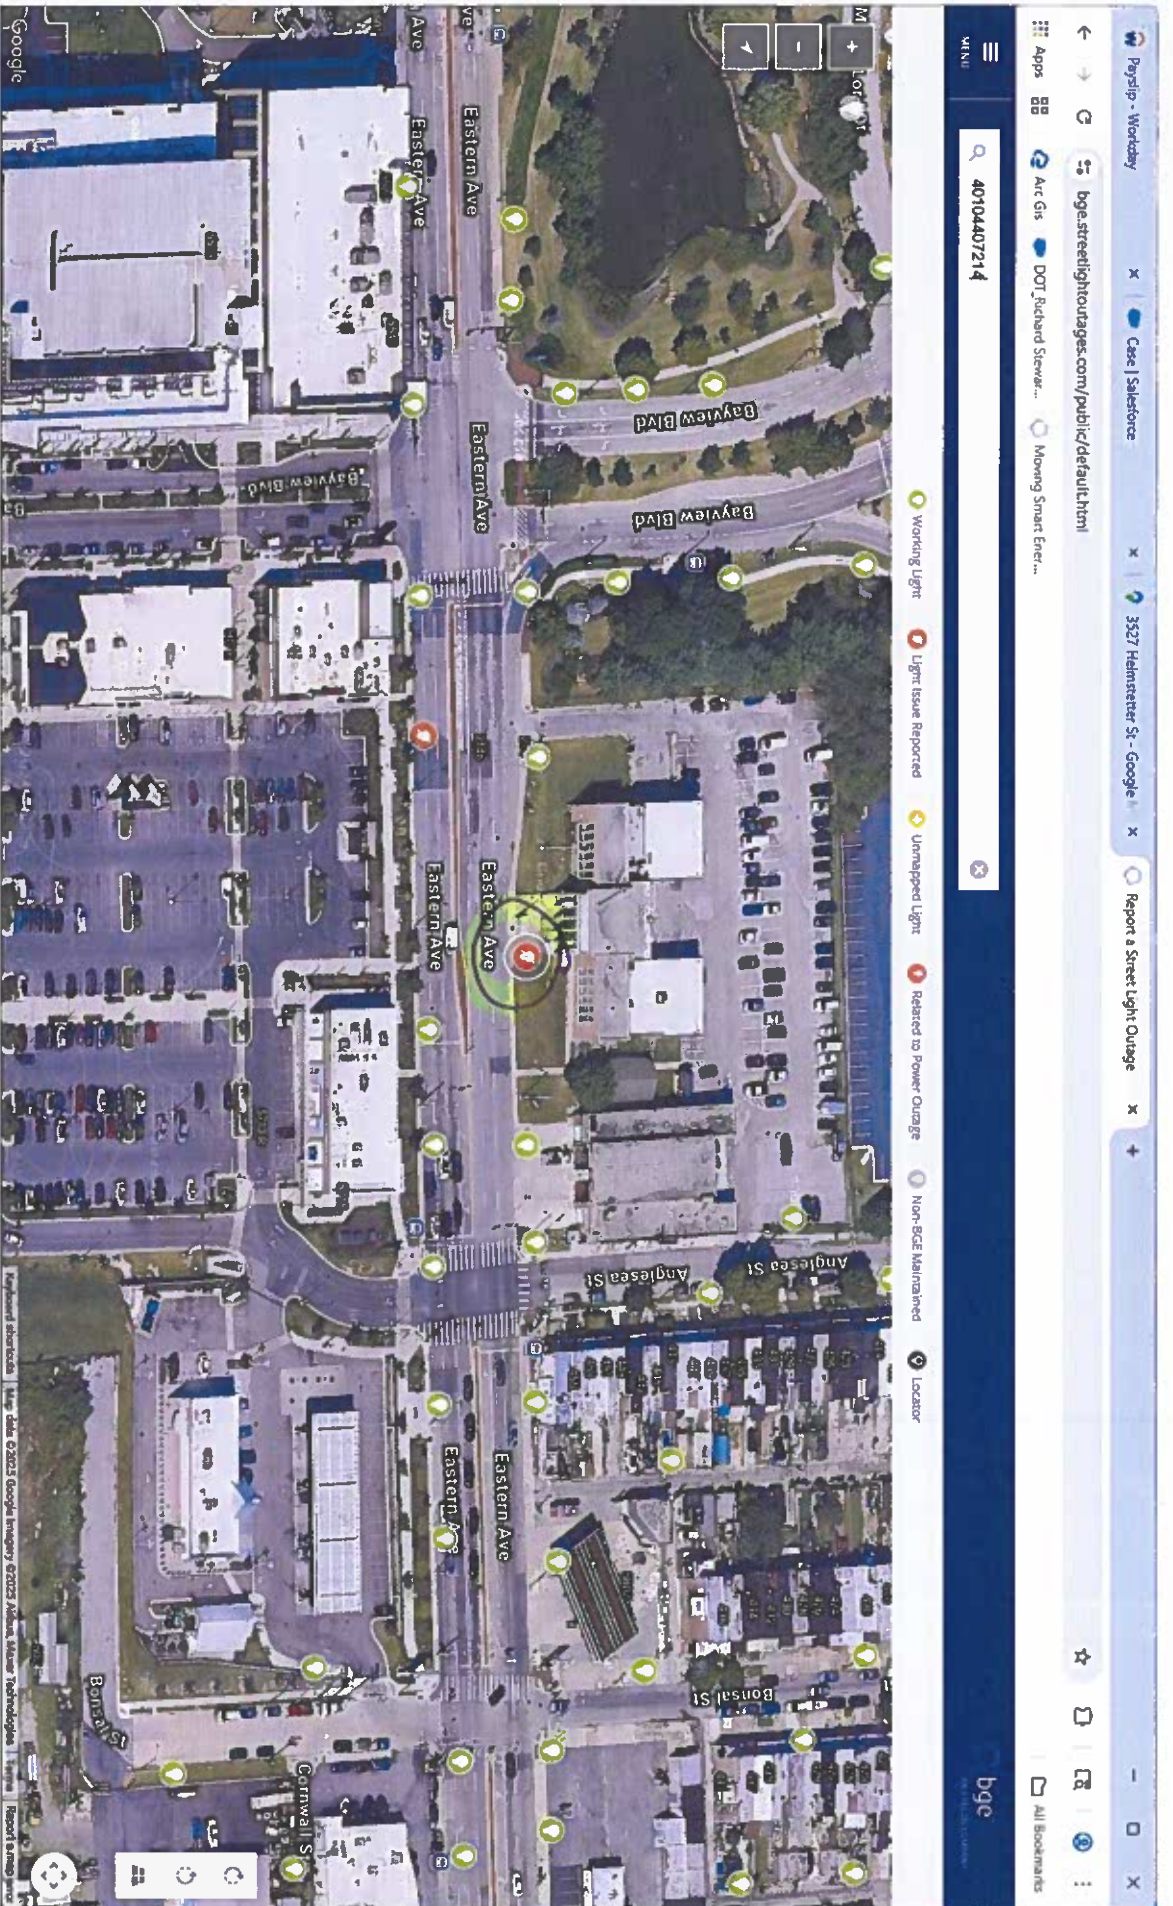
Missing ☒

30 Foot Aluminum  
Cobra Head  
LED
