# Inspections Damaged Pole Report

Service Request 25-00934655 Sector            Gateway            Primary

Location on Service Request: 1312 Southview Rd

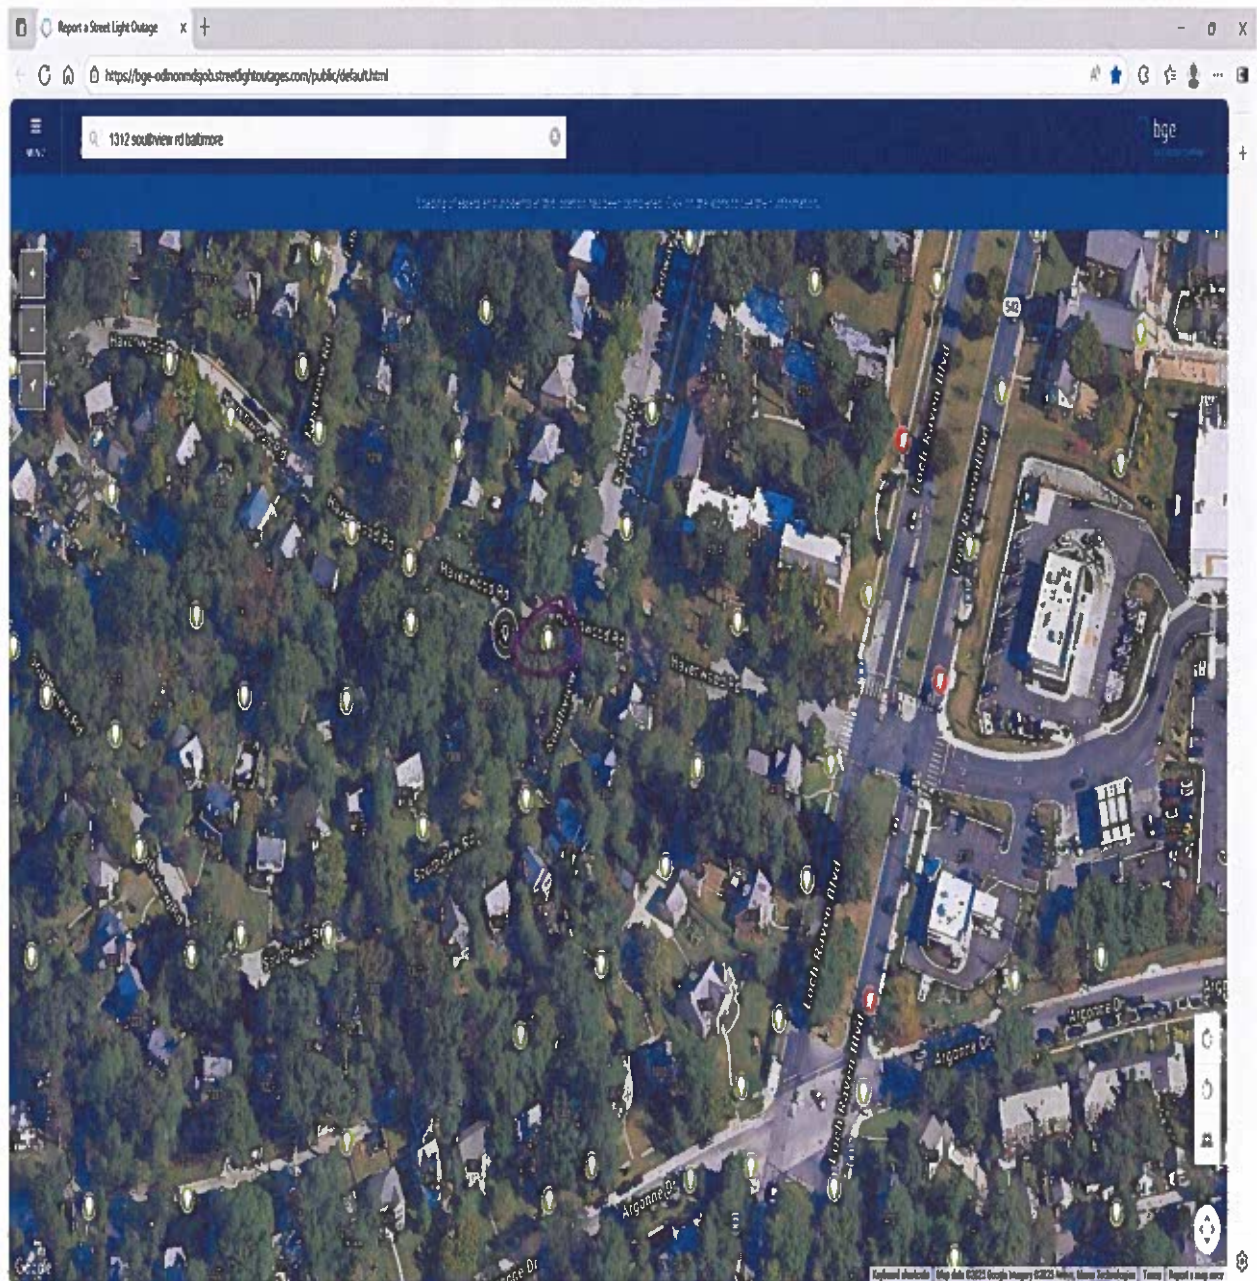
Missing ✓

NEEDS  
NEW  
BASE
