Inspections: Damaged Pole Report

Service Request 25-00953300 Sector 5610 Gateway Sanctuary Primary 4N

Location on Service Request: 5610 Sanctuary 4N

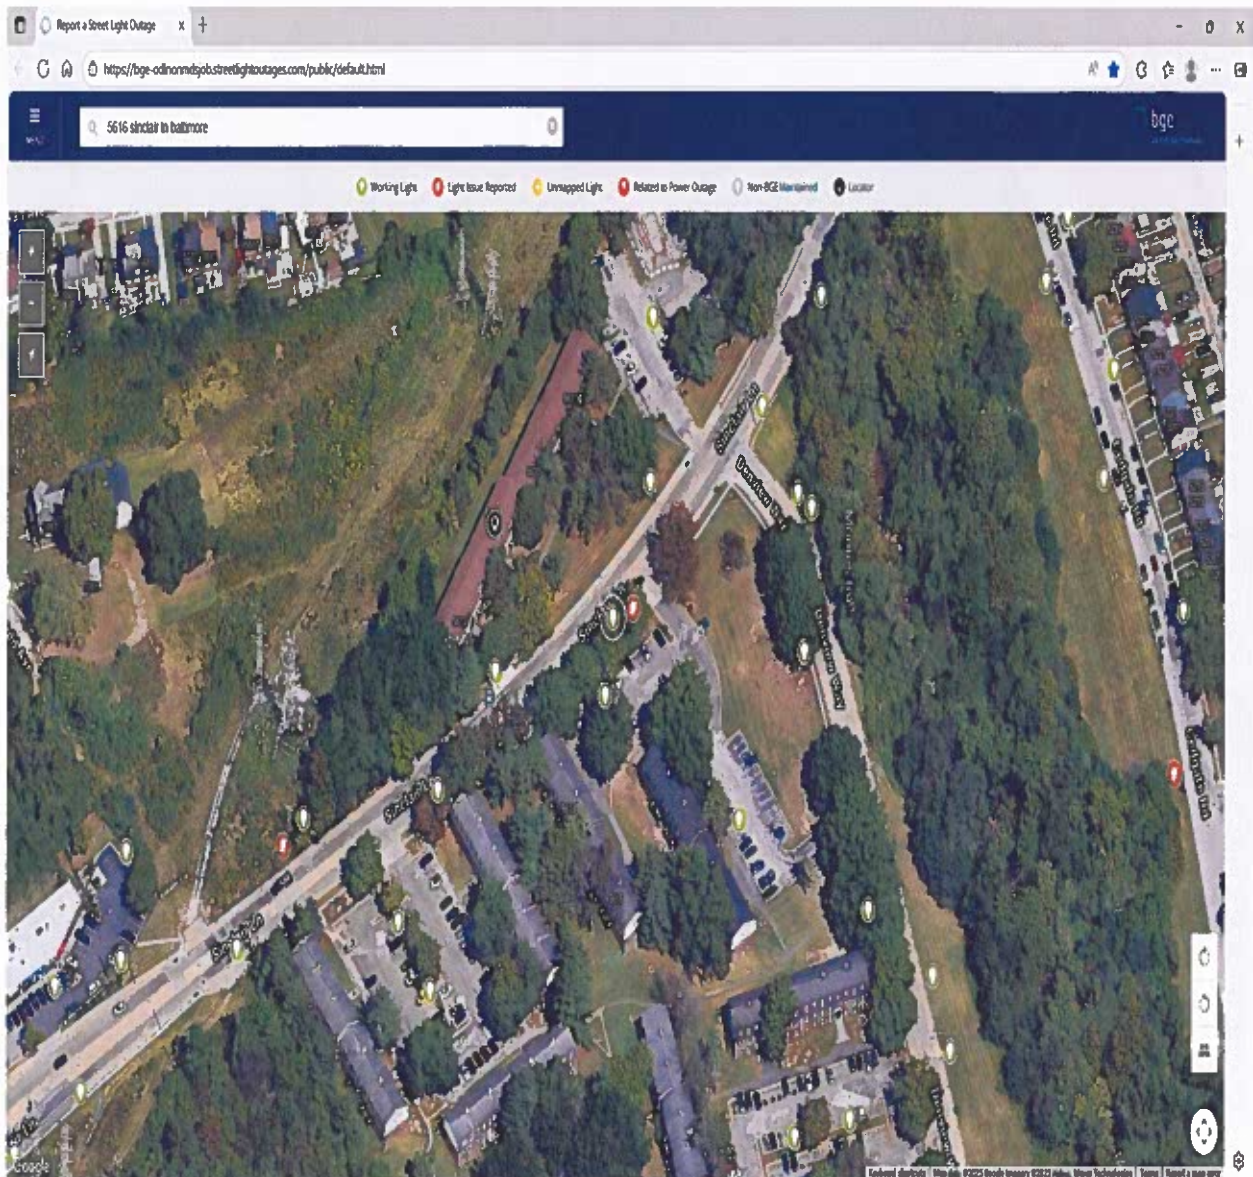
30 Foot Aluminum  
pole  
cobra head  
LED
