# Inspections: Damaged Pole Report

Service Request: 25-00951355 Sector: \_\_\_\_\_ Gateway: \_\_\_\_\_ Primary: \_\_\_\_\_  
 Location on Service Request: 1453 PATAPSCO ST  
 Grid : 4020135 LLC: 7431

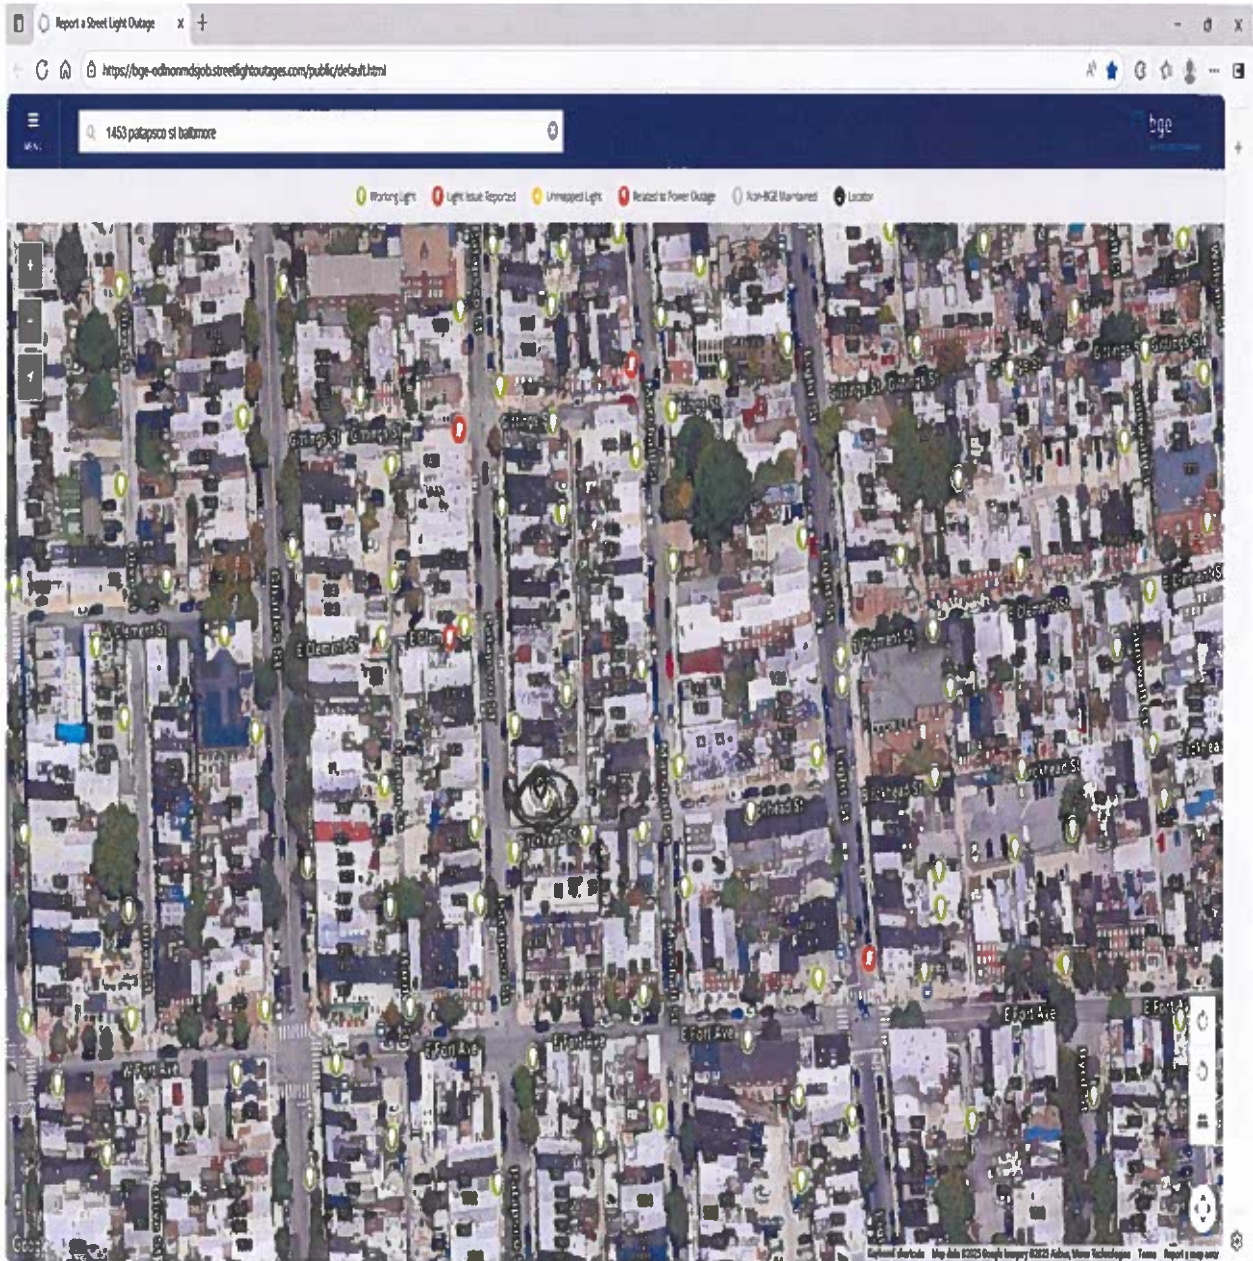
Deteriorated ☒  
 Missing ☒  
 Damaged \_\_\_\_\_  
 Arm/Fixture Missing \_\_\_\_\_  
 Other \_\_\_\_\_

PMA  
Town guide  
Fixture
