# Inspections: Damaged Pole Report

Service Request: 25-01000657 Sector: \_\_\_\_\_ Gateway: \_\_\_\_\_ Primary: \_\_\_\_\_

Location on Service Request: 3316 Moravia Rd

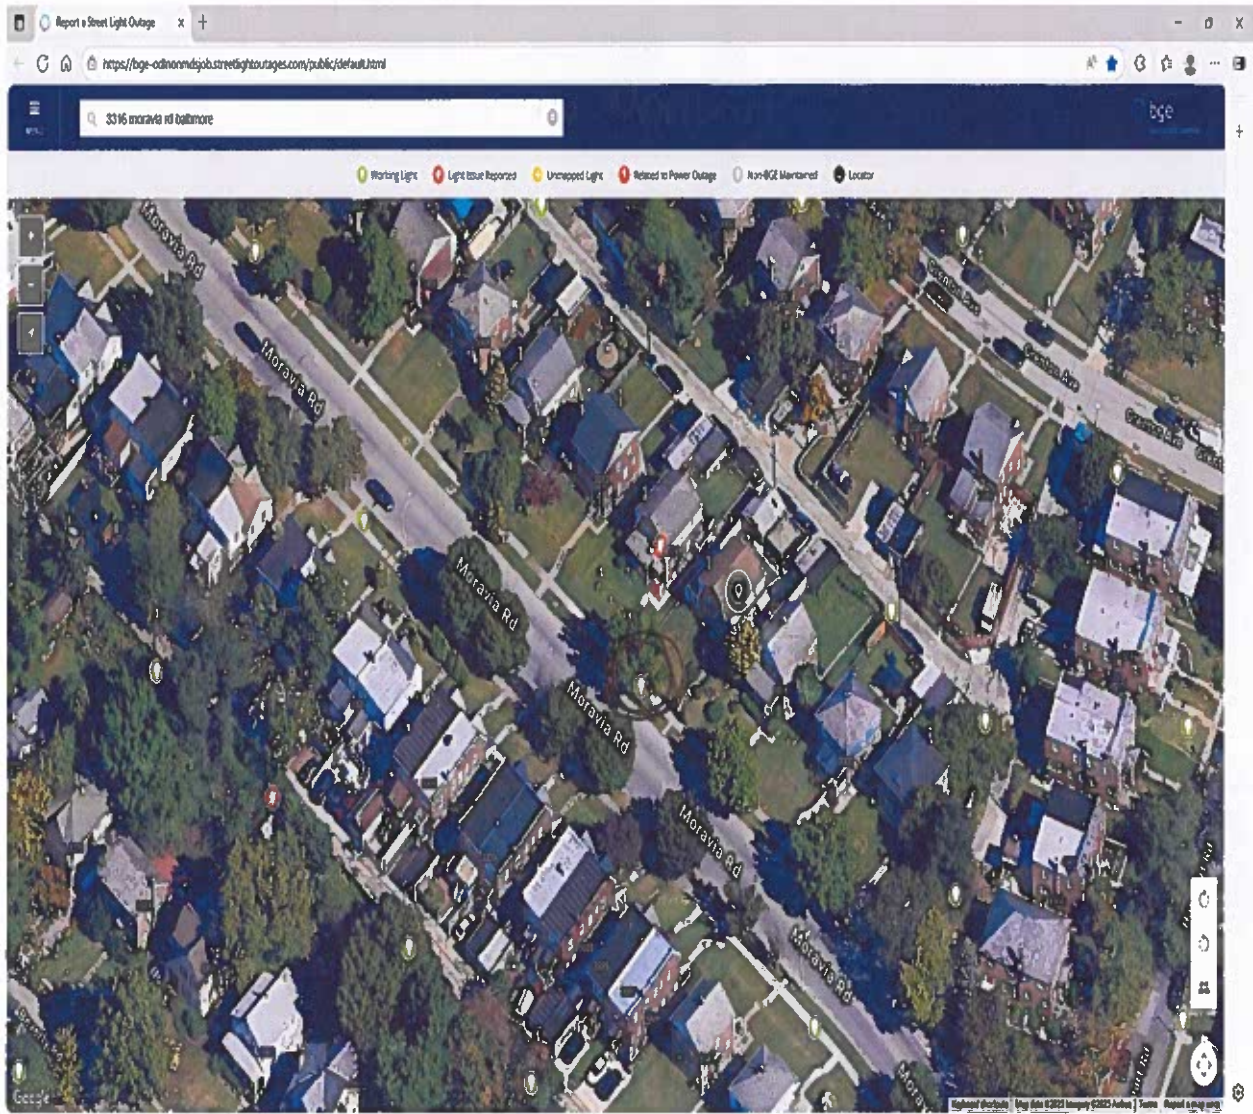
Missing ☒

NEEDS  
New Base

25 Foot  
Aluminum pole  
cobra head  
LED

Work Order #  
19974681
