# Inspections: Damaged Pole Report

Service Request 25-01009292 Sector: \_\_\_\_\_ Gateway: \_\_\_\_\_ Primary: \_\_\_\_\_  
 Location on Service Request: 12 E. Fort Ave  
 Grid : 4020130 LLC: 7548

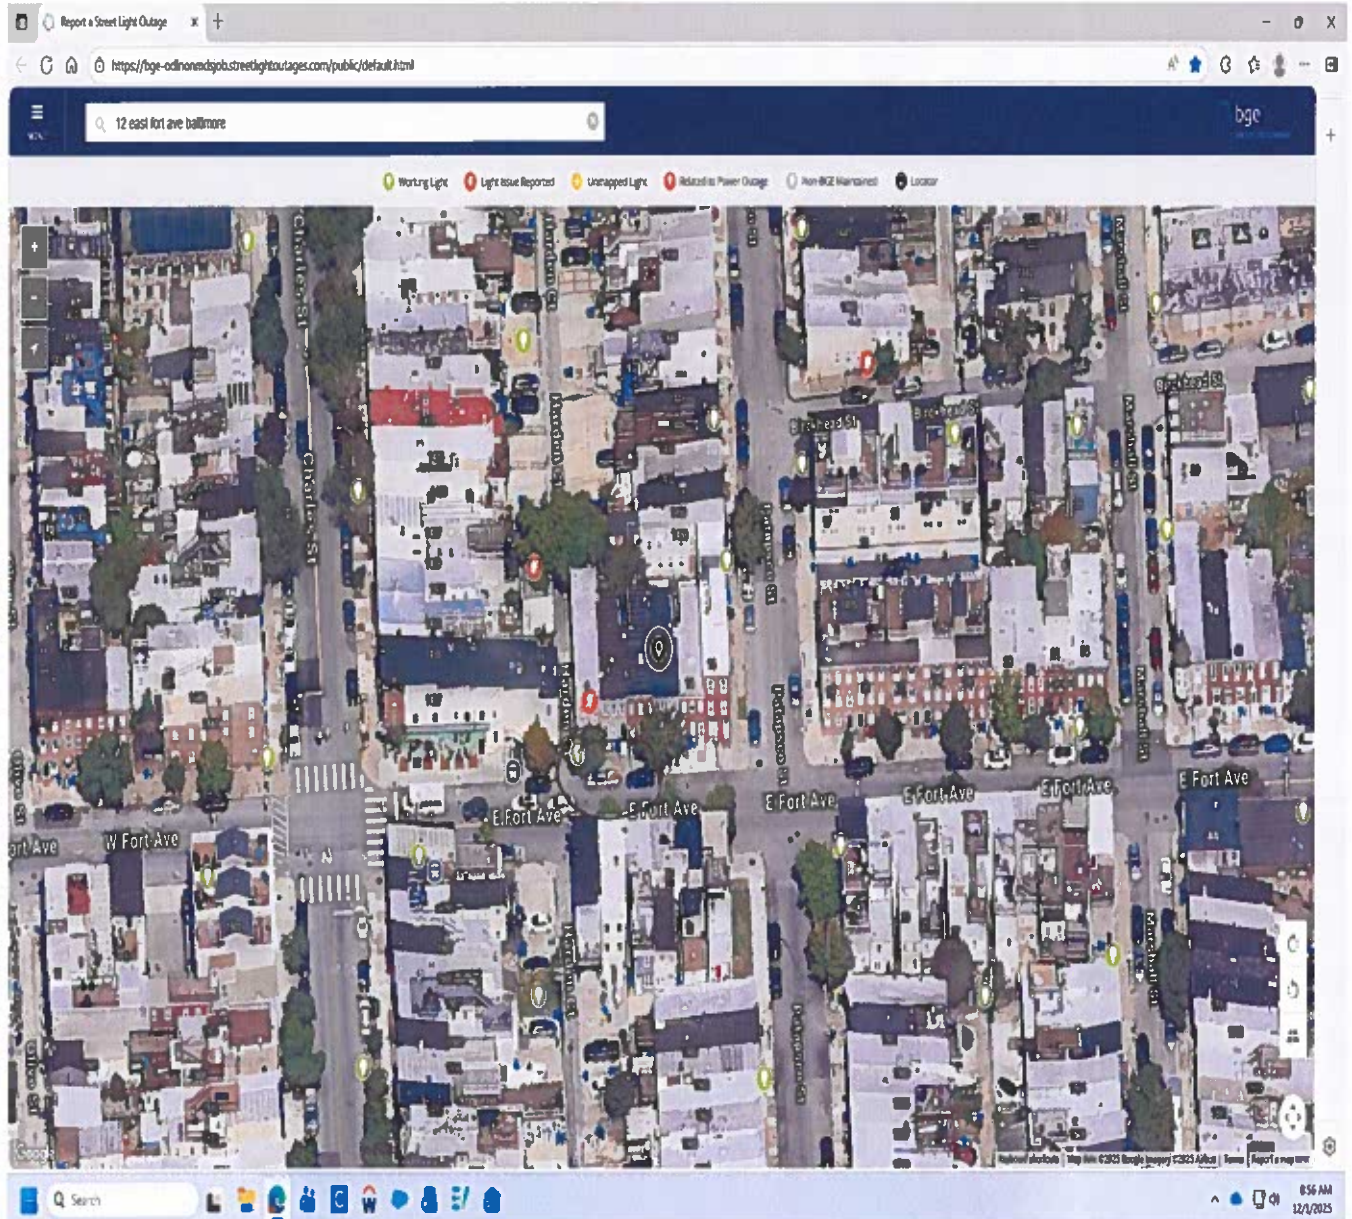
Deteriorated ☐  
 Missing ☒  
 Damaged ☐  
 Arm/Fixture Missing \_\_\_\_\_  
 Other \_\_\_\_\_

25 Foot  
Aluminum pole  
Cobra Head  
LED
