# Inspections: Damaged Pole Report

Service Request: 25-01010995 Sector: \_\_\_\_\_ Gateway: \_\_\_\_\_ Primary: \_\_\_\_\_  
 Location on Service Request: 1826 E. 28th<sup>st</sup>  
 Grid : 2020216 LLC: 7102

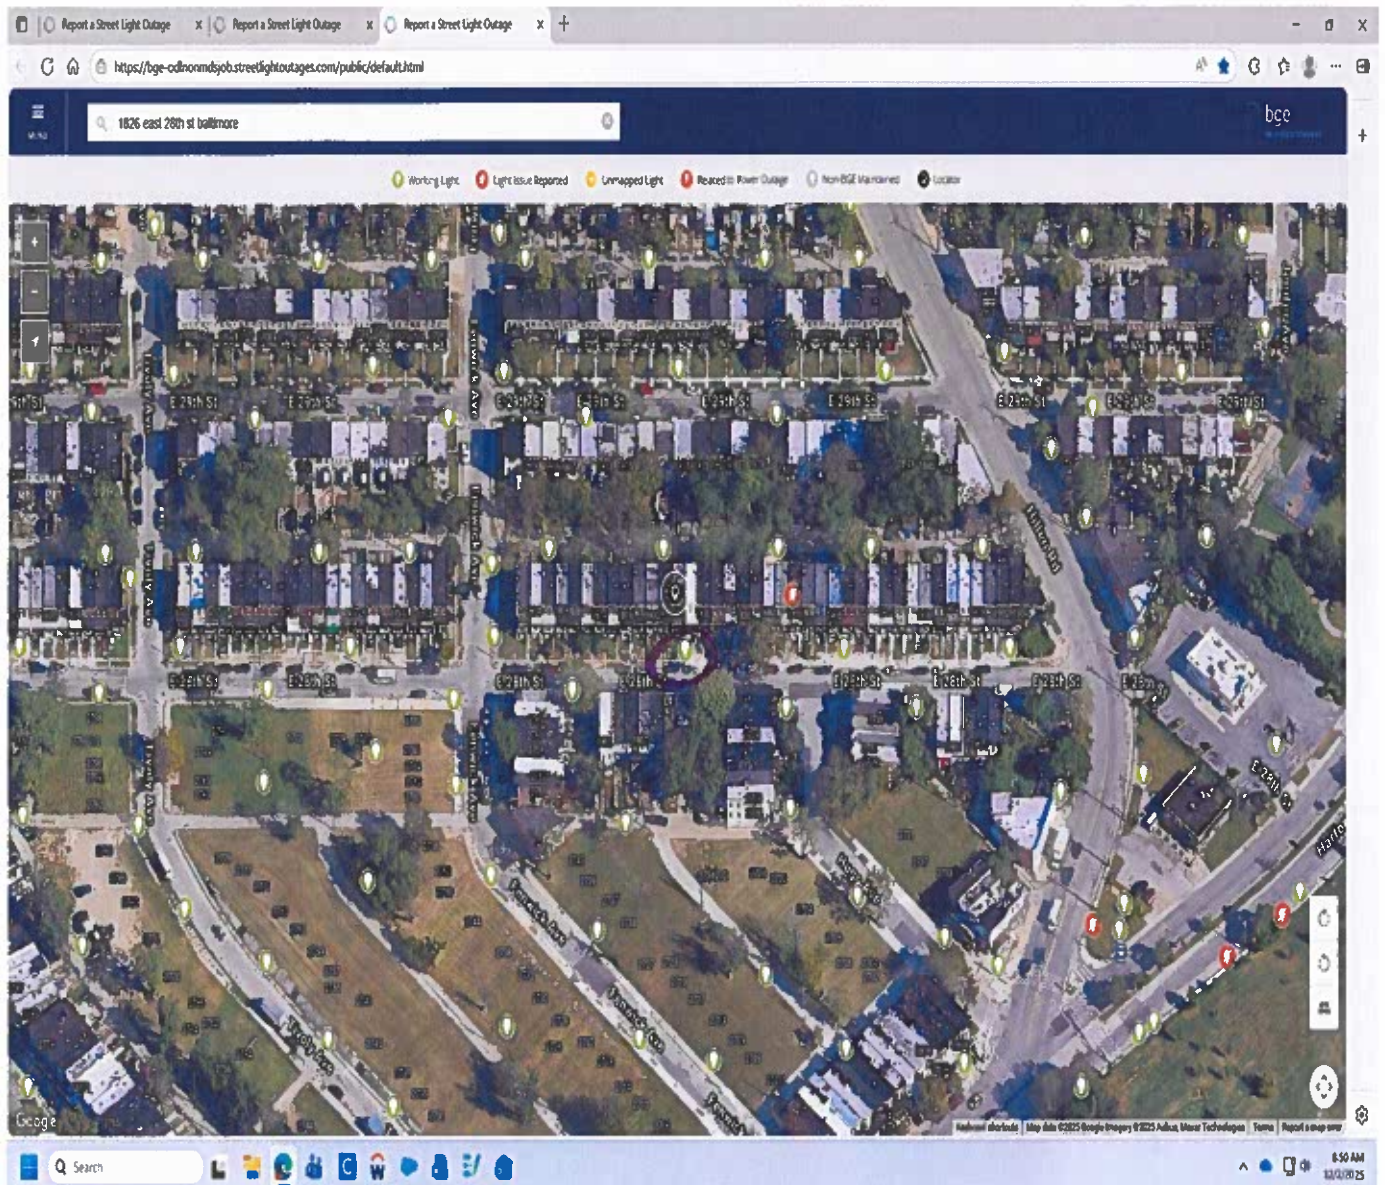
Deteriorated ☒  
 Missing ☒  
 Damaged \_\_\_\_\_  
 Arm/Fixture Missing \_\_\_\_\_  
 Other \_\_\_\_\_

NEEDS  
NEW BASE

PMA  
HPS
