# Inspections: Damaged Pole Report

Service Request 25-01014824 Sector: \_\_\_\_\_ Gateway: \_\_\_\_\_ Primary: \_\_\_\_\_

Location on Service Request: 429 S. Chester<sup>st</sup>

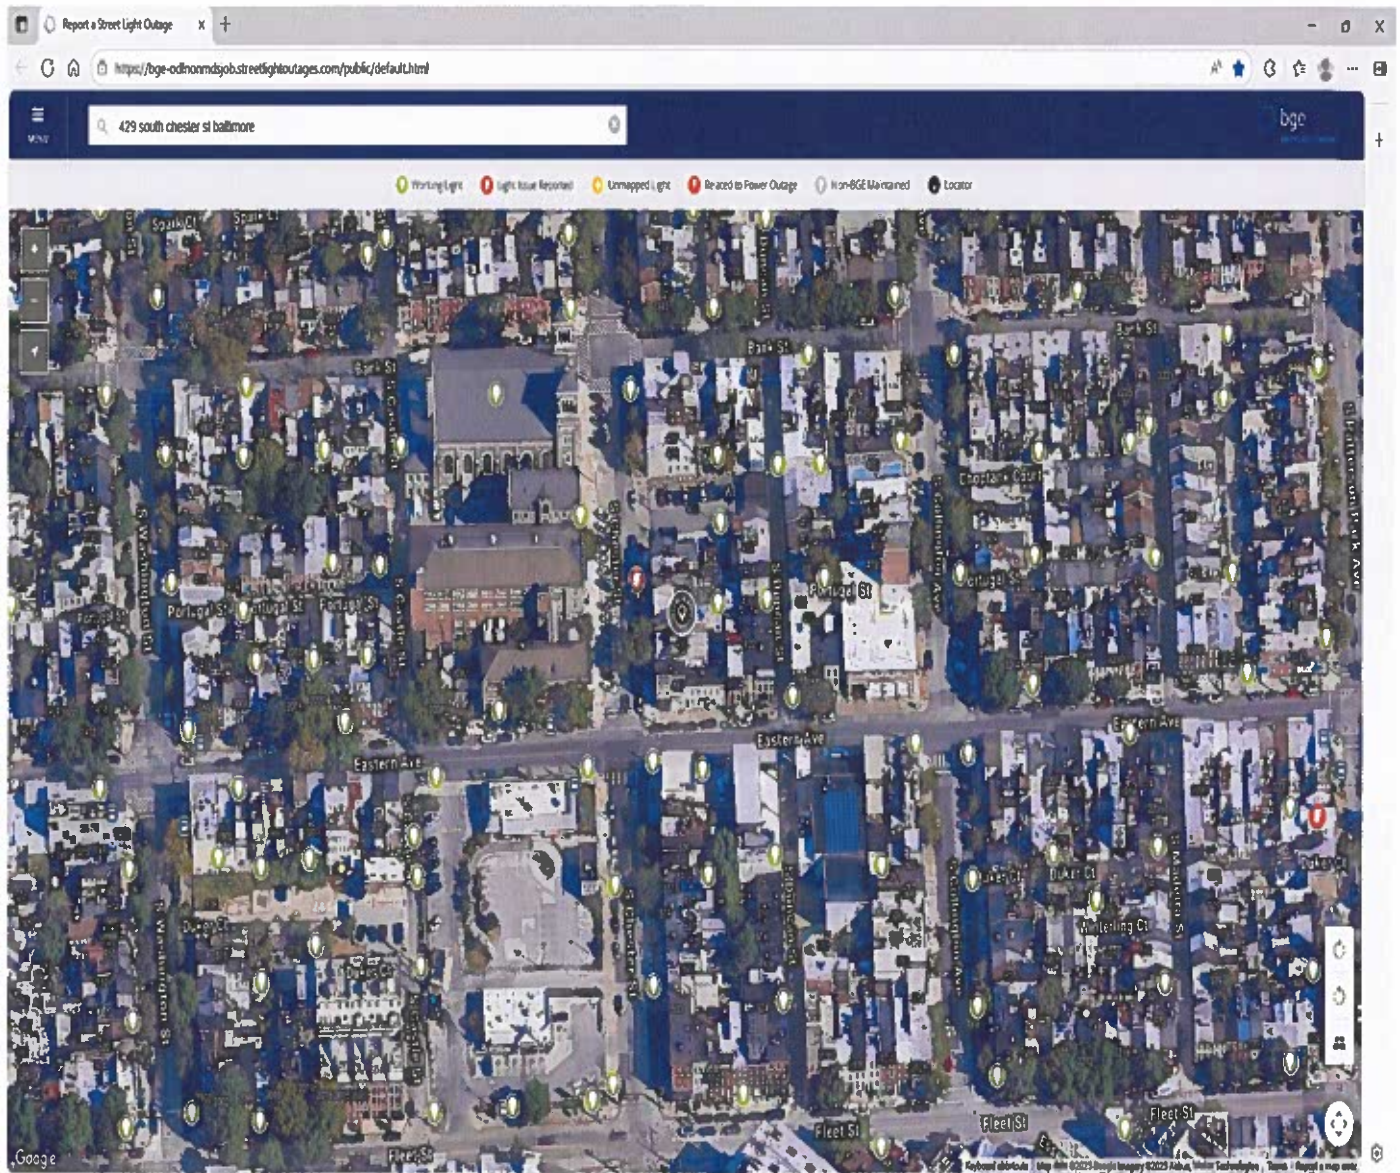
Missing ☒

NEEDS  
New Base

25 Foot  
Aluminum  
pole  
Cobra Head  
LED

Work order #  
20624467
