# Inspections: Damaged Pole Report

Service Request 25-01017461 Sector: \_\_\_\_\_ Gateway: \_\_\_\_\_ Primary: \_\_\_\_\_  
 Location on Service Request: 1524 Brentwood Ave  
 Grid : 2010110 LLC: 7155

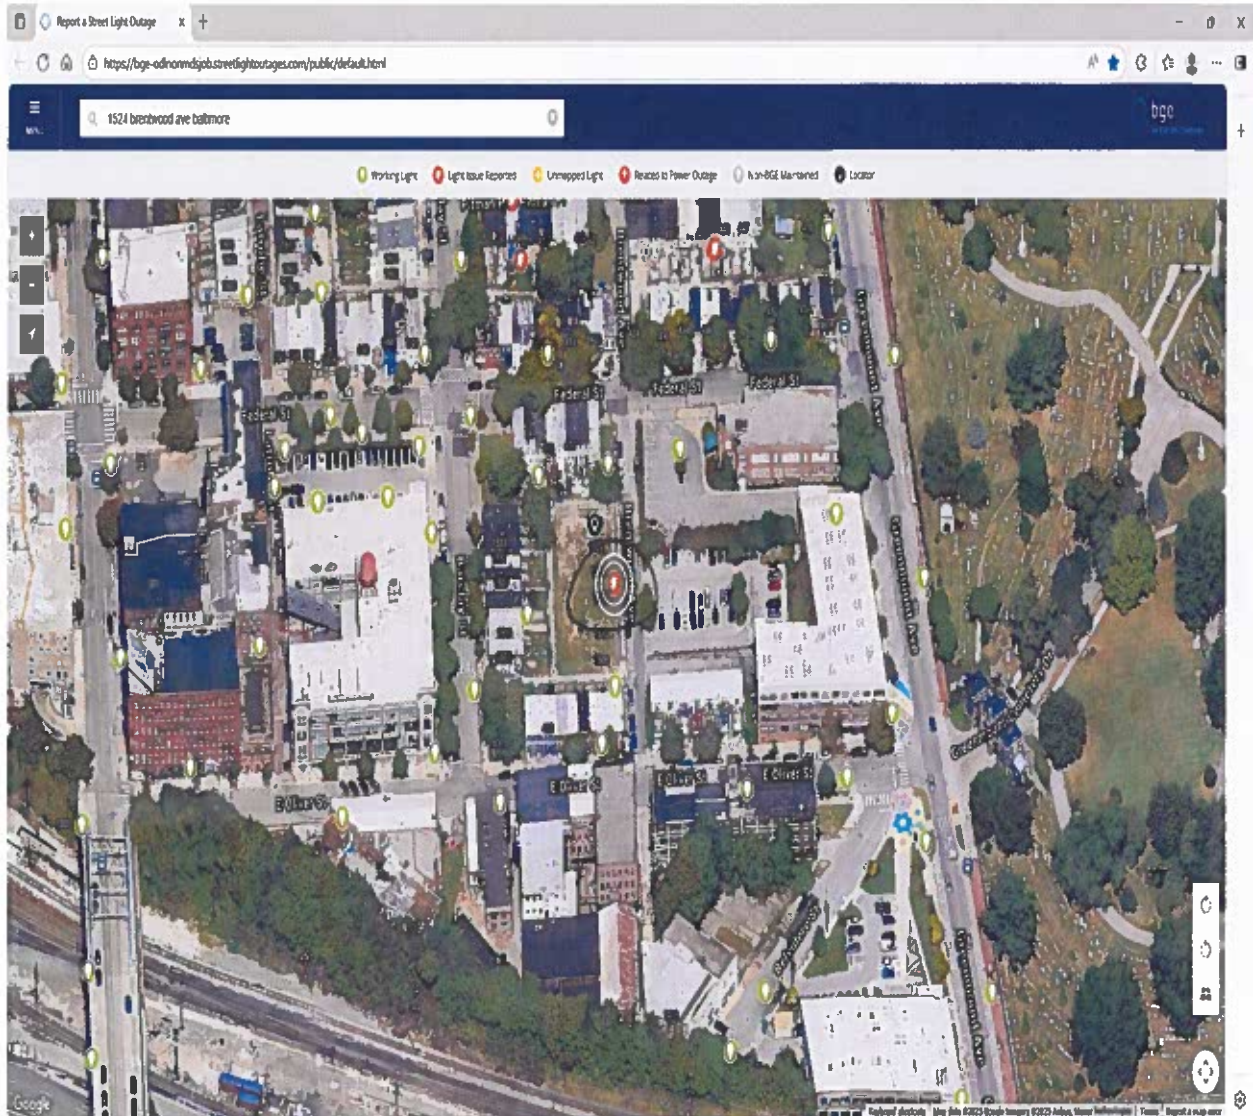
Deteriorated \_\_\_\_\_  
 Missing ☒  
 Damaged \_\_\_\_\_  
 Arm/Fixture Missing \_\_\_\_\_  
 Other \_\_\_\_\_

NEEDS  
New Base

25 Foot  
Aluminum  
pole  
Cobra Head  
LED
