# Inspections: Damaged Pole Report

Service Request: 25-01029678 Sector: \_\_\_\_\_ Gateway: \_\_\_\_\_ Primary: \_\_\_\_\_

Location on Service Request: 3400 Dillon St

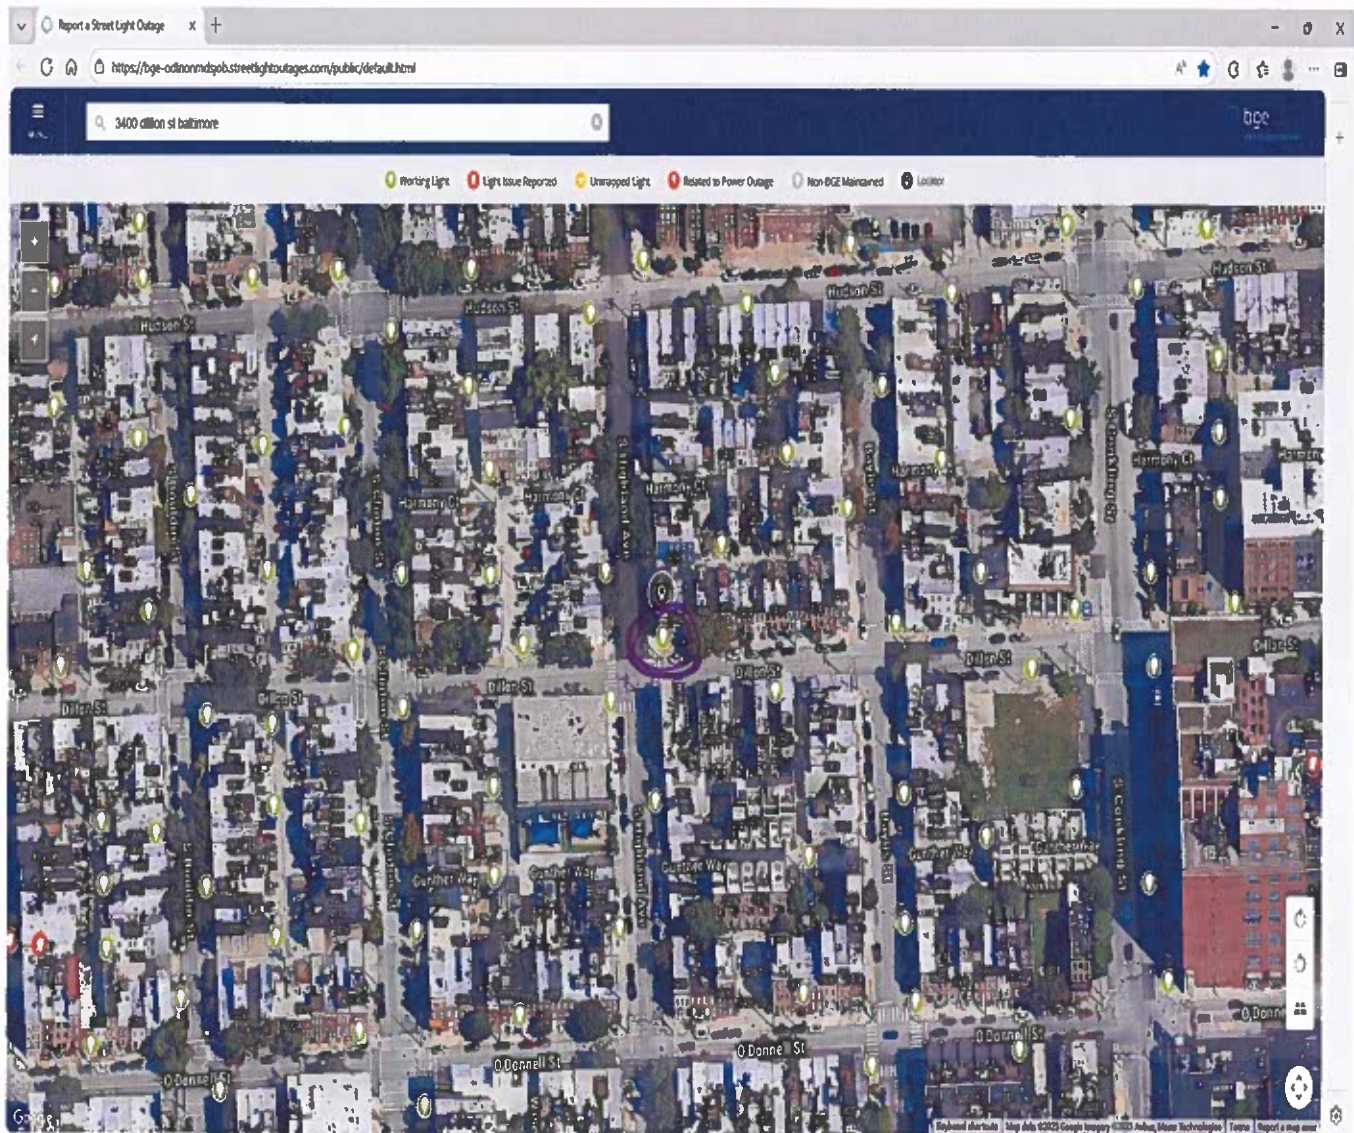
Deteriorated ☒

Missing ☒

25 Foot Aluminum  
pole  
Cobra Head  
LED
