Inspections: Damaged Pole Report

Service Request: 25-01039732 Sector \_\_\_\_\_ Gateway \_\_\_\_\_ Primary \_\_\_\_\_  
 Location on Service Request: E. Oliver St & N. Chester St  
 Grid : 2010210 LLC: 7518

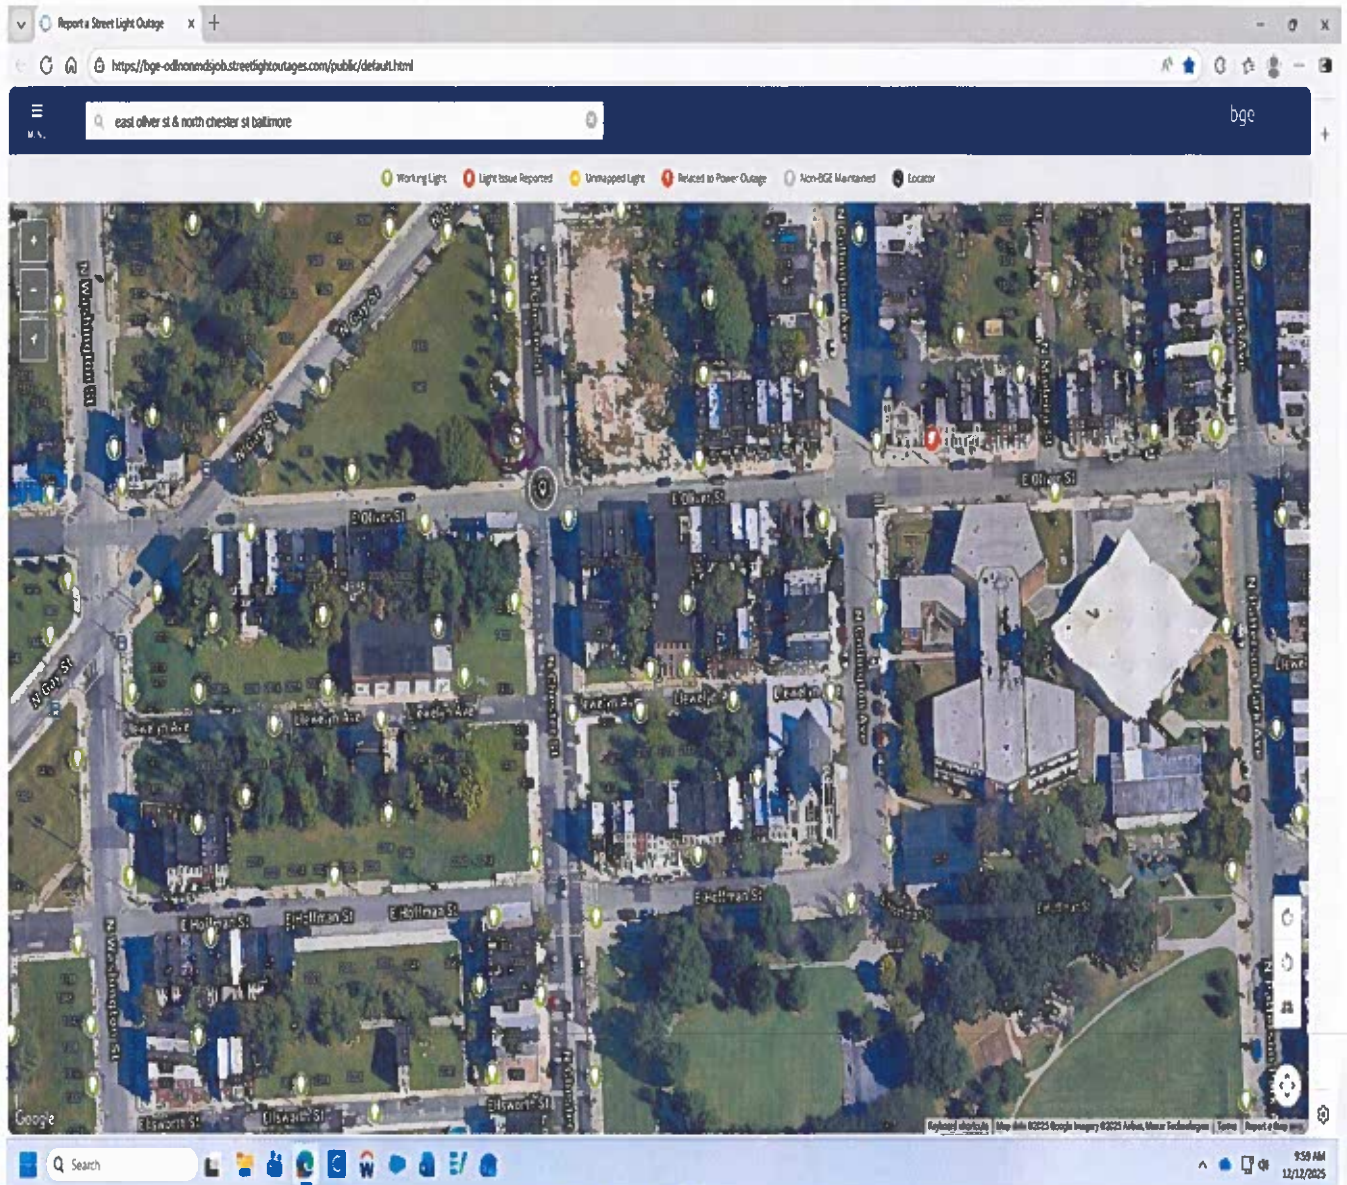
Missing ☒

25 Foot  
Aluminum pole  
Cobra Head  
LED
