# Inspections: Damaged Pole Report

Service Request: 25 01043804 Sector: \_\_\_\_\_ Gateway: \_\_\_\_\_ Primary: \_\_\_\_\_  
 Location on Service Request: 3610 Clifton Ave  
 Grid : 1010420 LLC: 7087

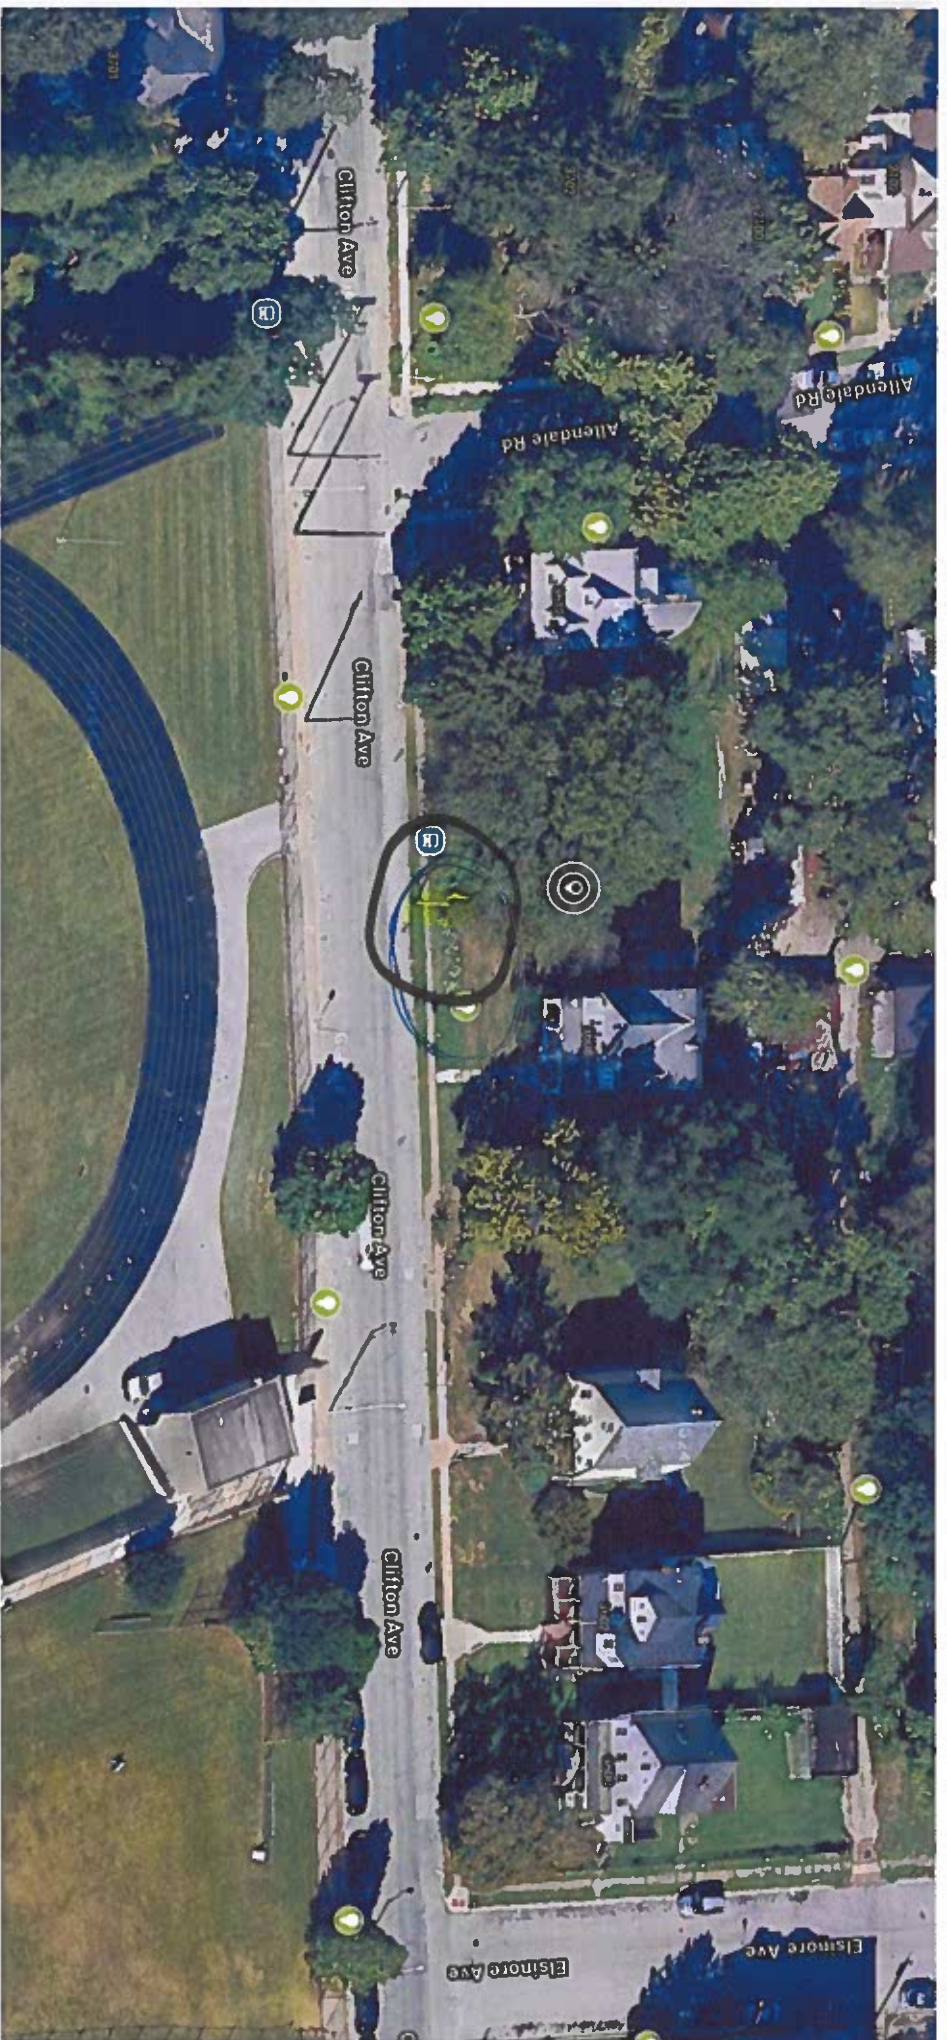
254 CHLED

Deteriorated \_\_\_\_\_  
 Missing ☒  
 Damaged \_\_\_\_\_  
 Arm/Fixture Missing \_\_\_\_\_  
 Other \_\_\_\_\_

**Location:** 3610 CLIFTON AVE, Baltimore City, 21216  
**Location Details:** It was removed Aug 1, 2025 case number 653020 and never replaced. It's dark on the street  
**Description:** Don't know if it's city or BGE maintained. Called the city to get it fixed when it was laying on the ground and it was removed immediately but not replaced
