# Inspection: Damaged Pole Report

Service Request 25-01056704 S to: Gateway Priority

Location on Service Request 951 Fell St

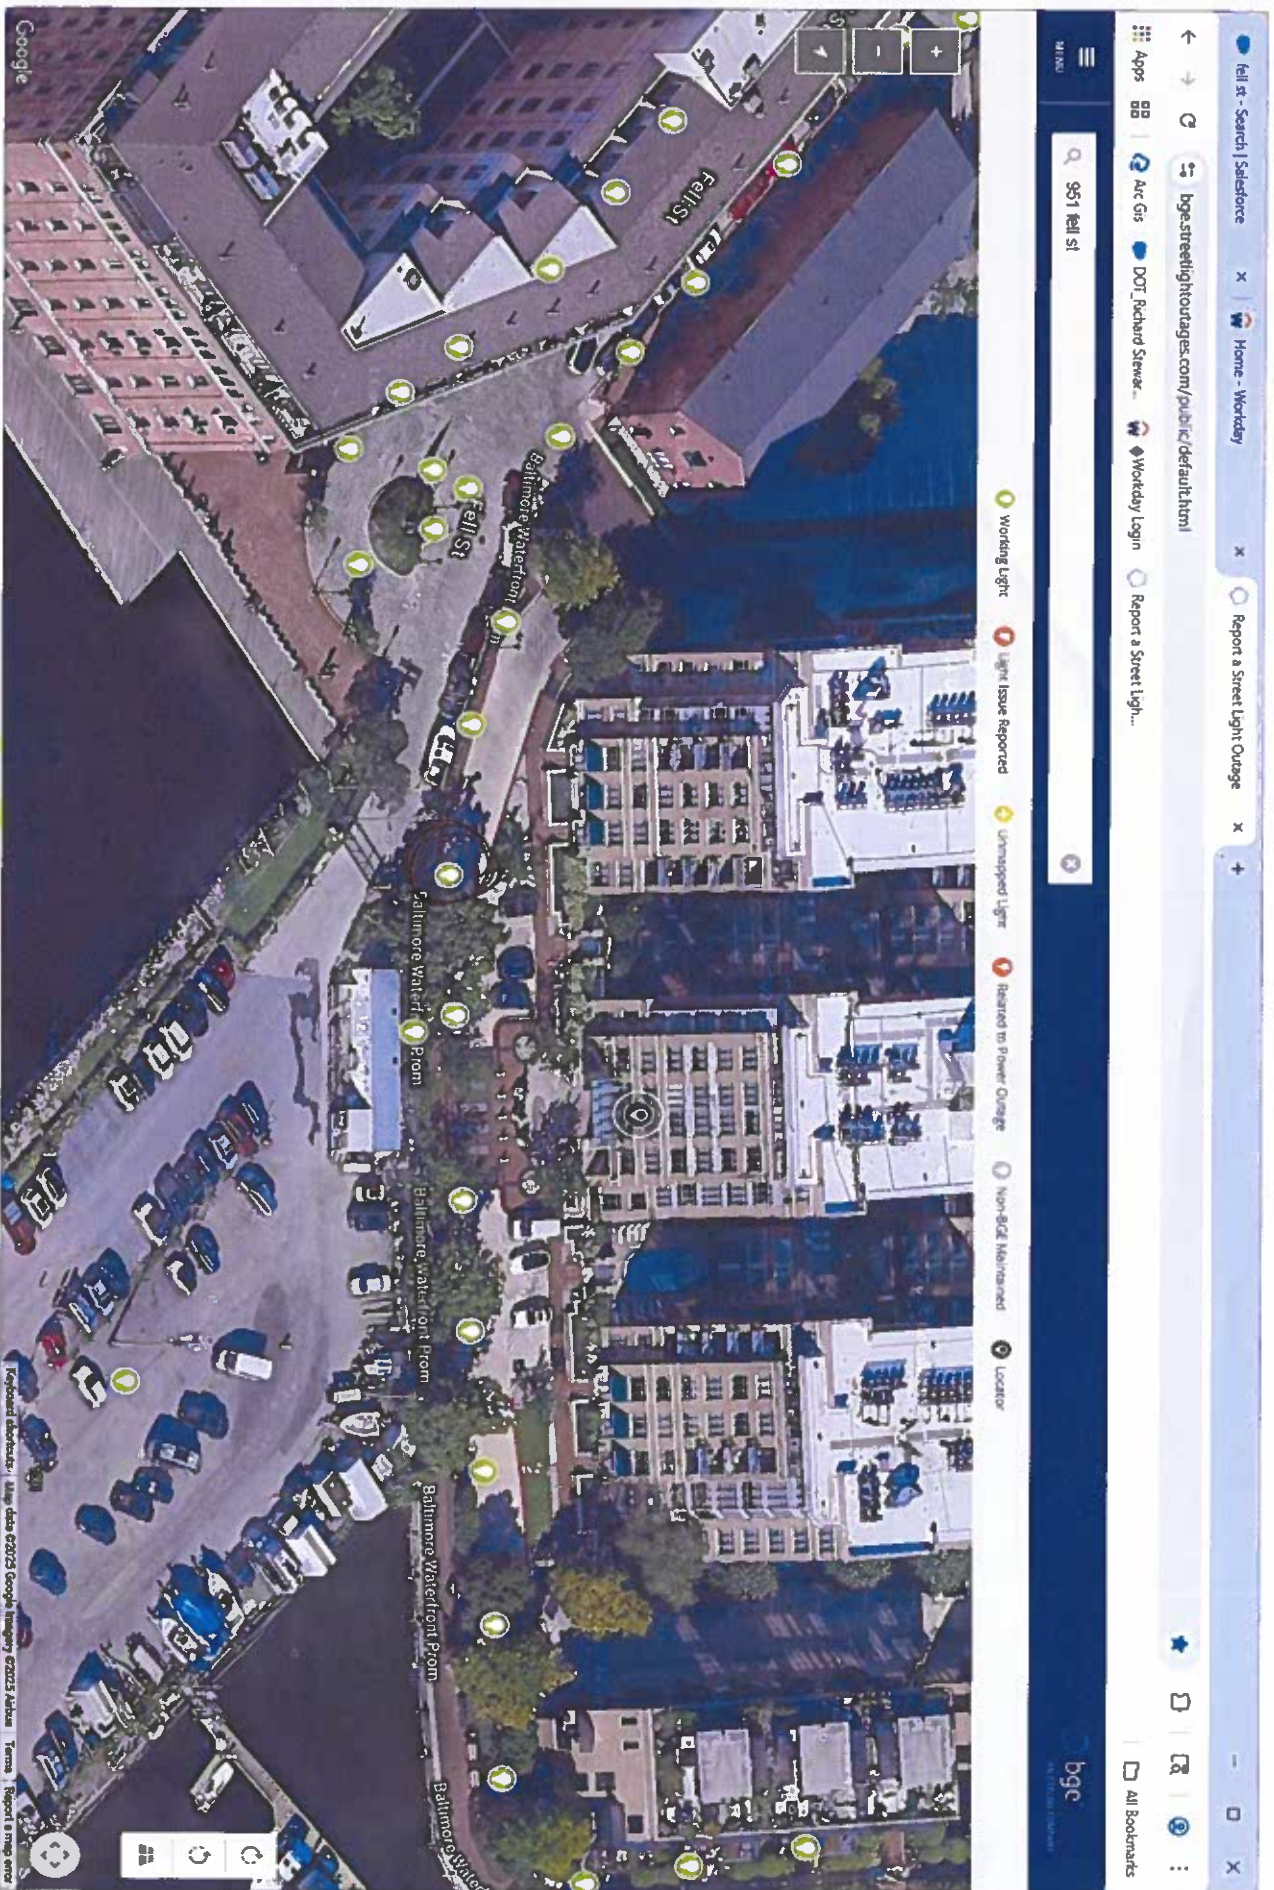
Deteriorated         
Missing ✓  
Damaged         
Arm/Fixture Missing         
Other

Off the beaten path  
of urban fixture
