Inspections Damaged Pole Report

Service Request **25-01084304** S to: Gateway Priority  
 Location on Service Request **3415 Hudson St**  
 Grid : **4020320** LLC: **7085**

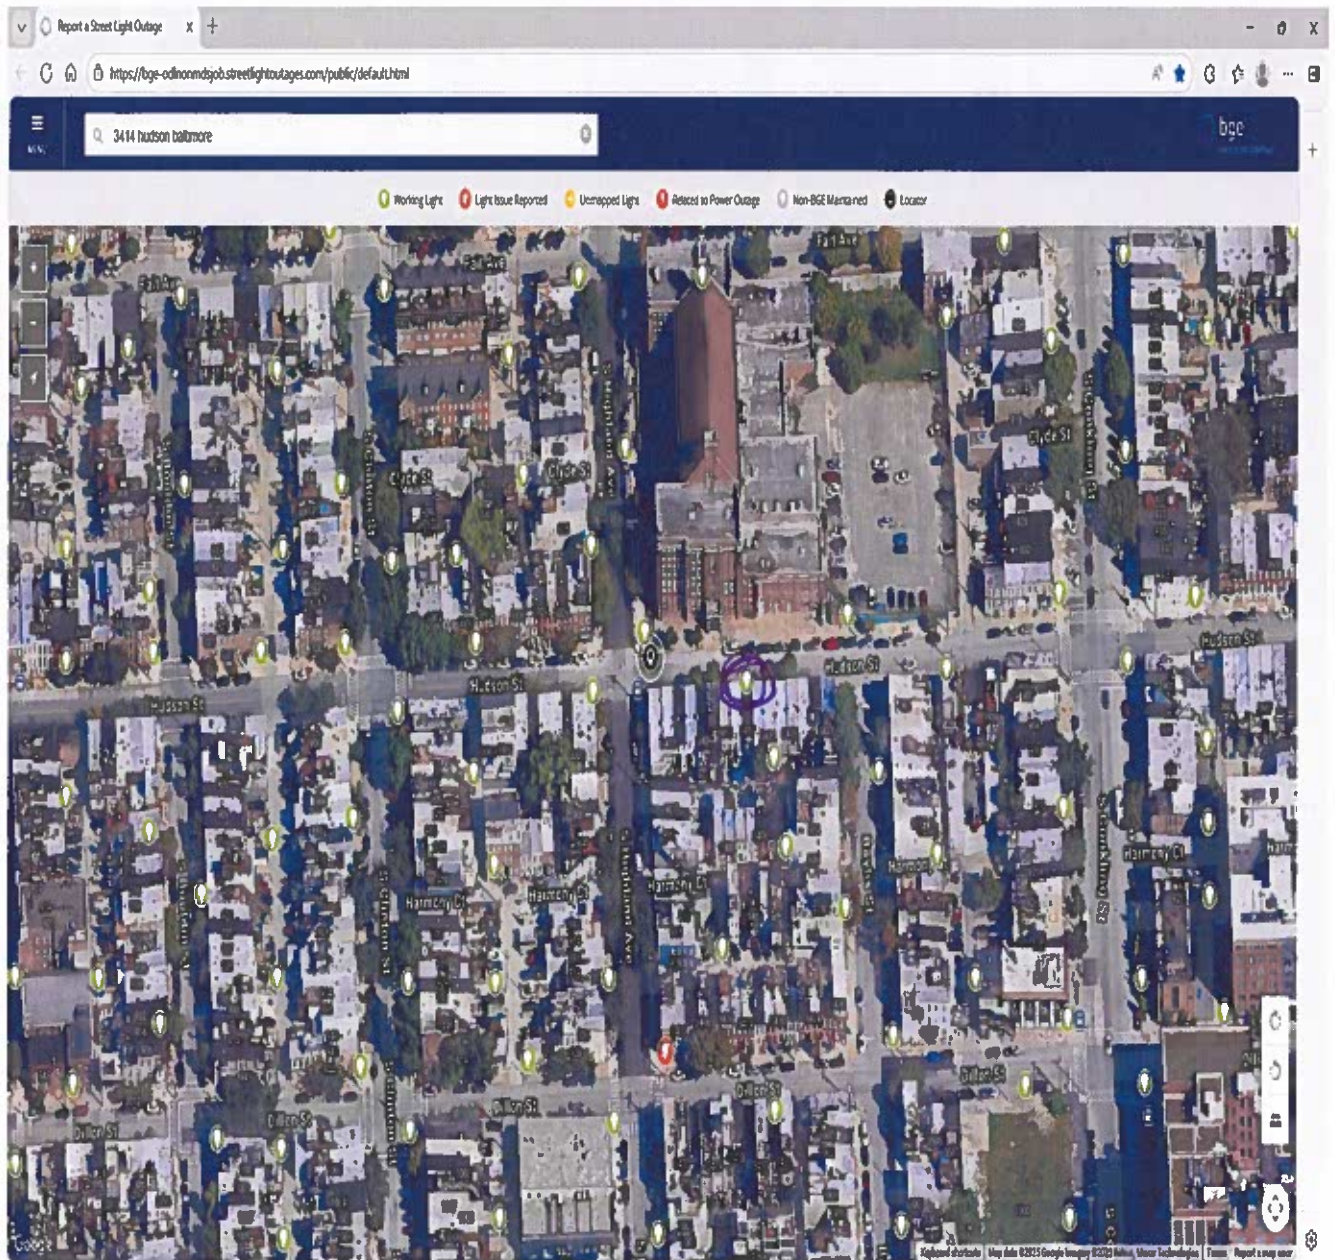
Deteriorated ☒  
 Missing ☒  
 Damaged ☐  
 Arm/Fixture Missing ☐  
 Other ☐

**NEEDS  
New Base**

25 Foot Aluminum  
pole  
Cobra Head  
LED
