# Inspections: Damaged Pole Report

Service Request: 26-00000760 Sector: \_\_\_\_\_ Gateway: \_\_\_\_\_ Primary: \_\_\_\_\_

Location on Service Request: 3100 Guilford Ave

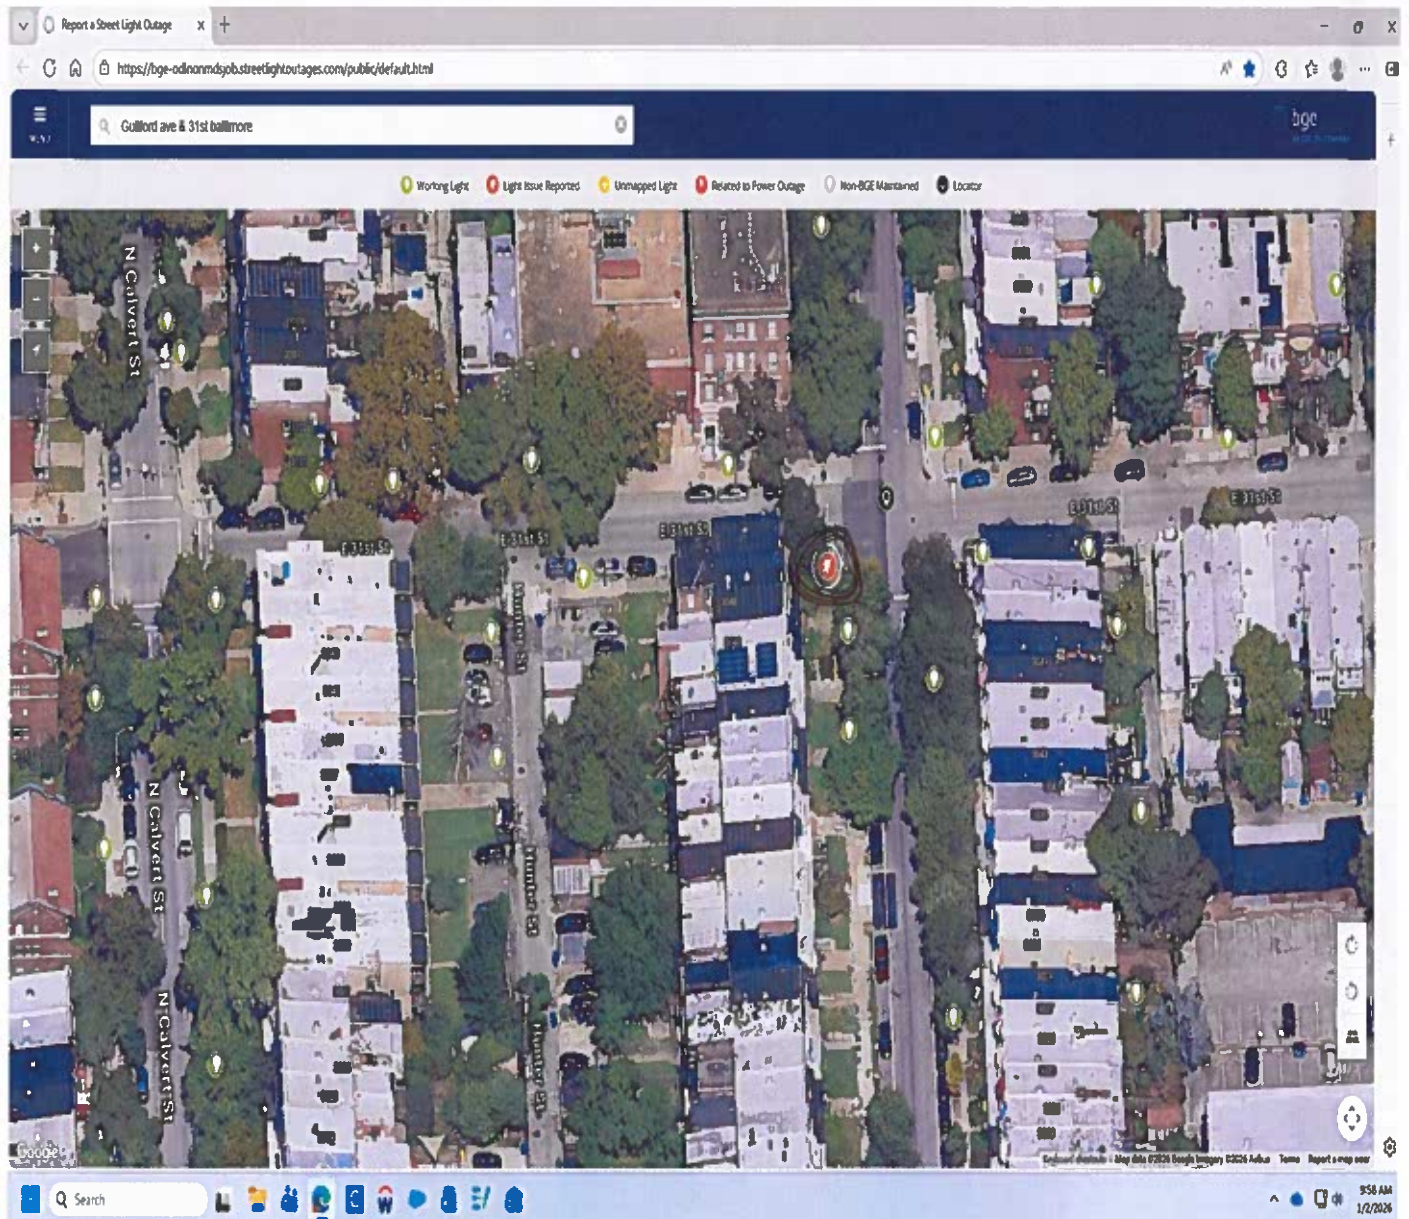
Deteriorated \_\_\_\_\_  
Missing ☒  
Damaged \_\_\_\_\_  
Arm/Fixture Missing \_\_\_\_\_  
Other \_\_\_\_\_

NEEDS  
New Base

30 Foot Aluminum  
pole  
COBRA Head  
LED
