# Inspections: Damaged Pole Report

Service Request: 25-01091331 Sector: \_\_\_\_\_ Gateway: \_\_\_\_\_ Primary: \_\_\_\_\_

Location on Service Request: 135 N. Broadway

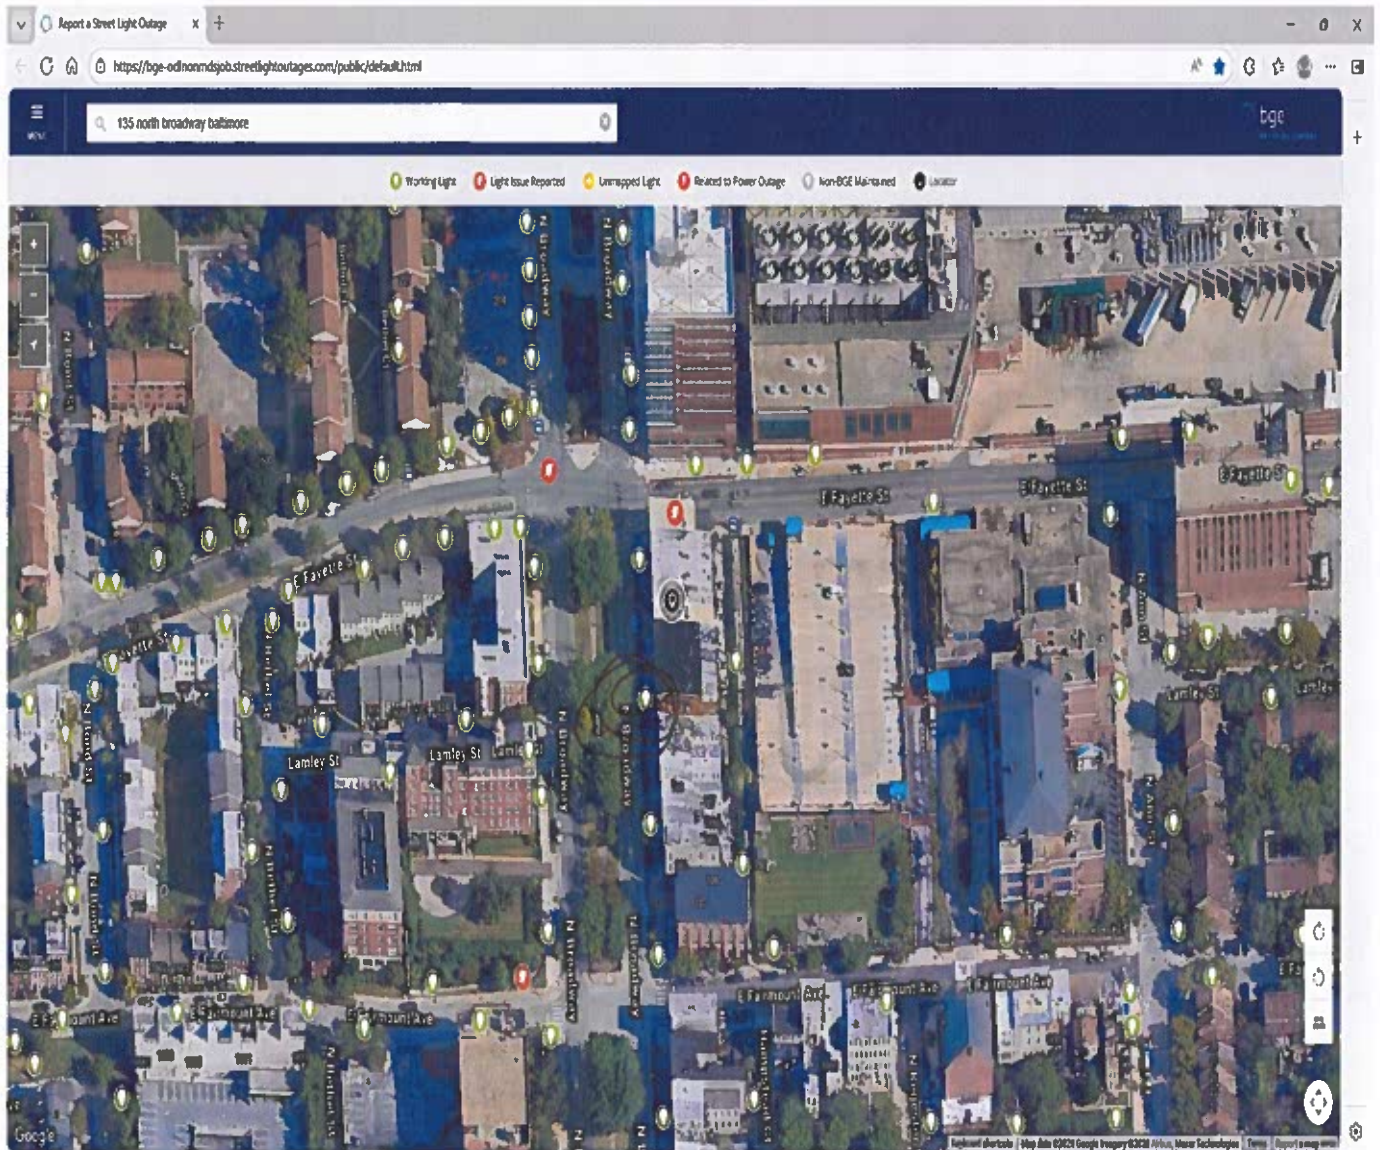
Deteriorated ☒  
Missing ☒  
Damaged \_\_\_\_\_  
Arm/Fixture Missing \_\_\_\_\_  
Other \_\_\_\_\_

NEEDS  
New Base

25 Foot  
Steel pole  
Cobra Head  
LED
