# Inspections: Damaged Pole Report

Service Request: 25-01091087 Sector: \_\_\_\_\_ Gateway: \_\_\_\_\_ Primary: \_\_\_\_\_

Location on Service Request: 24 N. Ironwood Ave

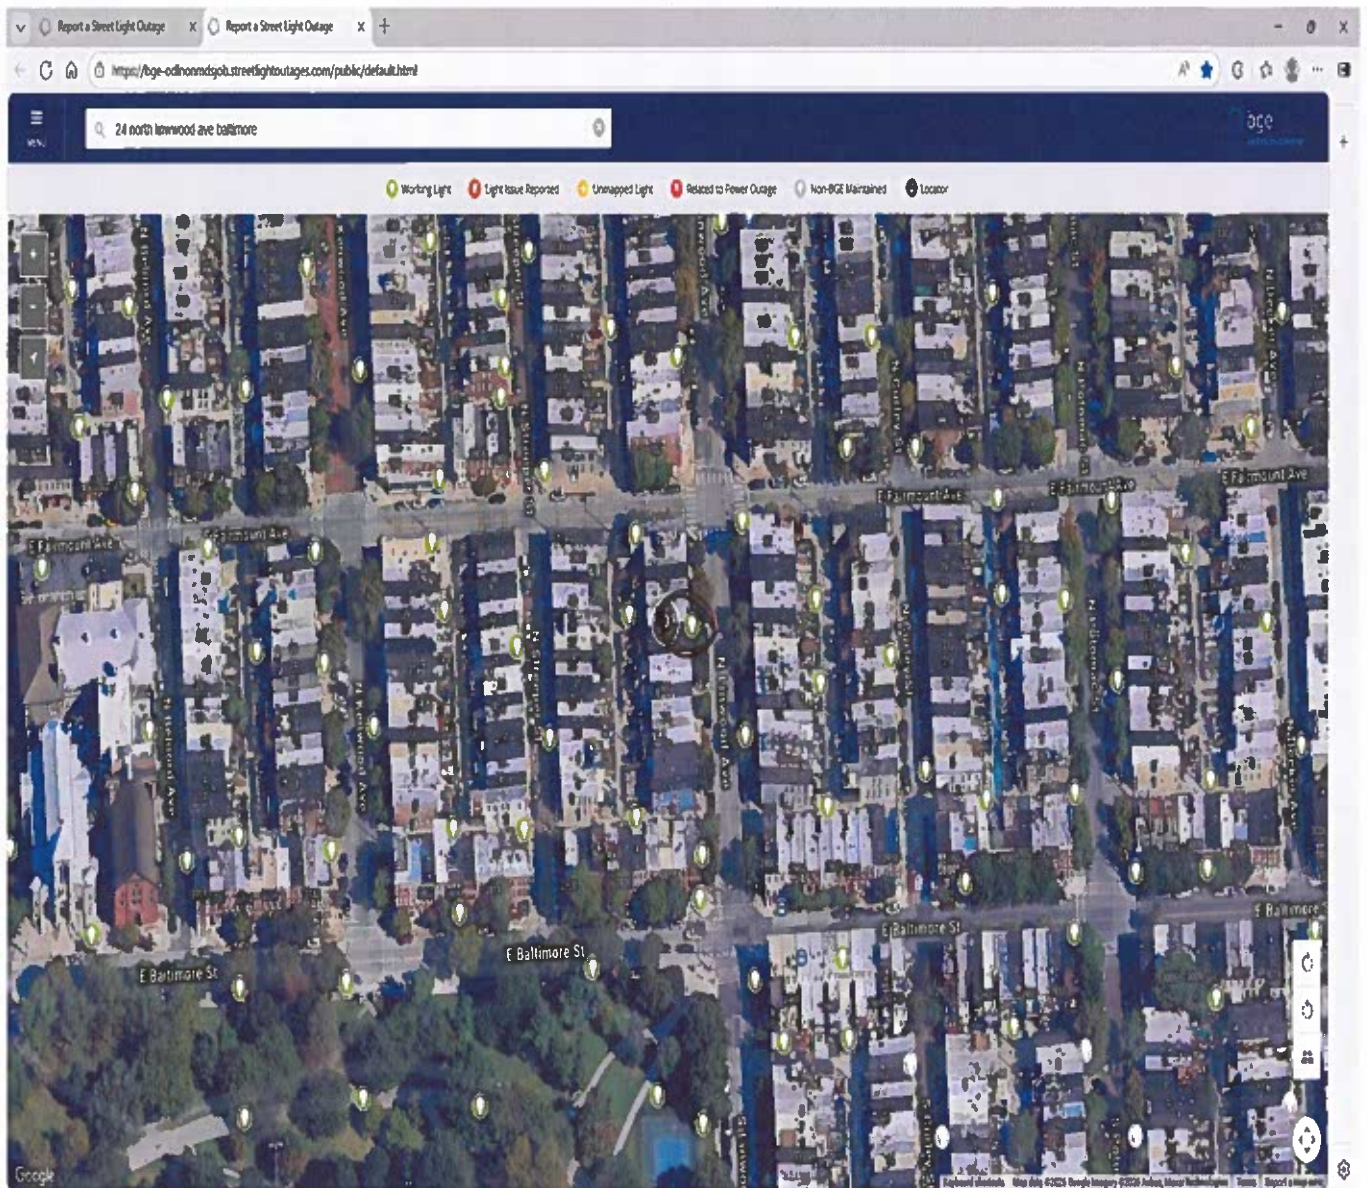
25 Foot Aluminum pole  
Corona Hiend  
LED
