Inspections: Damaged Pole Report

Service Request: 25-00964606 Sector: \_\_\_\_\_ Gateway: \_\_\_\_\_ Primary: \_\_\_\_\_  
 Location on Service Request: 3700 Tudor Arms Ave  
 Grid : 1030130 LLC: 7166

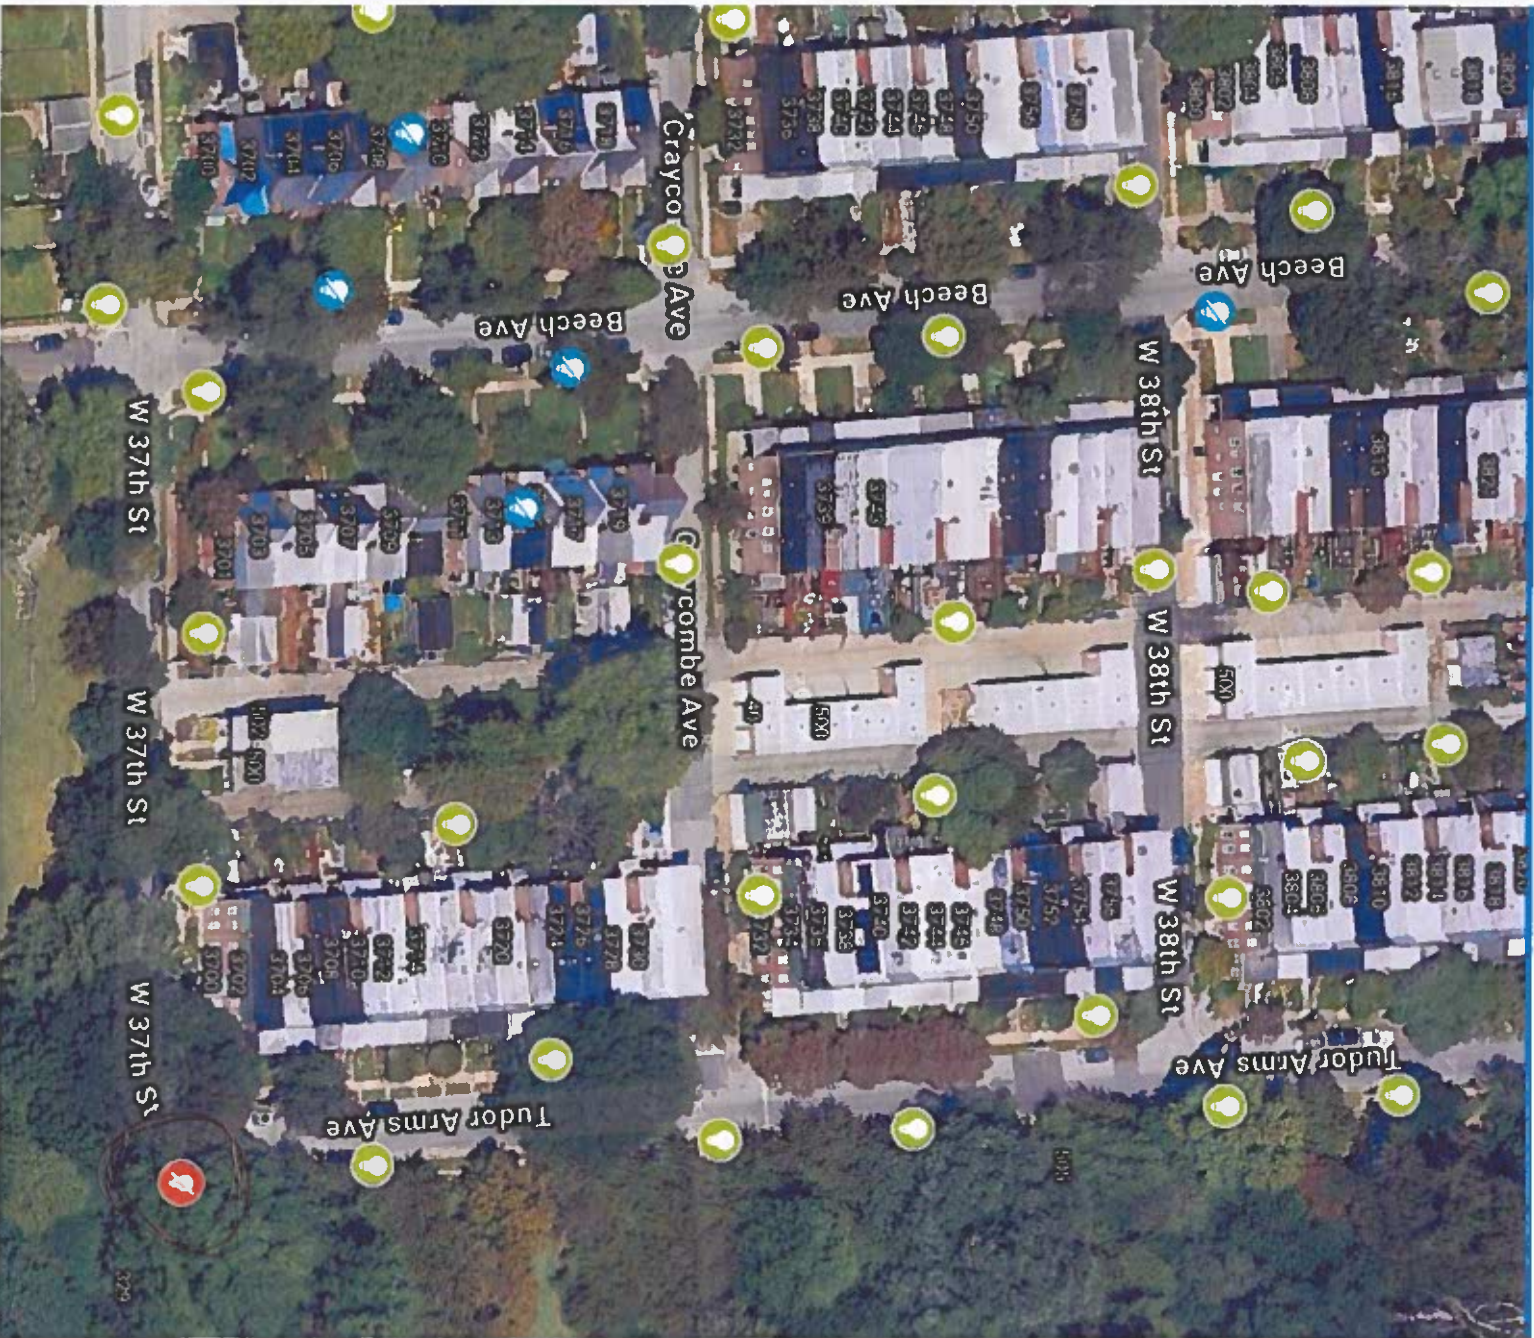
Missing ☒

Need new base

**Location:** 3700 TUDOR ARMS AVE, Baltimore City, 21211  
**Location Details:** Corner of W 37th and Tudor Arms Ave 21211  
**Description:** Pole was hit by a car traveling the wrong way on a one way street. Pole Already had a dent at the bottom and went over when hit by the car
