# Inspections: Damaged Pole Report

Service Request: 26-00010695 Sector: \_\_\_\_\_ Gateway: \_\_\_\_\_ Primary: \_\_\_\_\_

Location on Service Request: S. High St & Trinity St

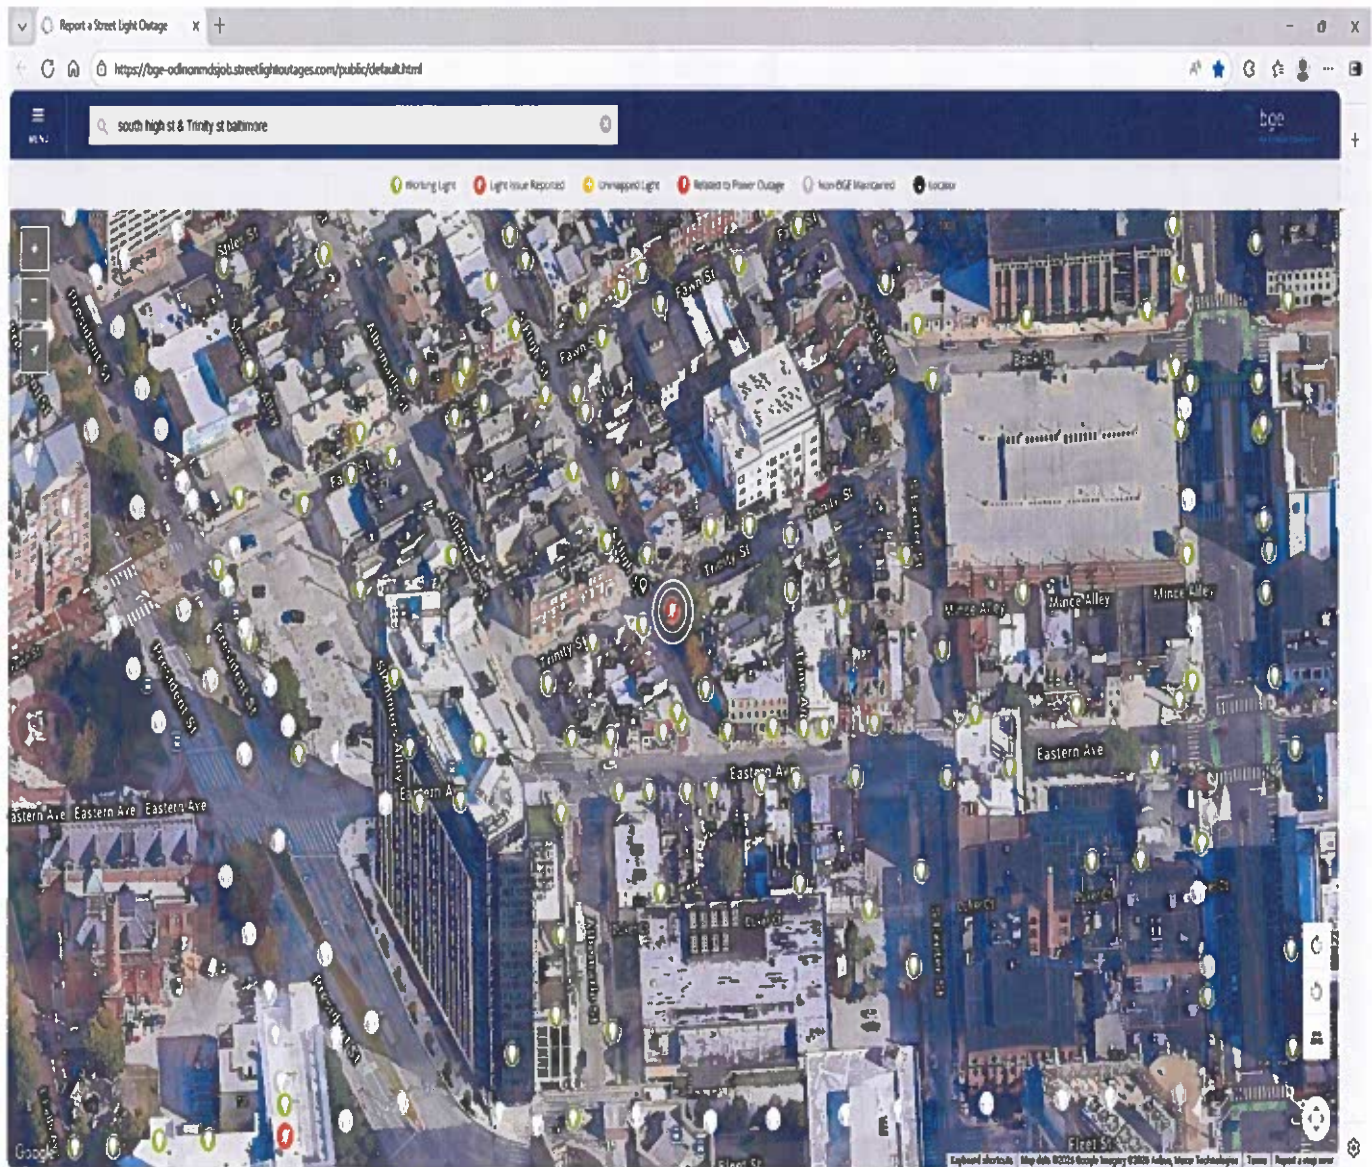
Deteriorated ☒

Missing ☒

25 Foot Aluminum  
pole  
Cobra Hiend  
LED

**NEEDS  
New Base**

**work order #  
20557156**
