# Inspections: Damaged Pole Report

Service Request: 26-00026362 Sector: \_\_\_\_\_ Gateway: \_\_\_\_\_ Primary: \_\_\_\_\_

Location on Service Request: 4913 Goodnow Rd

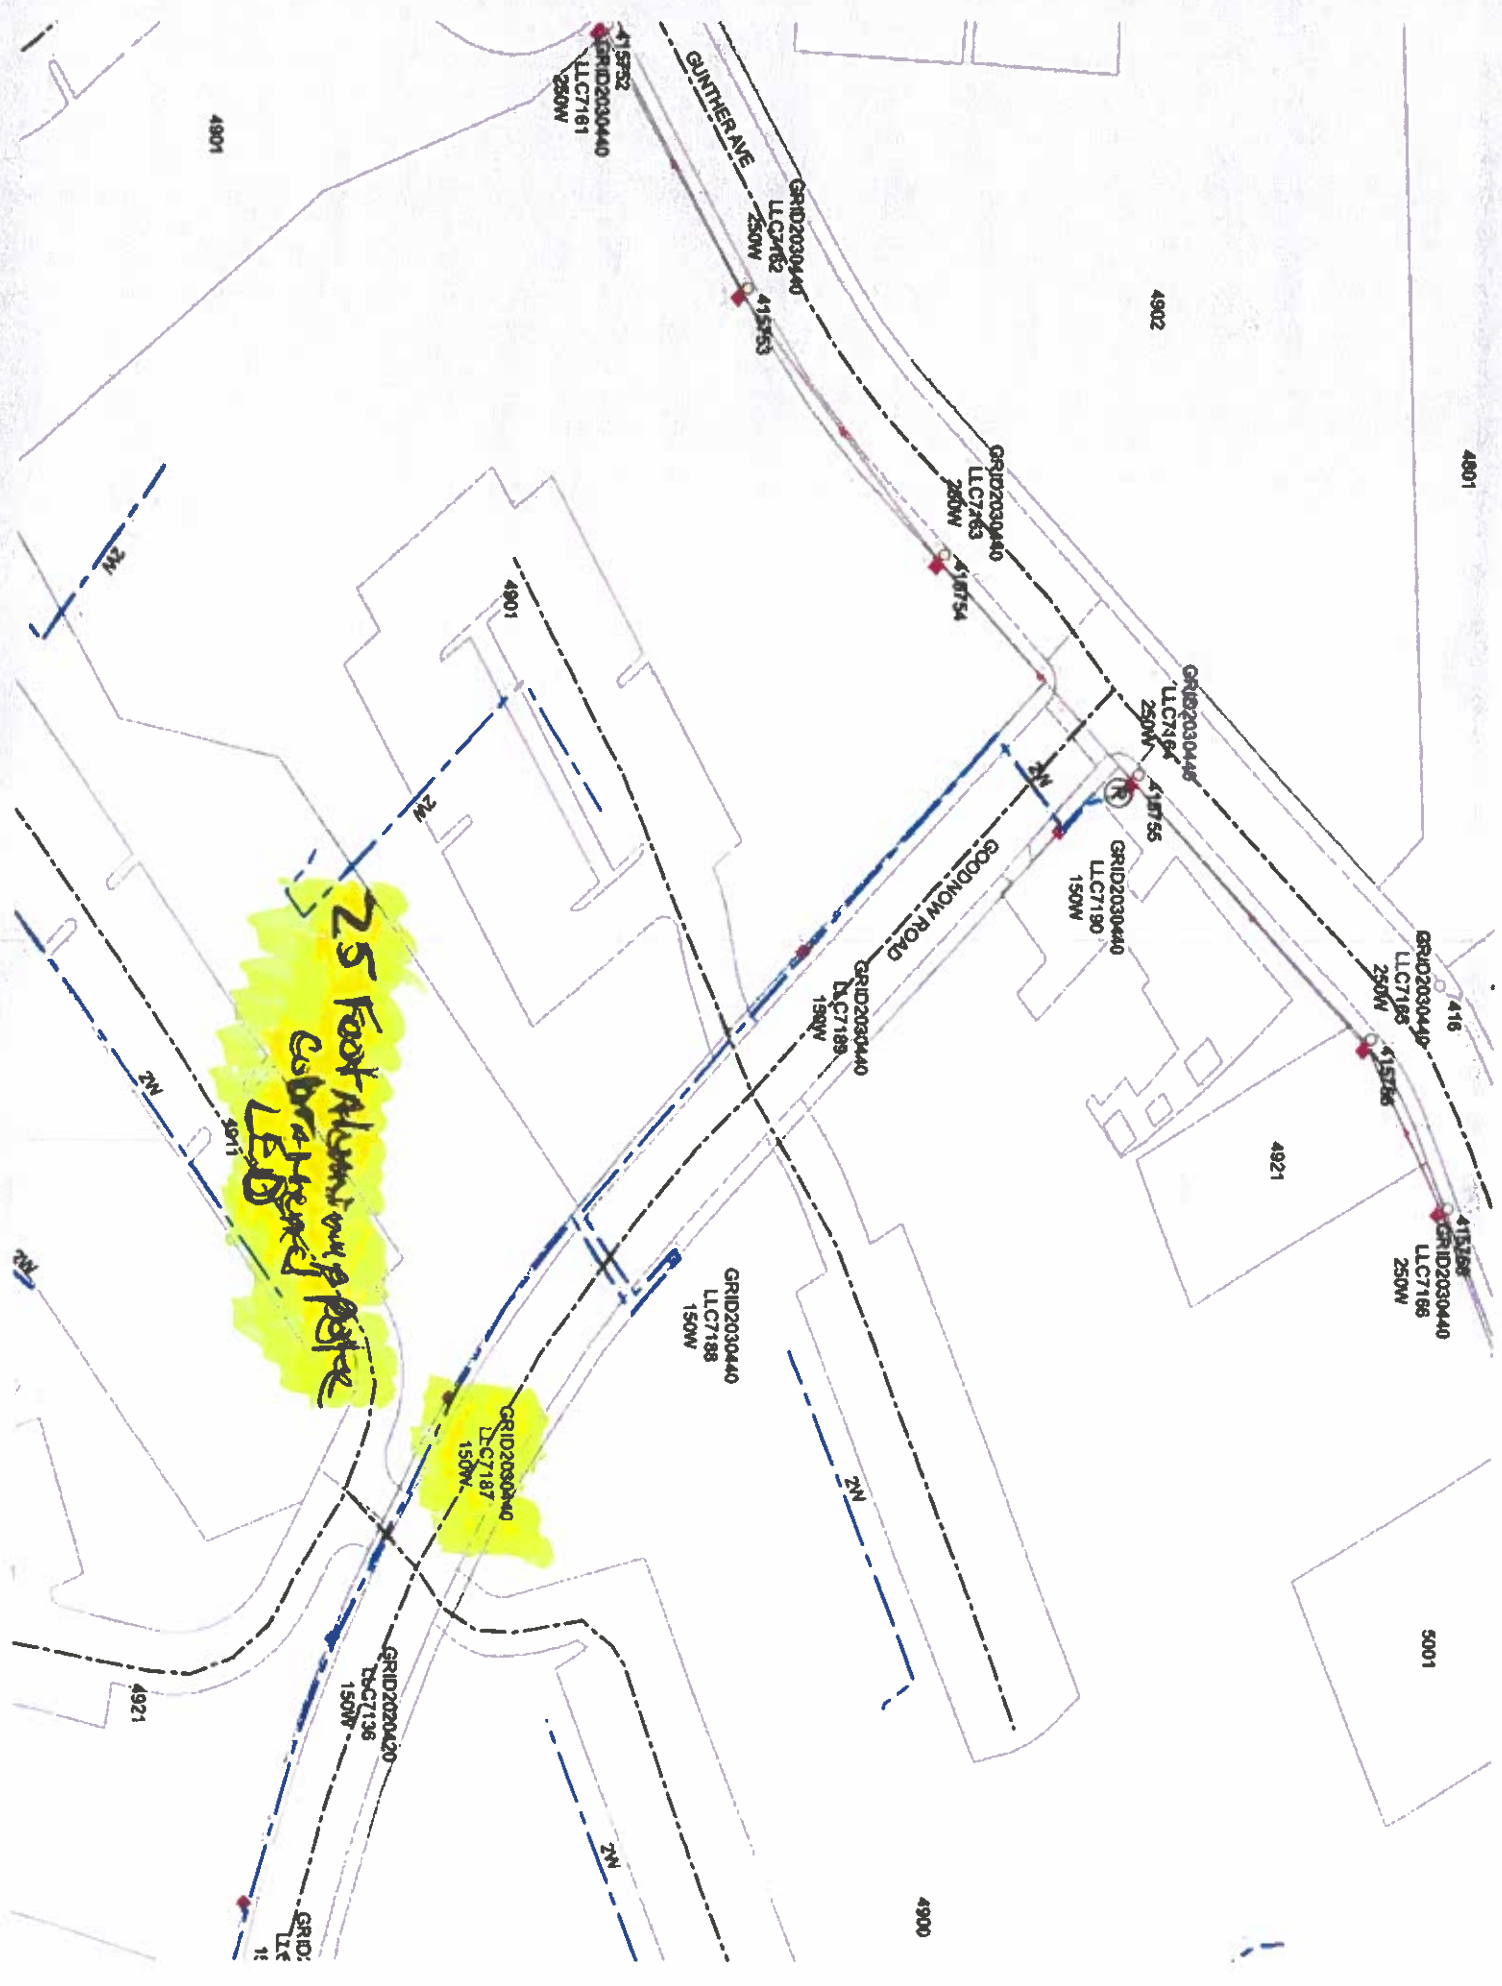
Missing ☒

NEEDS  
New  
Base
