# Inspections: Damaged Pole Report

Service Request: 26-00035824 Sector: \_\_\_\_\_ Gateway: \_\_\_\_\_ Primary: \_\_\_\_\_

Location on Service Request: 1227 Eo LAWVale St

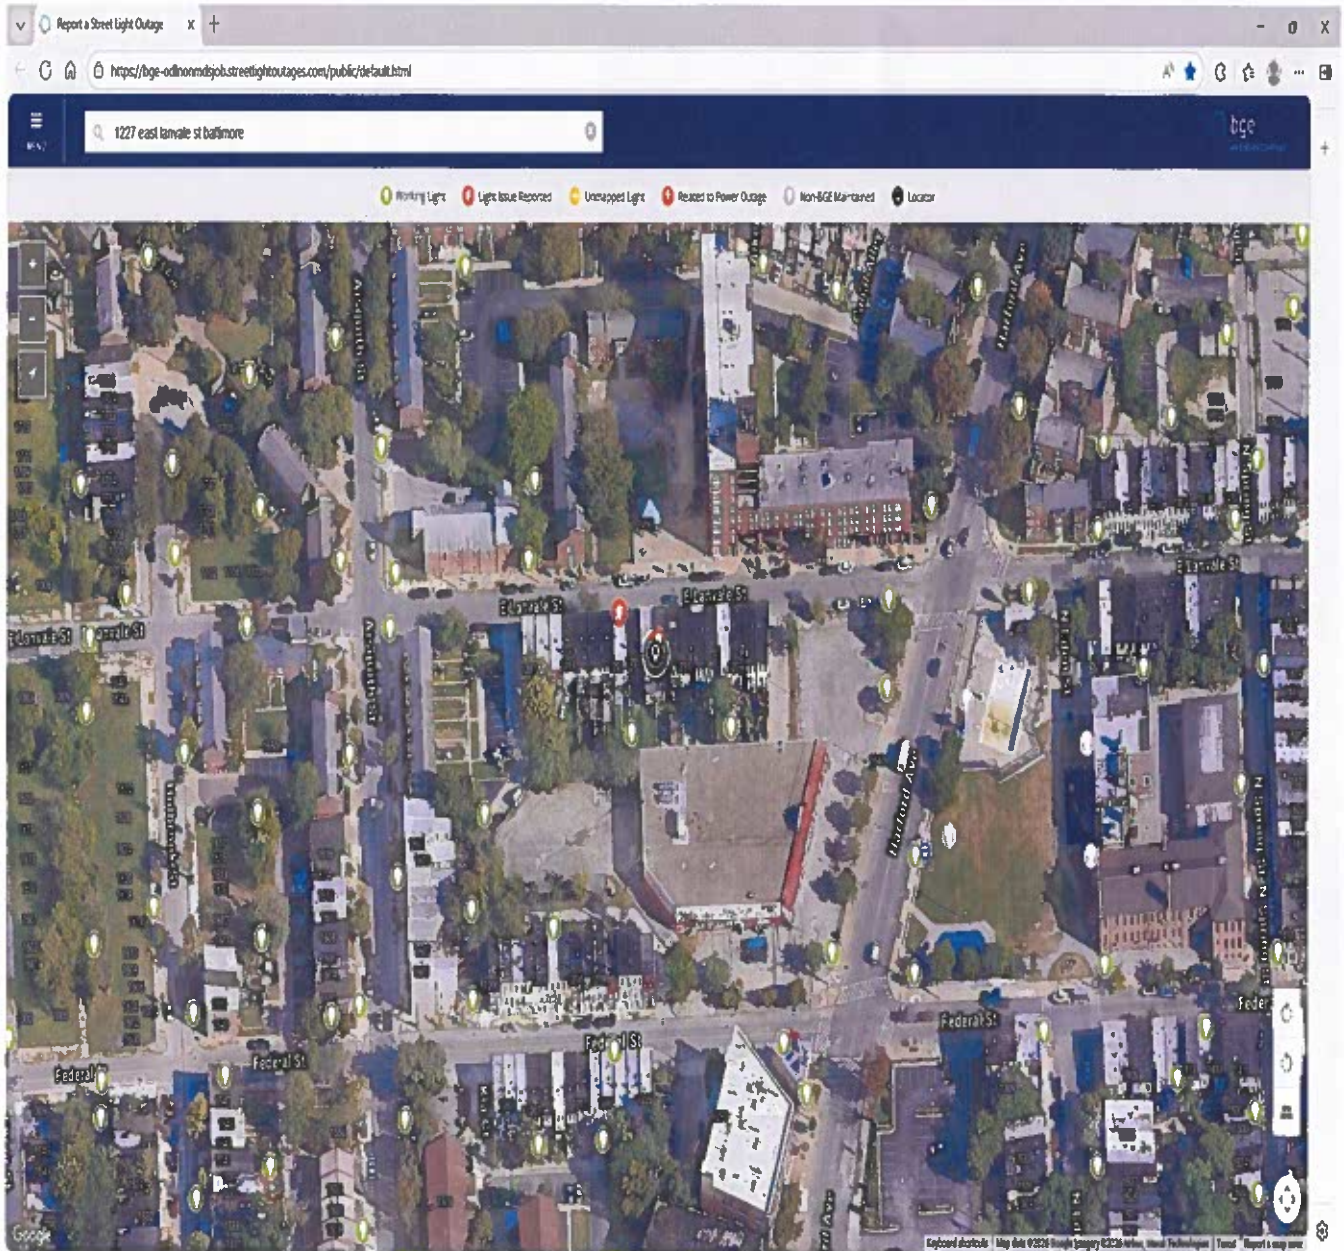
Deteriorated ☒

NEEDS  
New  
Base

25 Foot  
Steel Pole  
Cobra Head  
LED
