# Inspections: Damaged Pole Report

Service Request: 26-00041678 Sector: \_\_\_\_\_ Gateway: \_\_\_\_\_ Primary: \_\_\_\_\_  
 Location on Service Request: 513 PARK Ave  
 Grid : 3010120 LLC: 6261

**Service Request Summary Report**  
**26-00041078**  
Printed Date: Jan 21, 2026 - 2:52:47 PM

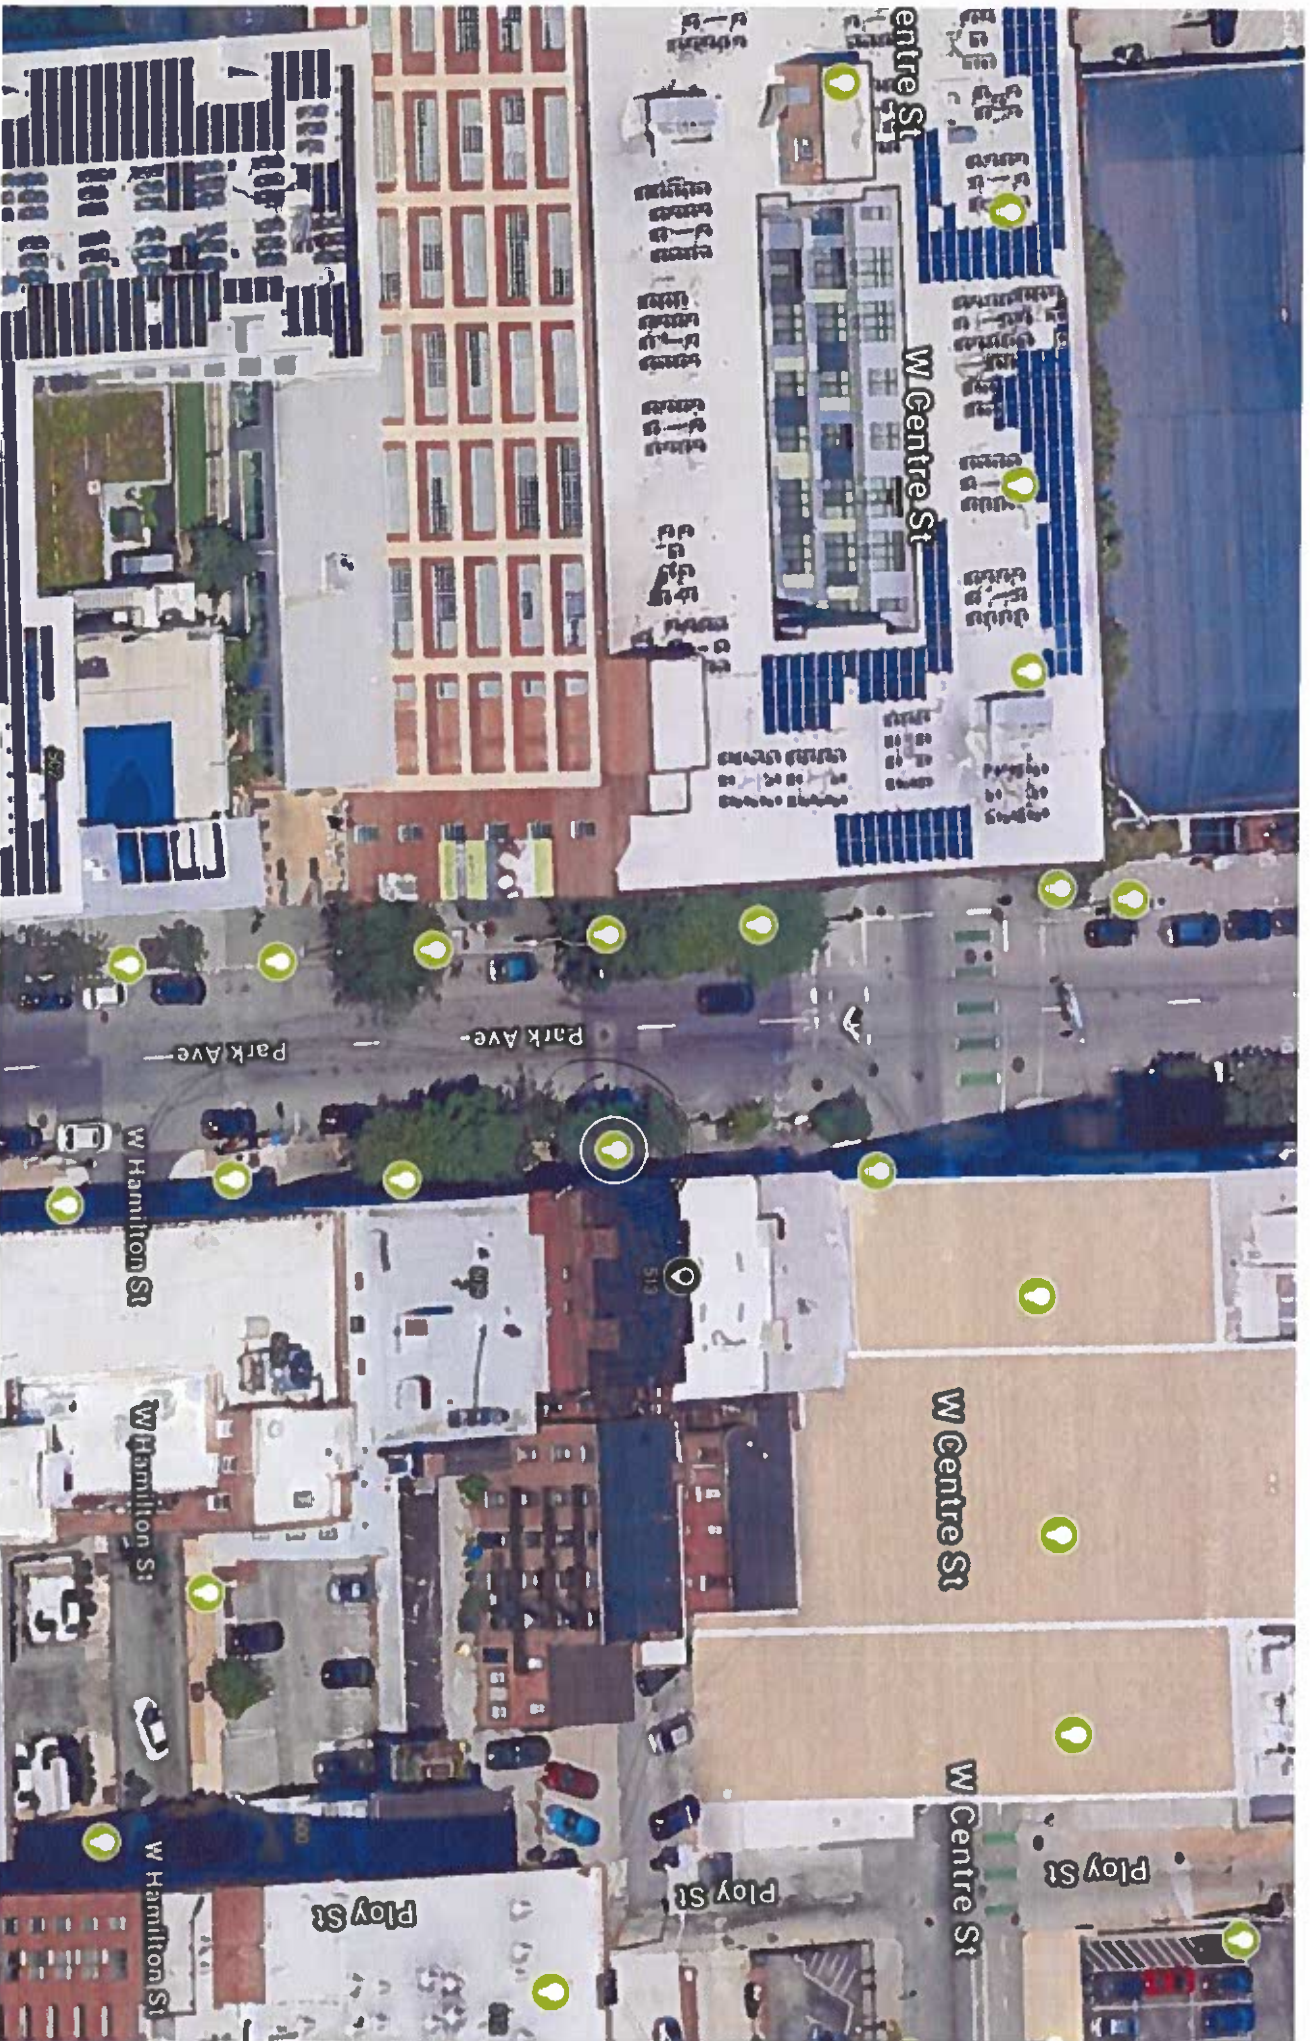
Deteriorated \_\_\_\_\_  
 Missing ☒  
 Damaged \_\_\_\_\_  
 Arm/Fixture Missing \_\_\_\_\_  
 Other \_\_\_\_\_

Need new base
