# Inspections: Damaged Pole Report

Service Request: 26-00043462 Sector: \_\_\_\_\_ Gateway: \_\_\_\_\_ Primary: \_\_\_\_\_

Location on Service Request: 2309 Orleans<sup>St</sup>

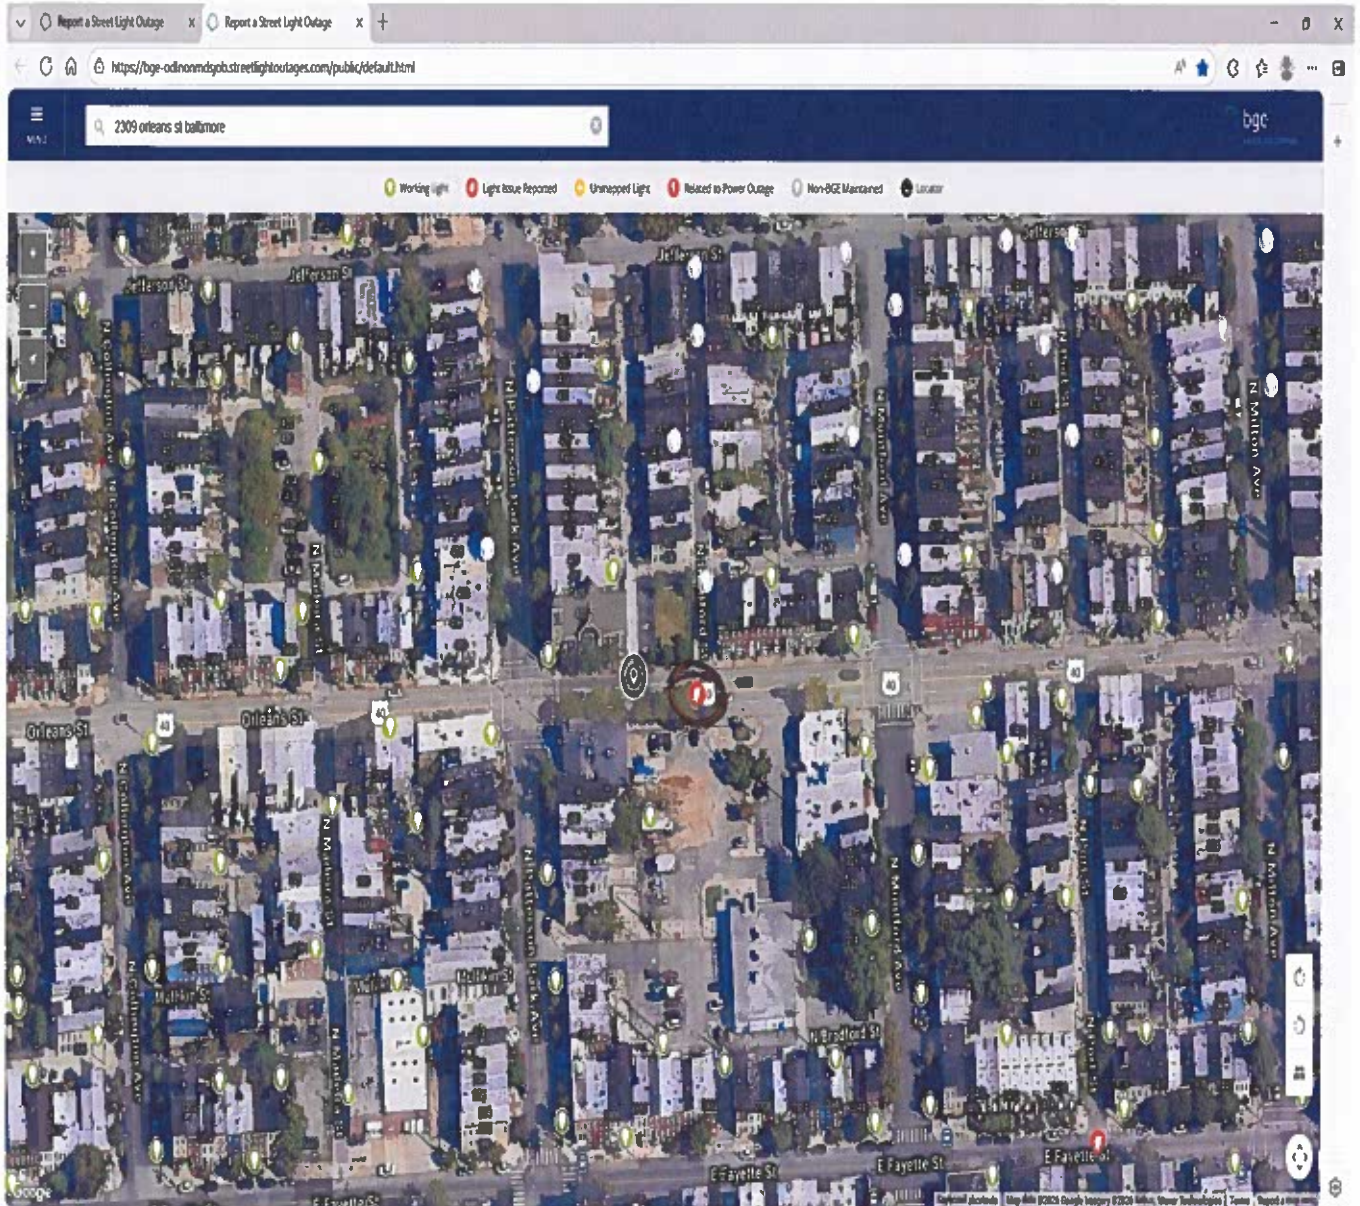
Missing ☒

NEEDS  
New  
Pedestal  
Base

30 Foot  
Aluminum  
pole  
Cobra Head  
LED

Work Order #  
~~2000~~  
20719727
