# Inspections: Damaged Pole Report

Service Request: 20-00041170 Sector: \_\_\_\_\_ Gateway: \_\_\_\_\_ Primary: \_\_\_\_\_

Location on Service Request: 4506 HAZELWOOD AVE

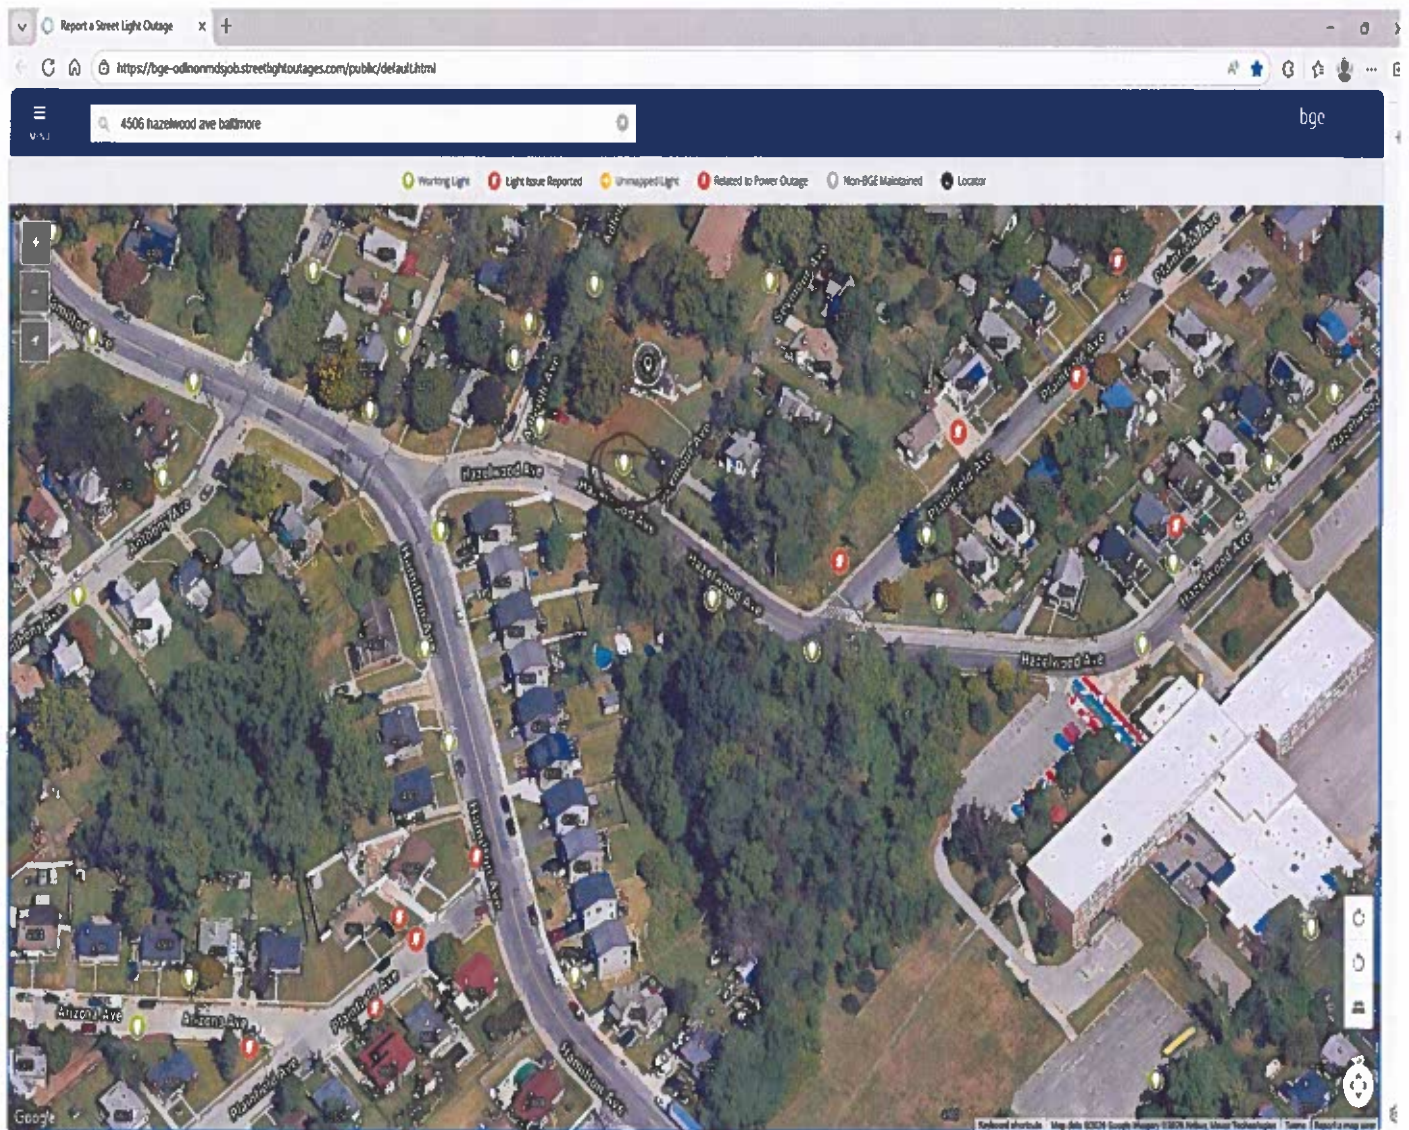
Missing ☒

25 Foot  
Steel pole  
Cobra Head  
HPS

NEEDS  
New  
Base
