# HOME LAND

## ENVIRONMENTAL

| Location | Inspector |
|---|---|
| 2500 Pickwick Road<br>Baltimore MD 21207 | Jonathan Blevins<br>Environmental Inspector |

Camera sewer inspection for the purpose of a real estate transaction.

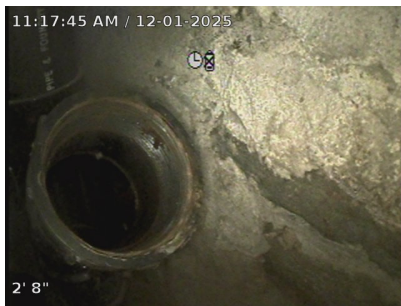
2' 8"

Start of video. Entry point PVC cleanout in basement floor near front of house.

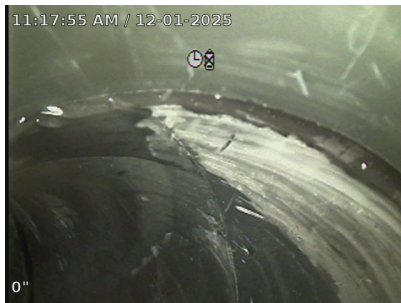
0"

Beginning of cleanout.

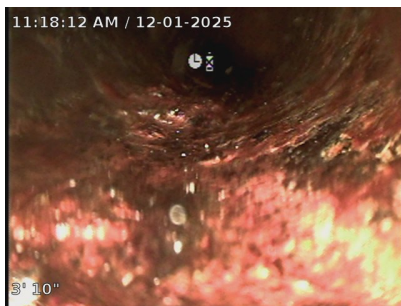
3' 10"

Level-off.

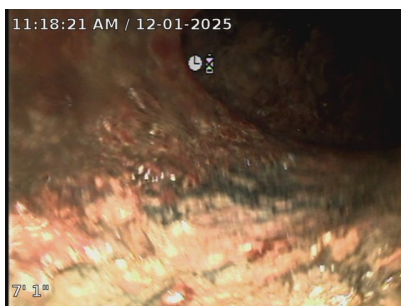
7' 1"

Slight right bend. Connection to additional indoor plumbing.

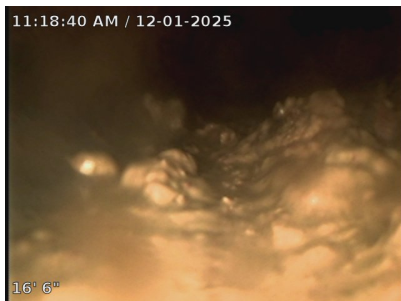
16' 6"

Minor sludge in cast-iron portion.

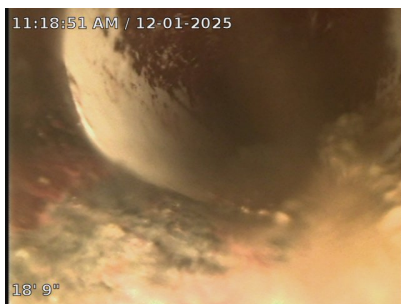
18' 9"

Change in line from cast-iron to PVC.

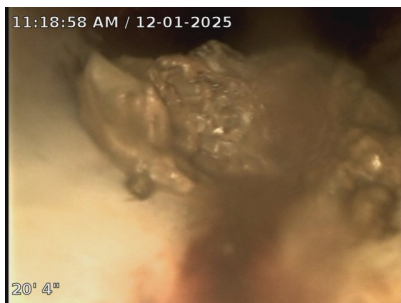
20' 4"

Debris in line (pushed through during inspection).

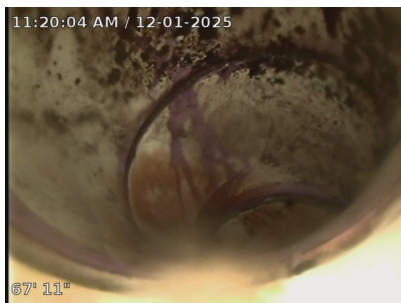
67' 11"

Downward bend just before snake line in front yard.

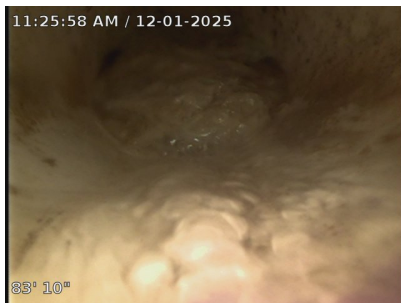
83' 10"

**Back-up:** Back-ups occur when something is obstructing the sewer line, not allowing anything to pass through the line. The sewer line will be completely full of liquid.

Showing back-up in sewer line.

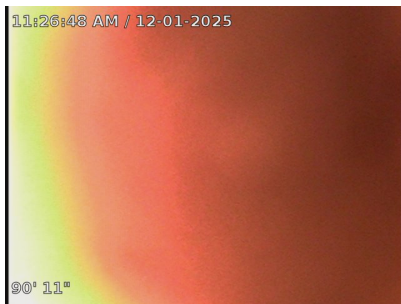
91' 0"

Could not push camera beyond this point.

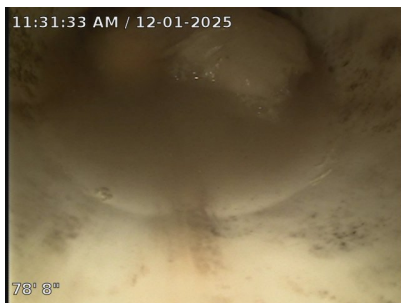
78' 8"

Showing back-up continuing. Camera removed from original entry point.

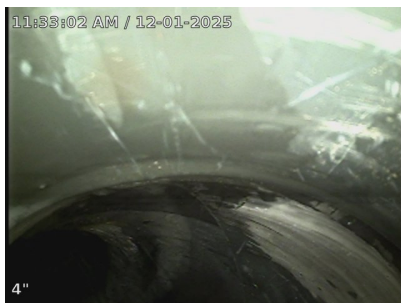
4"

Entry point PVC cleanout in basement floor near back of house.

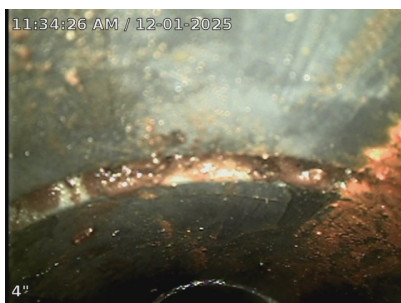
3"

Change in line from PVC to cast-iron.

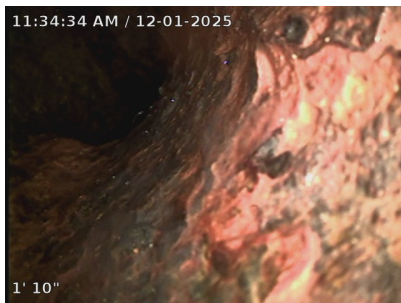
1' 9"

Slight left bend. Level-off under basement floor.

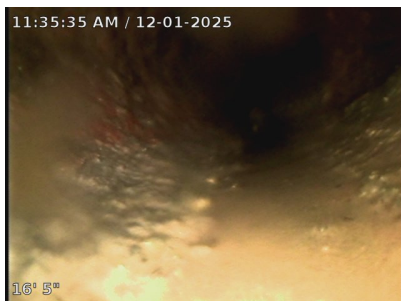
16' 5"

Connection to original entry point.

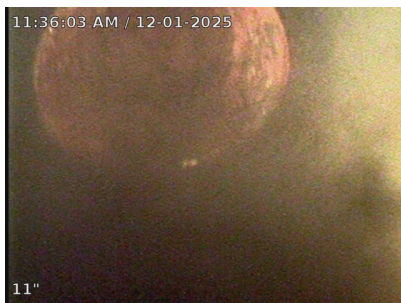
11"

Camera removed from second entry point.

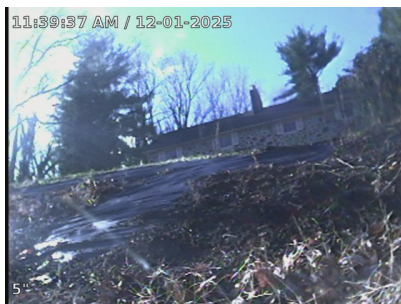
6"

Showing front of house. Entry point snake line in front yard.

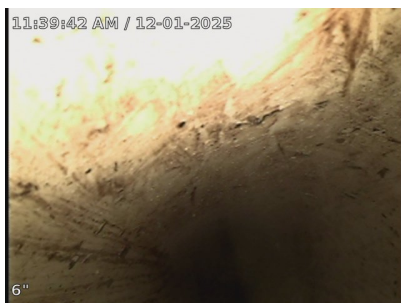
6"

Beginning of PVC snake line.

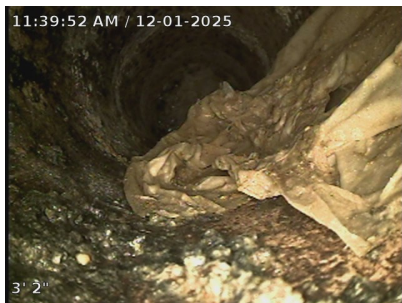
3' 2"

Debris in line. Could not push camera beyond the clog in the line.

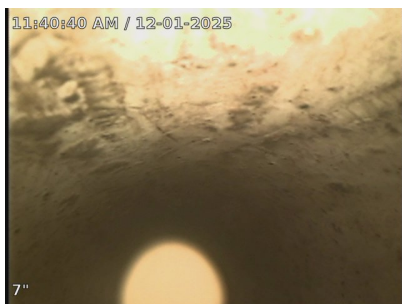
7"

Camera removed from snake line. End of inspection.
