# Inspections: Damaged Pole Report

Service Request 26-08102522 Sector: \_\_\_\_\_ Gateway: \_\_\_\_\_ Primary: \_\_\_\_\_

Location on Service Request: 200 No Calvert St

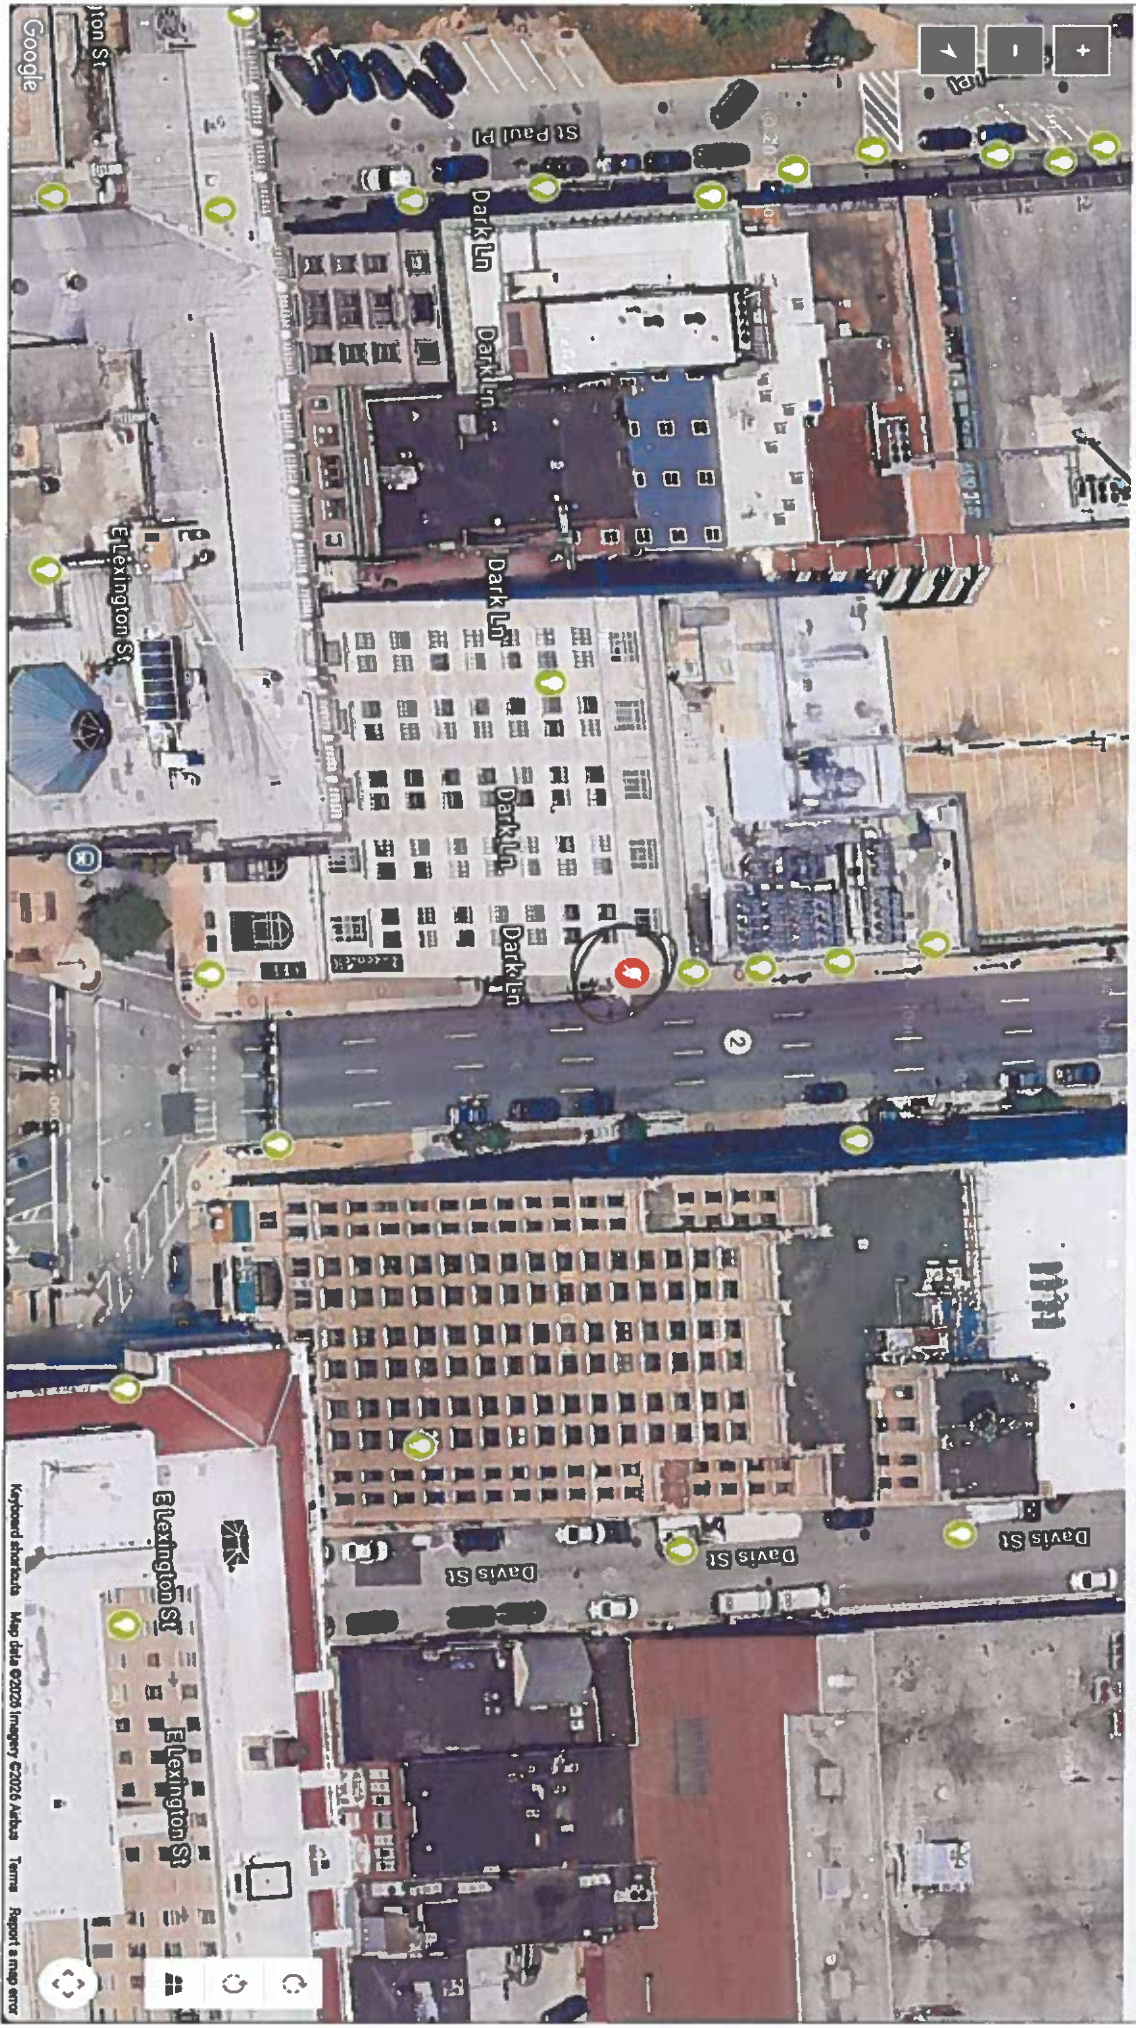
Deteriorated ☒

Missing ☒

NEEDS  
New  
pedestal  
base

30 Foot Aluminum Cobra Head
