# Inspections: Damaged Pole Report

Service Request: 26-00150615 Sector: \_\_\_\_\_ Gateway: \_\_\_\_\_ Primary: \_\_\_\_\_

Location on Service Request: 4903 HERRING RUN DR

Grid : 2040310 LLC: 7114

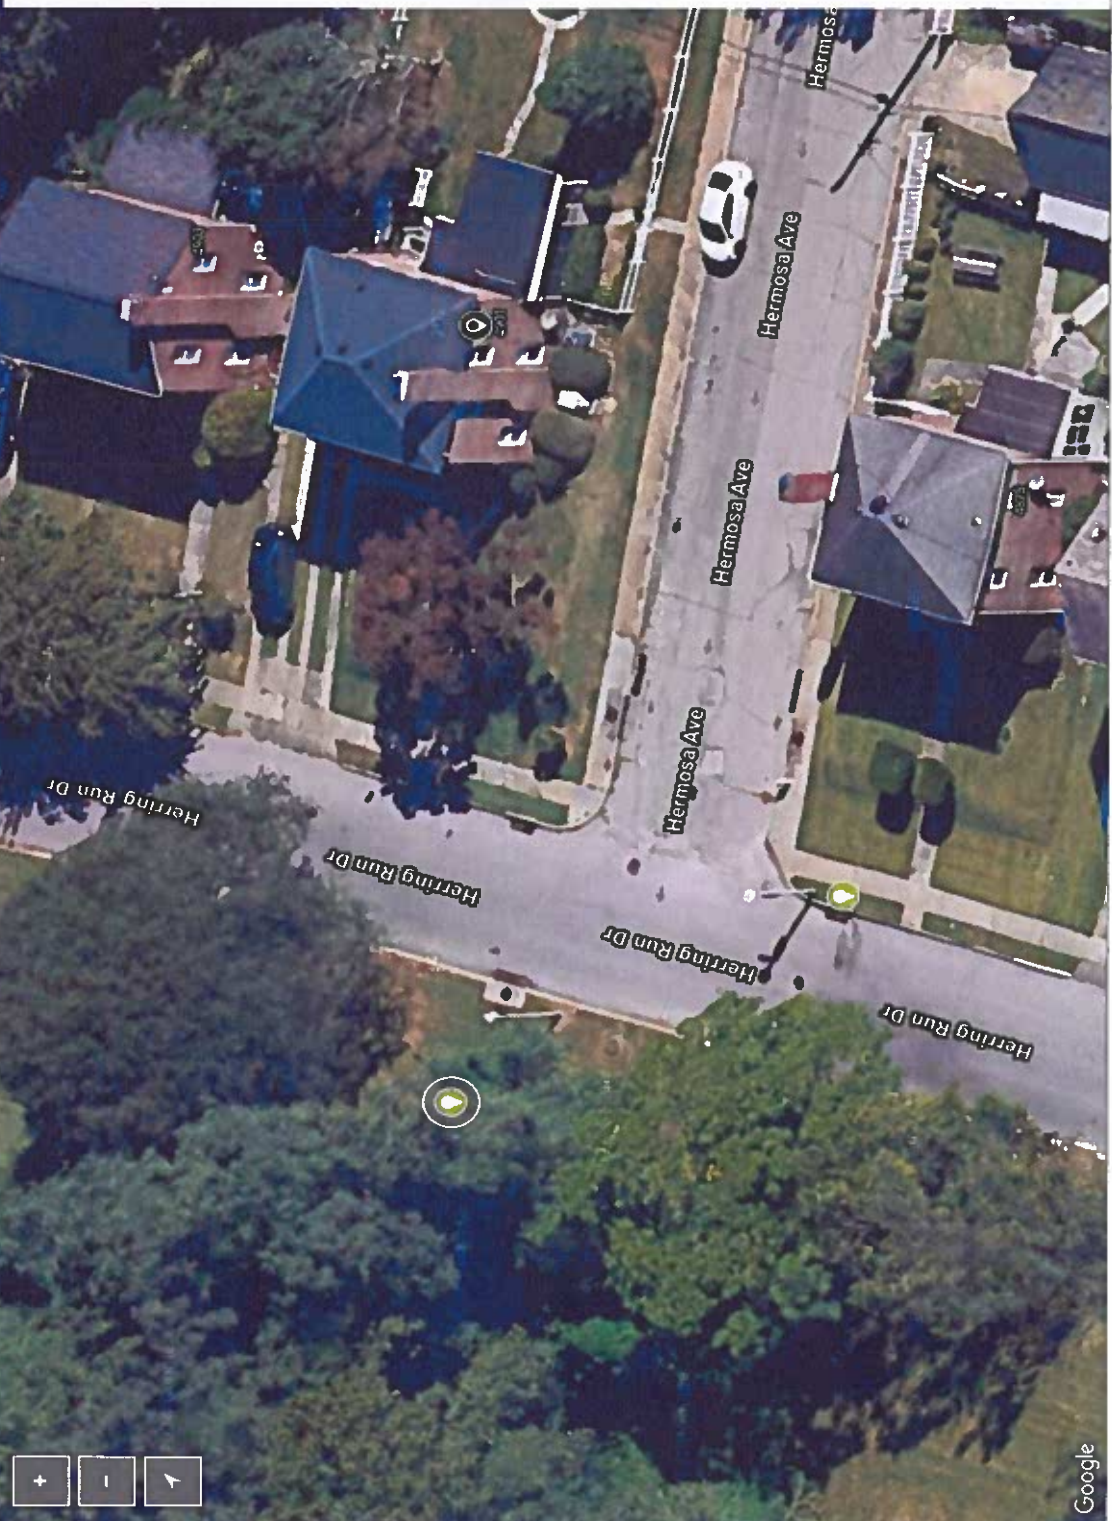
Missing ☒

There are no known outages for this light.
