# Inspections: Damaged Pole Report

Service Request: 26-00159935 Sector: \_\_\_\_\_ Gateway: \_\_\_\_\_ Primary: \_\_\_\_\_

Location on Service Request: 208 E Cold Spring Ln

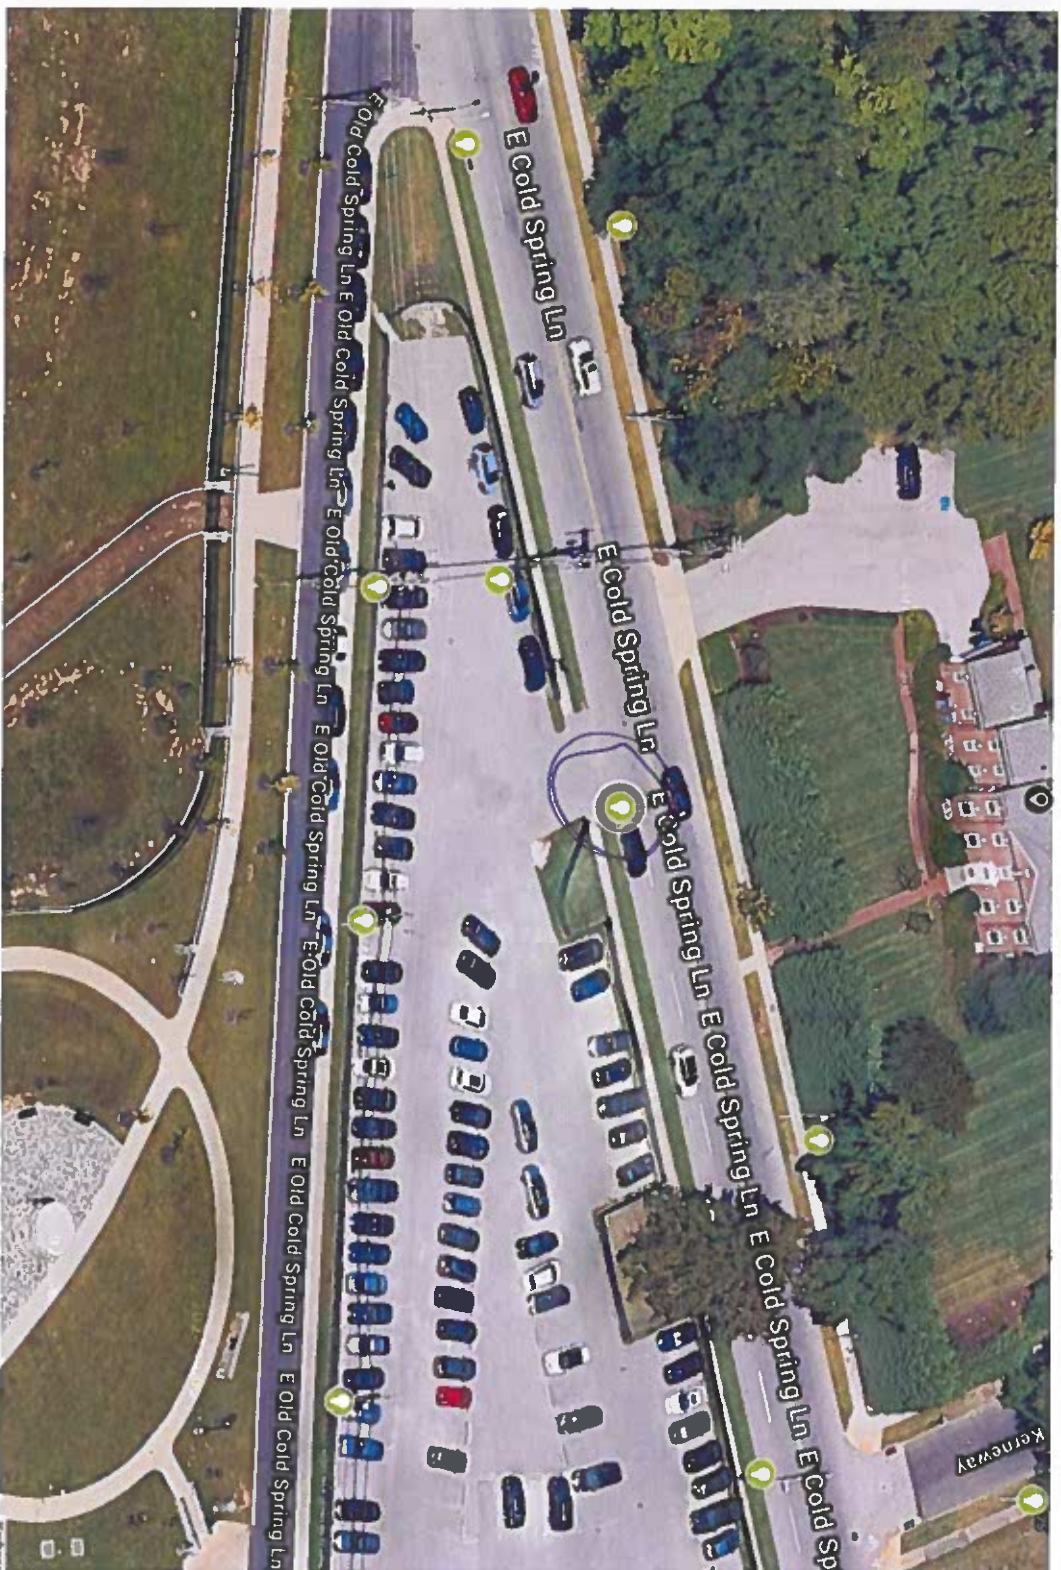
200  
E. Cold Spring Ln

There are no known outages for this light.

**Pole Number**

20401307159
