# Inspections: Damaged Pole Report

Service Request: 26-00198963 Sector: \_\_\_\_\_ Gateway: \_\_\_\_\_ Primary: \_\_\_\_\_

Location on Service Request: Eo Pratt St & So Broadway

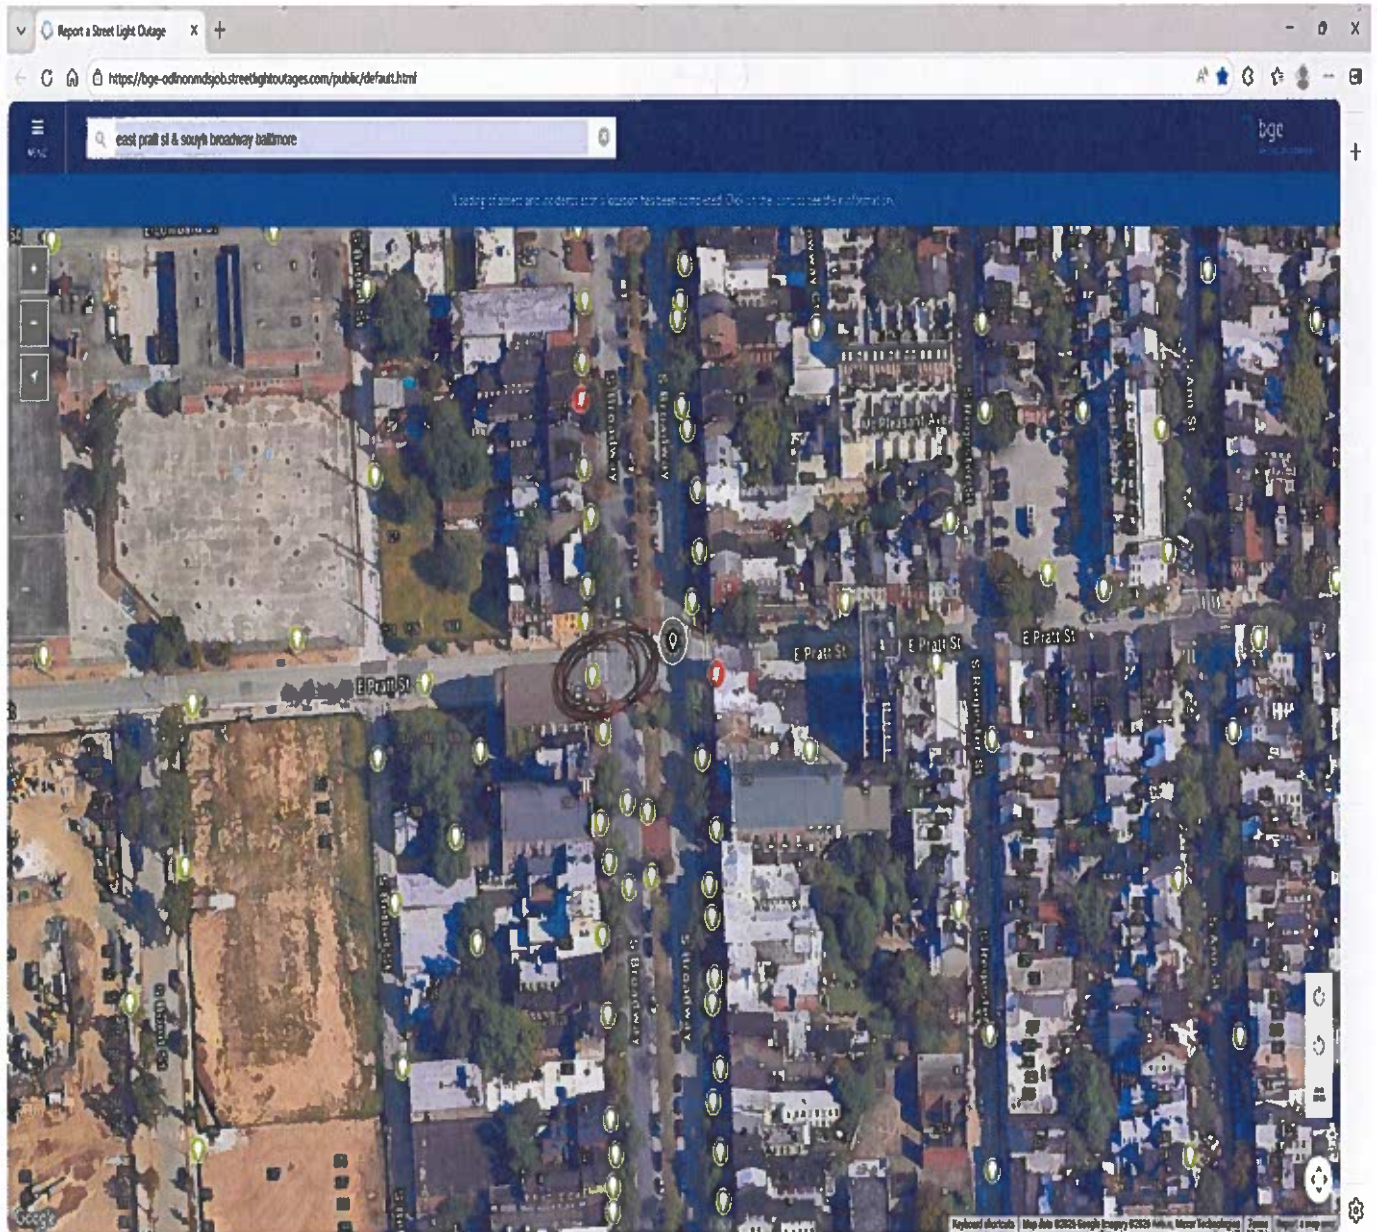
Missing ☒

NEEDS  
New  
Pedestal  
Base

30 Foot Aluminum  
pole  
Cobra Hired  
LED
