# Inspections: Damaged Pole Report

Service Request: 26-00208824 Sector: \_\_\_\_\_ Gateway: \_\_\_\_\_ Primary: \_\_\_\_\_

Location on Service Request: 115 W. 25th St

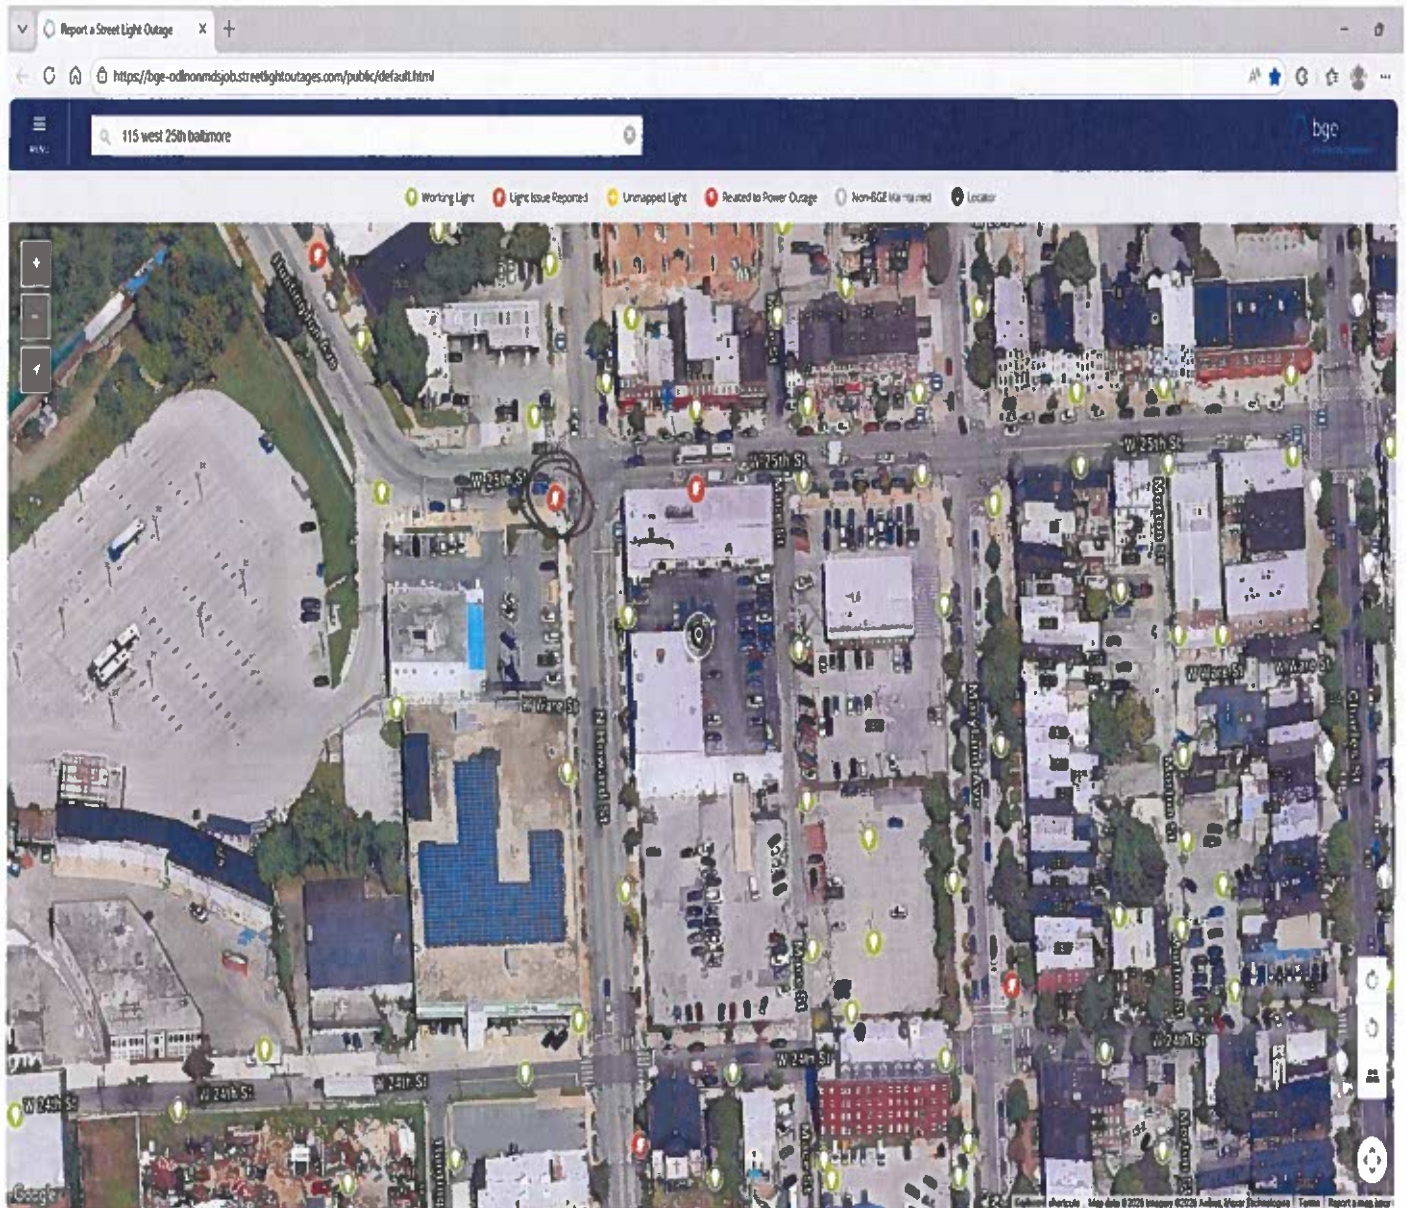
Deteriorated ☒

Missing ☒

30 Foot Aluminum  
pole  
Cobra Head  
LED
