# Inspections: Damaged Pole Report

Service Request 26-00203158 Sector: \_\_\_\_\_ Gateway: \_\_\_\_\_ Primary: \_\_\_\_\_

Location on Service Request: 2900 Hanford Rd

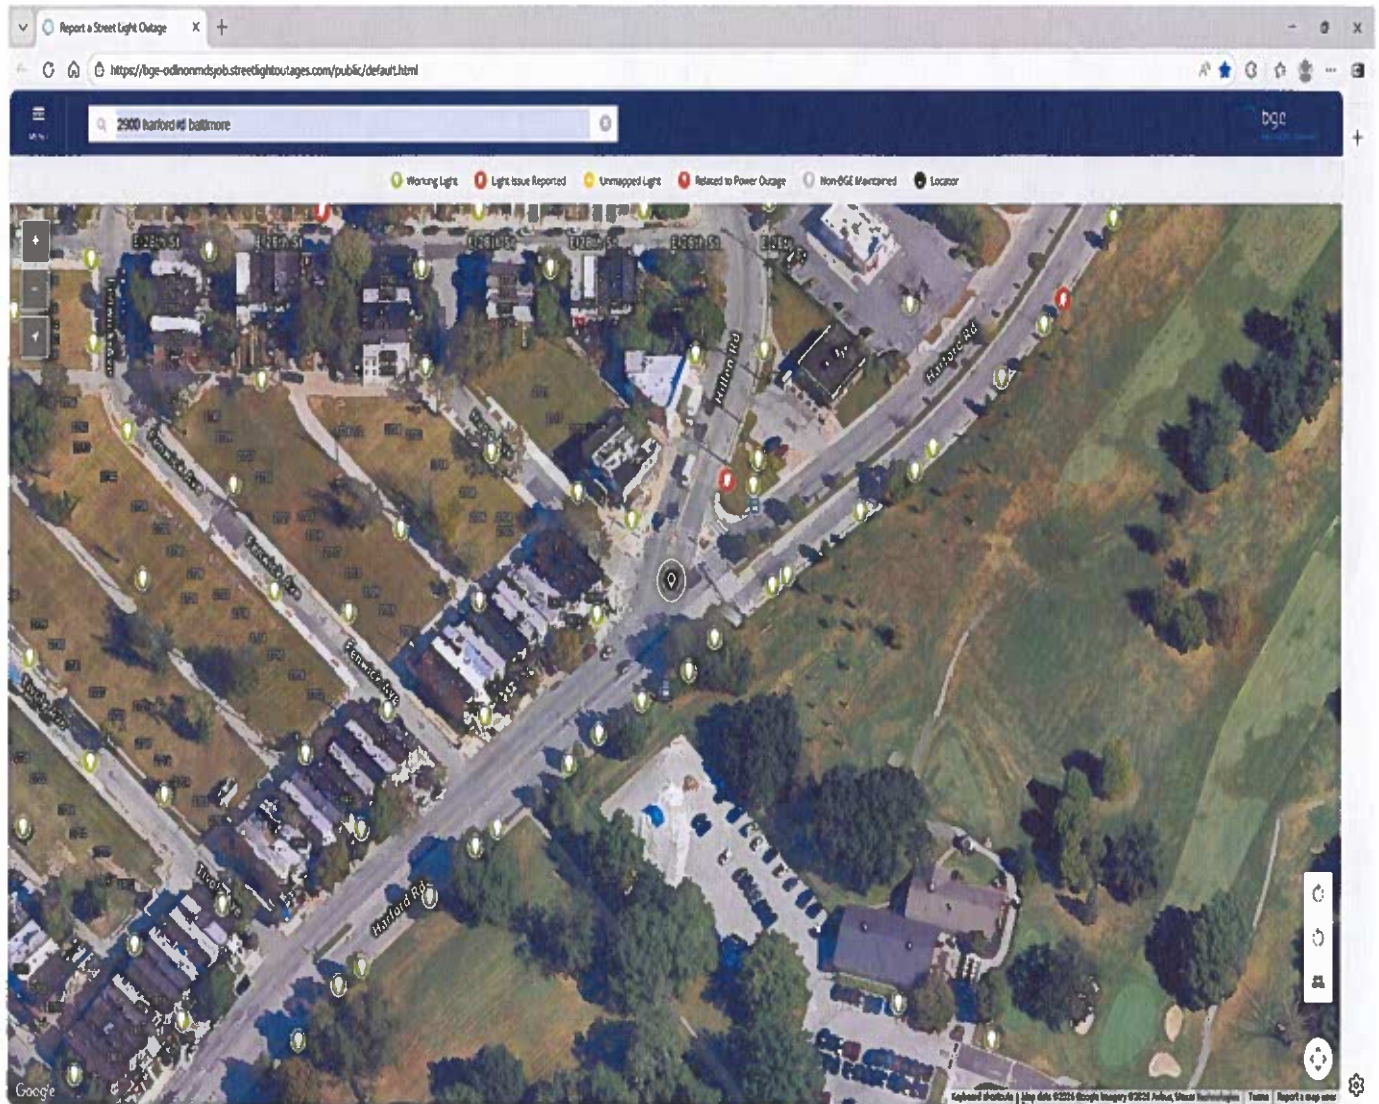
Deteriorated ☒

Missing ☒

NEEDS  
NEW  
Pedestal  
Base

30 Foot Aluminum pole  
Cobra Head  
LED
