# Inspections: Damaged Pole Report

Service Request: 26-00227162 Sector: \_\_\_\_\_ Gateway: \_\_\_\_\_ Primary: \_\_\_\_\_

Location on Service Request: 5102 Denvew Way

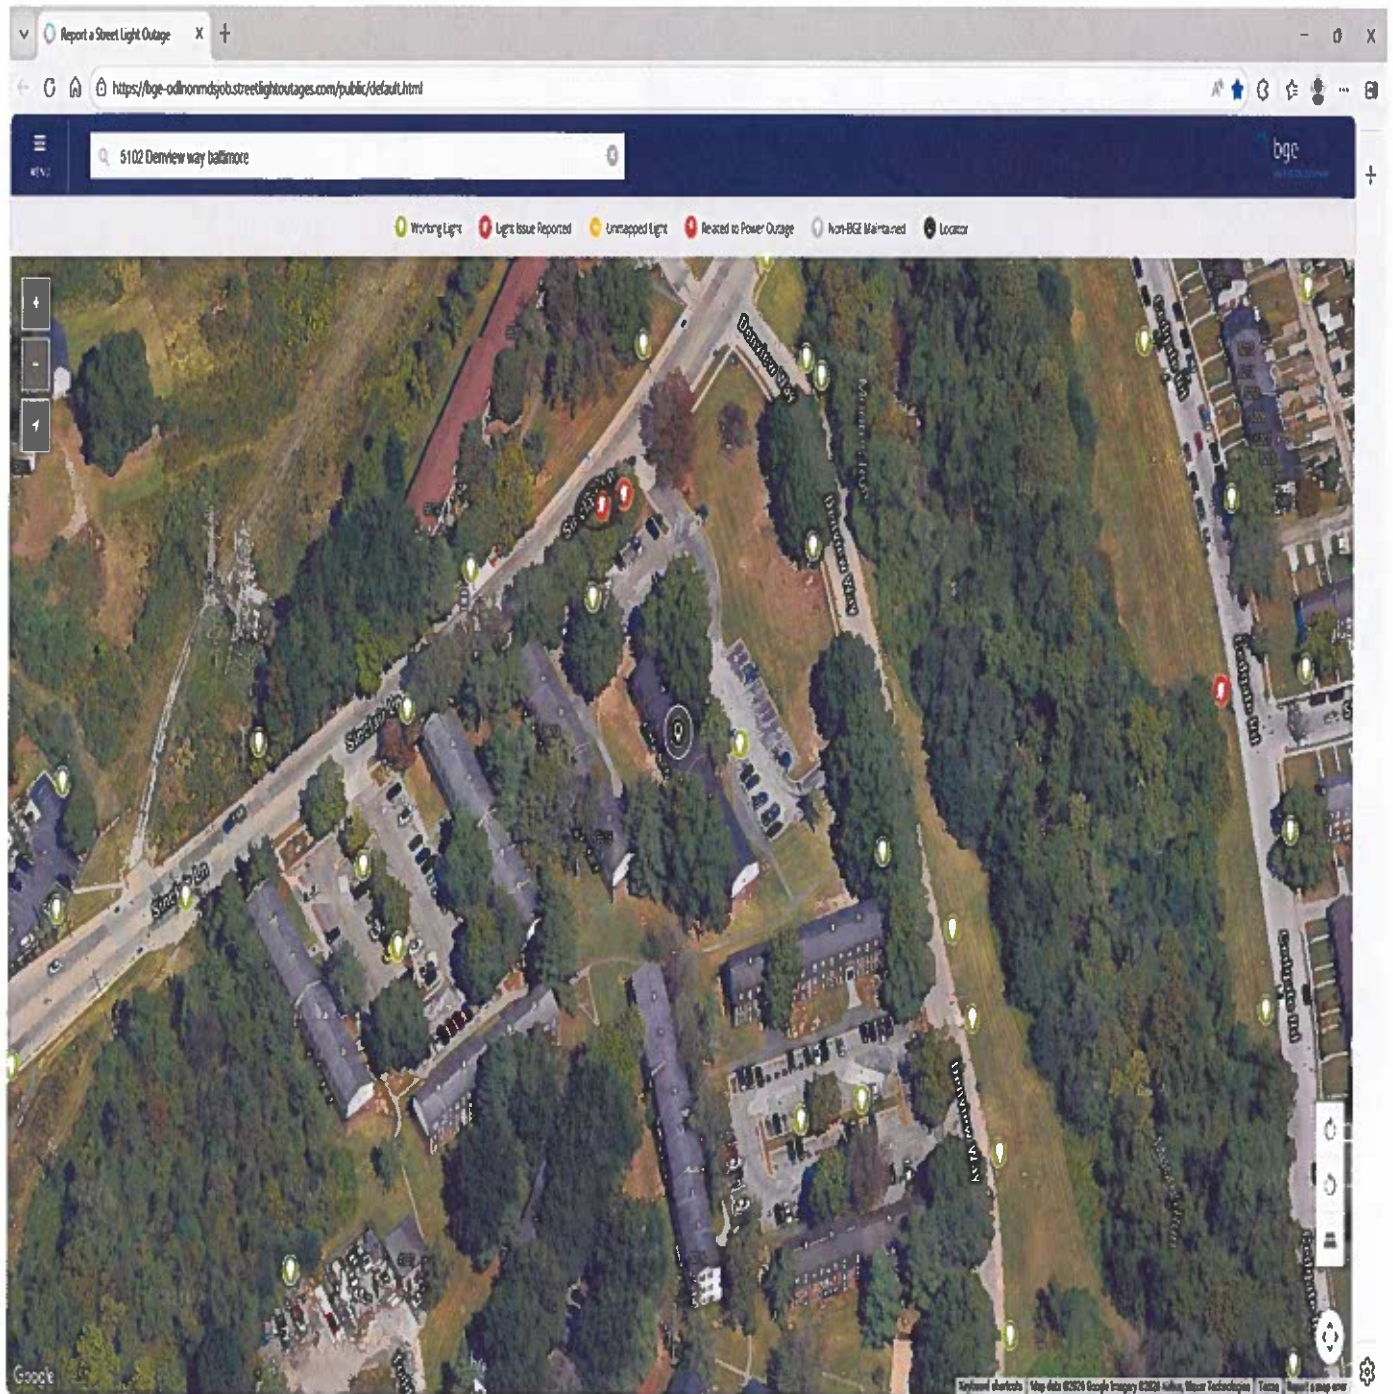
Deteriorated ☒

Missing ☒

30 Foot Aluminum  
pole  
Cobra Head  
LED
