# Inspections: Damaged Pole Report

Service Request 26-00239272 Sector: \_\_\_\_\_ Gateway: \_\_\_\_\_ Primary: \_\_\_\_\_

Location on Service Request: 3302 The Alameda

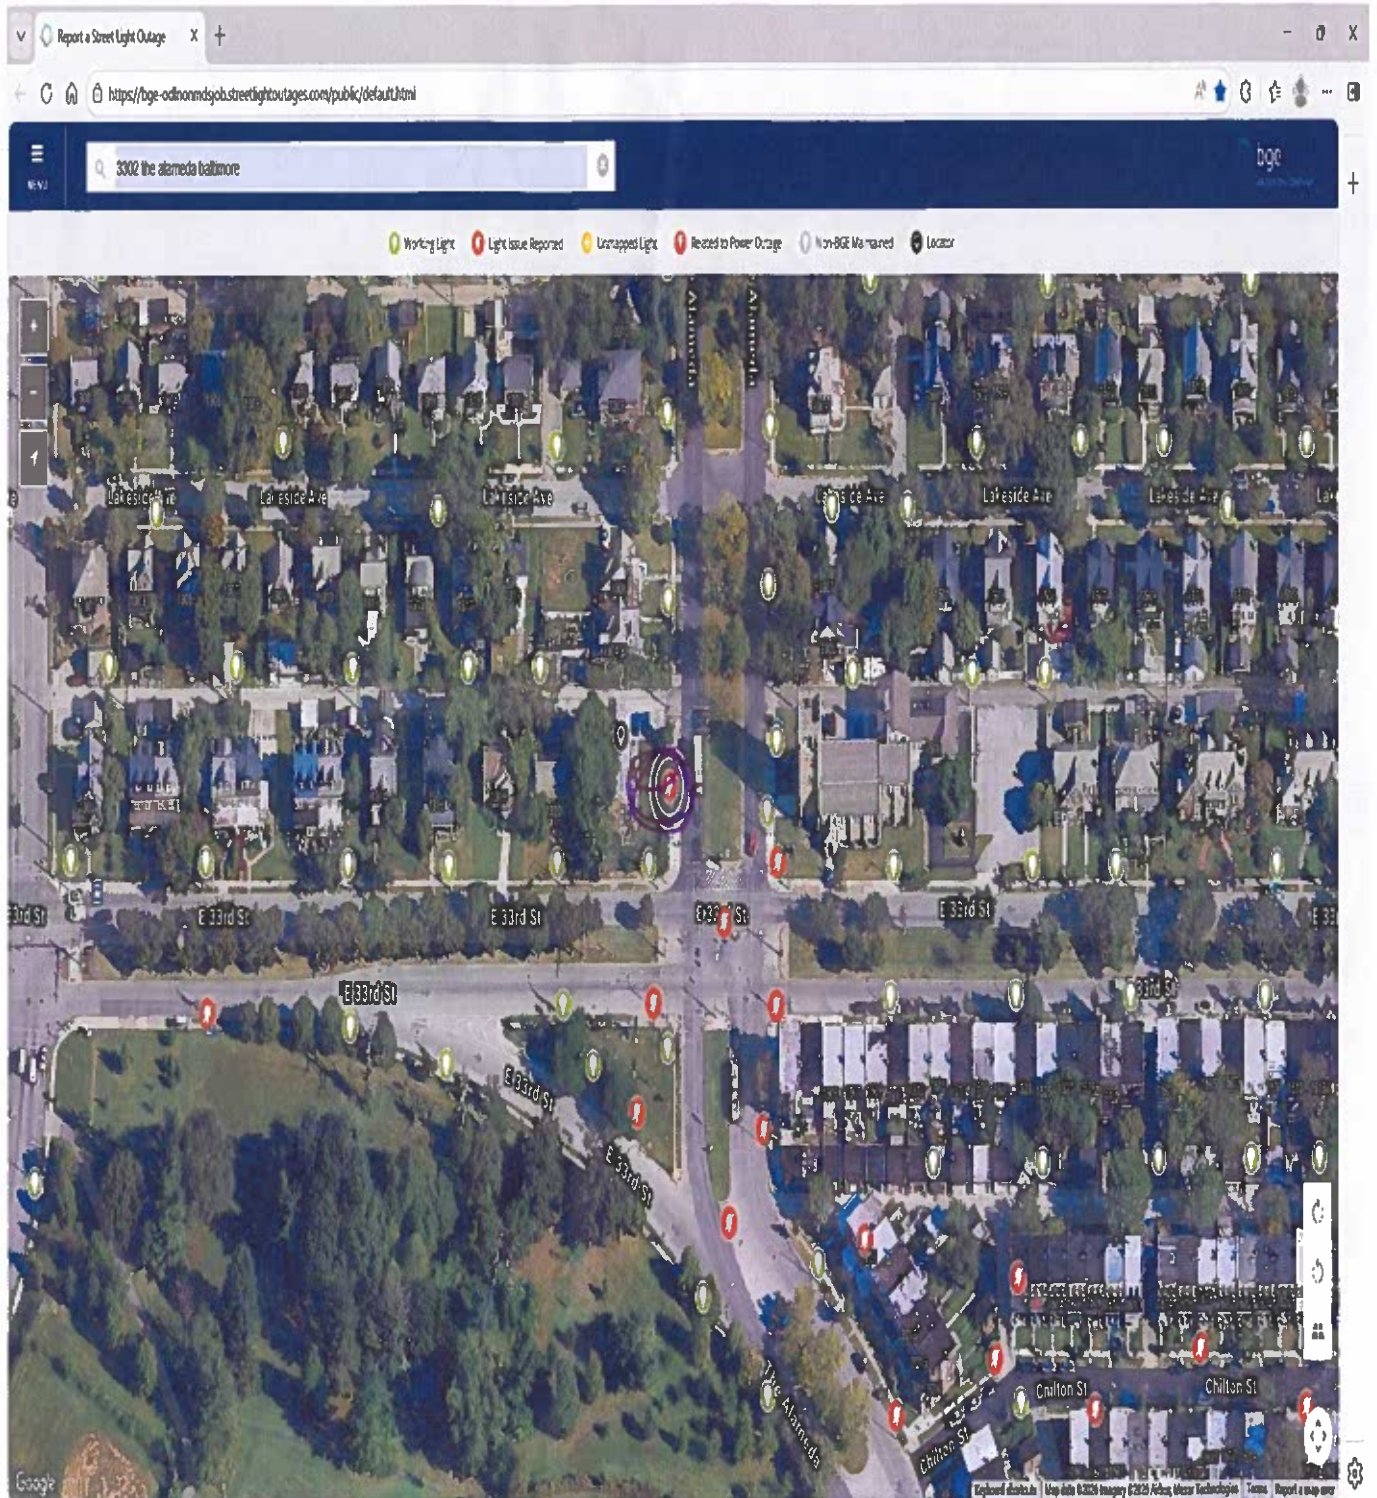
Deteriorated ☒

Missing ☒

30 Foot aluminum  
pole  
Colora Henry  
LED
