# INSPECTION REPORT

For the Property at:  
**4126 BALFERN AVE**  
BALTIMORE, MD 21213

Prepared for: KATEARA JOHNSON  
Inspection Date: Friday, January 9, 2026  
Prepared by: Charles Dobry, 32337

RE: Report No. 1428  
4126 Balfern Ave  
Baltimore, MD  
21213

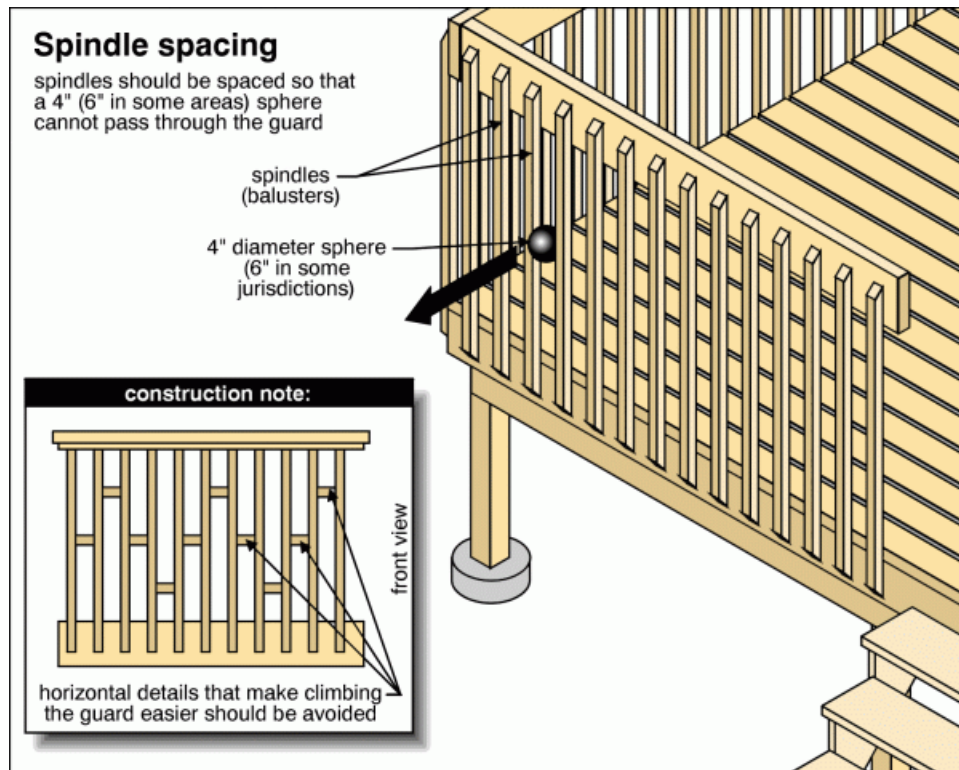
**Condition:** • [Spindles \(balusters\) too far apart](#)

**Implication(s):** Fall hazard

**Location:** Front Porch

**Task:** Repair or replace Further evaluation

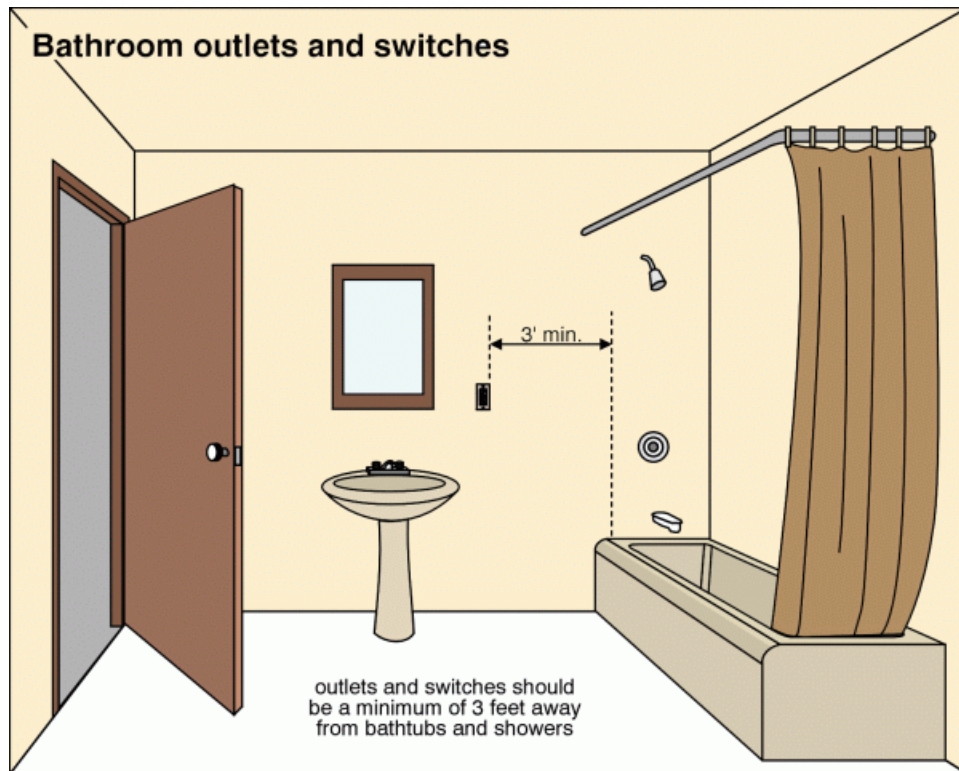
**Condition:** • [Too close to bathtub or shower](#)

**Implication(s):** Electric shock

**Location:** Basement

**Task:** Repair or replace Further evaluation Correct

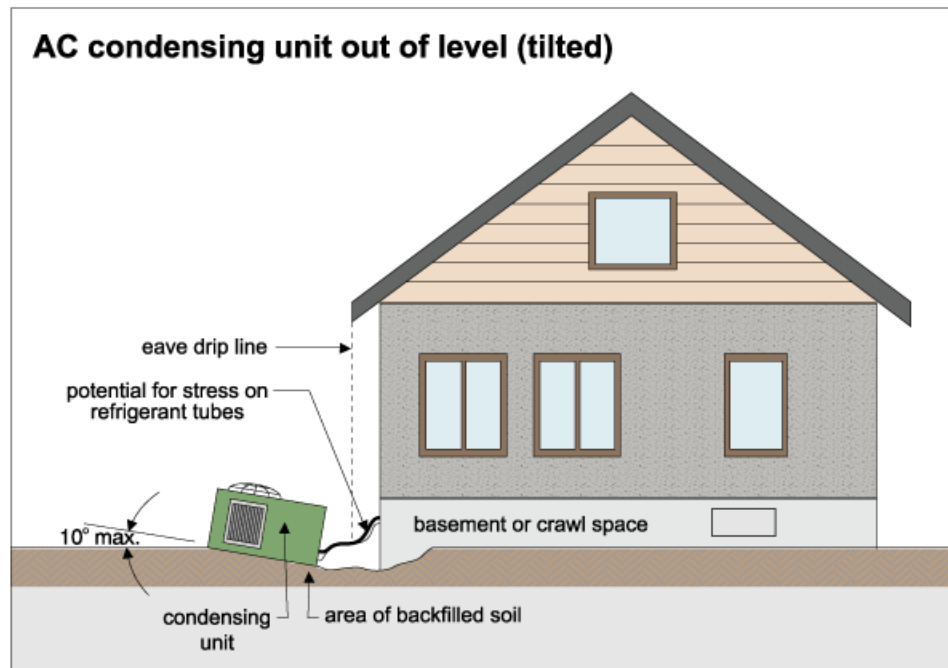
**Condition:** • [Out of level](#)

**Implication(s):** Reduced system life expectancy | Damage to equipment

**Location:** Rear Yard

**Task:** Further evaluation Correct

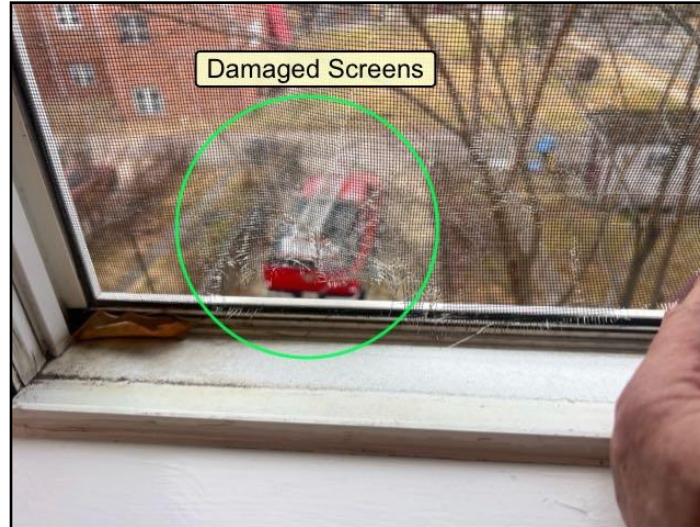
1. Damaged Screens

**General:** • Recommend having Licensed contractor properly replace damaged or missing screens as needed.

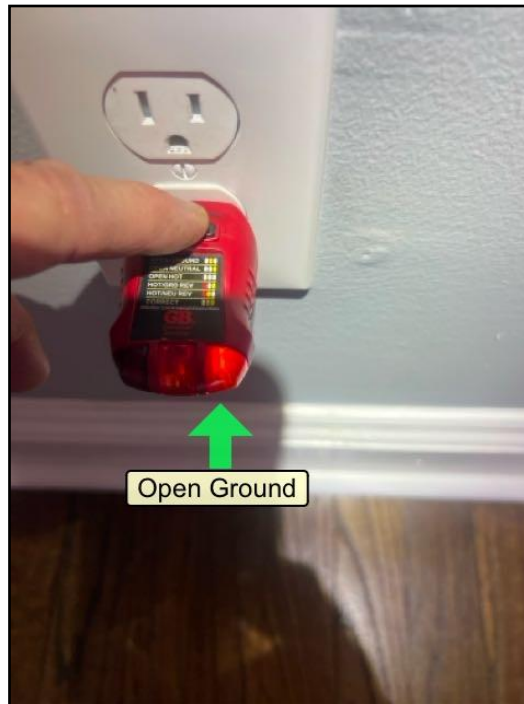
5. Recommend having Licensed contractor correc...

- Recommend having Licensed contractor correct any open ground receptacles as needed in home.

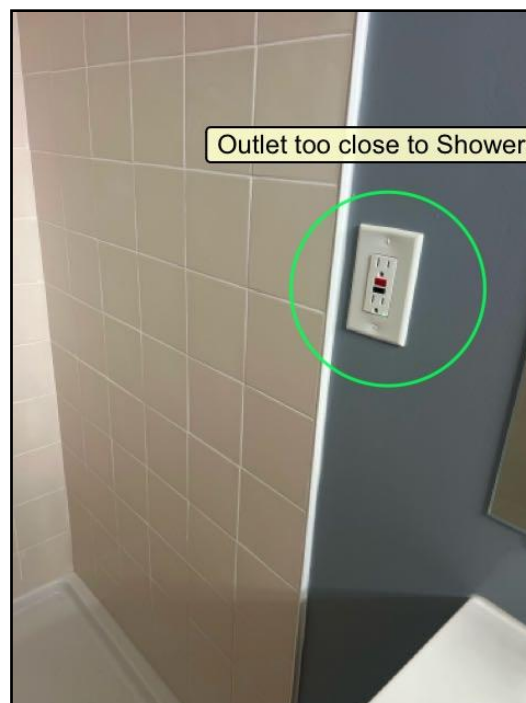
6. GFCI - bathroom

3. Condition: • [Too close to bathtub or shower](#)

Implication(s): Electric shock

Recommend having Licensed contractor place electrical outlet at safe distance from shower to meet standards of at least 3 feet clearance.

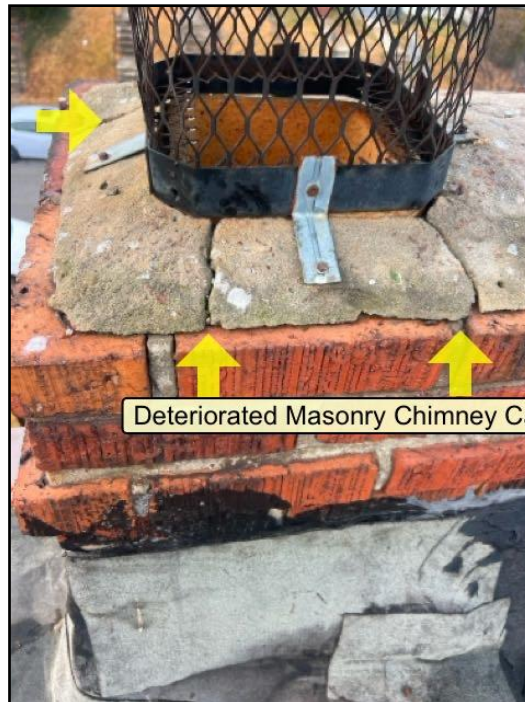
11. Recommend having Licensed contractor...

4. Condition: • [Cracked](#)

**Implication(s):** Chance of water damage to structure, finishes and contents | Shortened life expectancy of material

- Recommend having Licensed contractor properly repair deteriorated masonry Chimney.

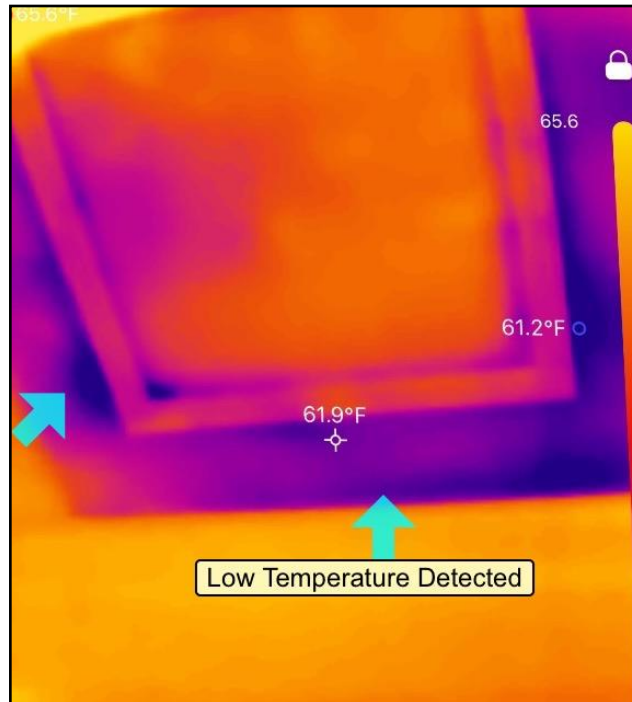
15. Not visible

Unable to Access attics due ro access door being sealed shut. Thermal image shows areas of low temperature which would indicate lack of sufficient insulation. Recommend having attic evaluated for additional insulation.

6. Condition: • [Inaccessible](#)

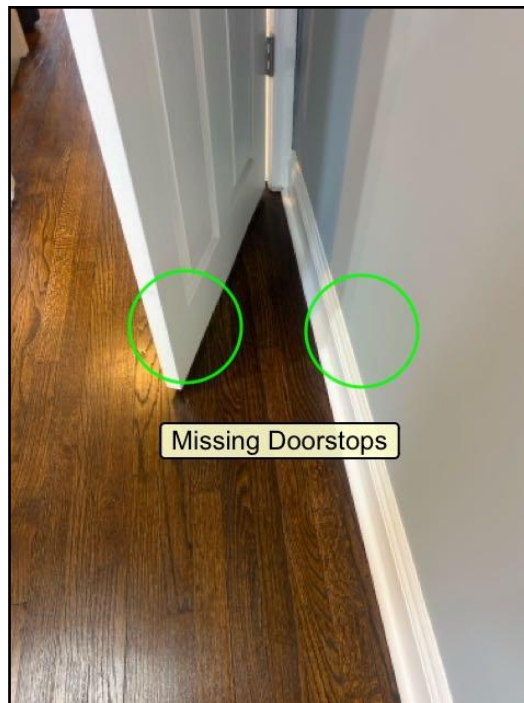
18. Recommend having Licensed Contractor instal...

- Recommend having Licensed Contractor install door stops as needed to prevent damage to drywall.

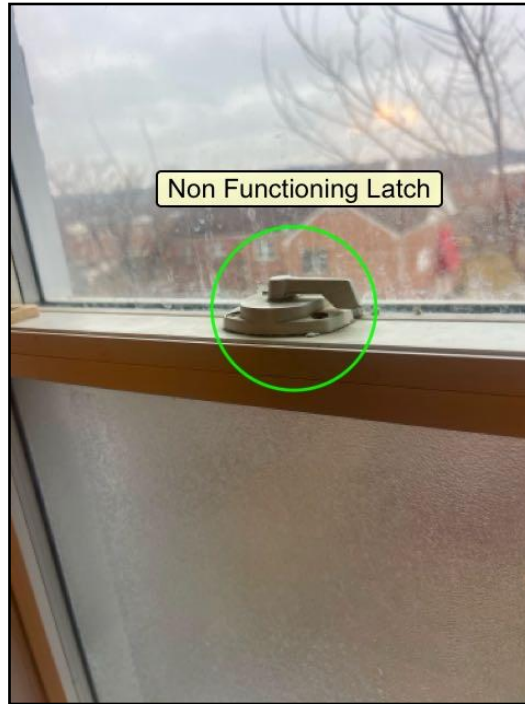
22. Single/double hung

7. Condition: • [Inoperative](#)

Recommend having Licensed contractor repair or replace any non functioning hardware.

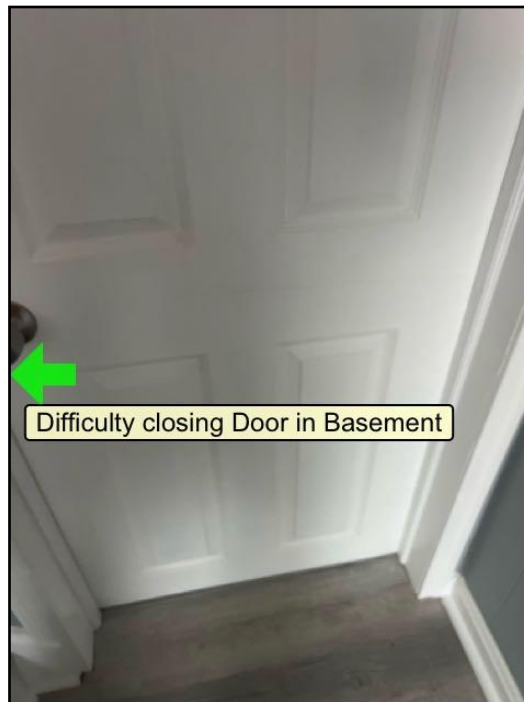
24. Recommend having Licensed contractor...

- Recommend having Licensed contractor properly adjust interior doors that have difficulty closing.

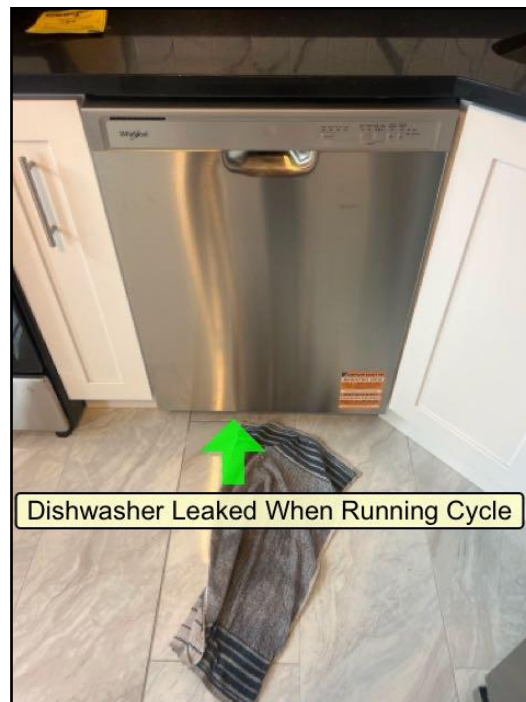
28. Whirlpool

8. Condition: • Leak

**Implication(s):** Chance of water damage to structure, finishes and contents

Recommend having Licensed contractor service leaking dishwasher.
