# Inspections: Damaged Pole Report

Service Request 26-00248980 Sector \_\_\_\_\_ Gateway: \_\_\_\_\_ Primary: \_\_\_\_\_

Location on Service Request: 2310 E. Enger St

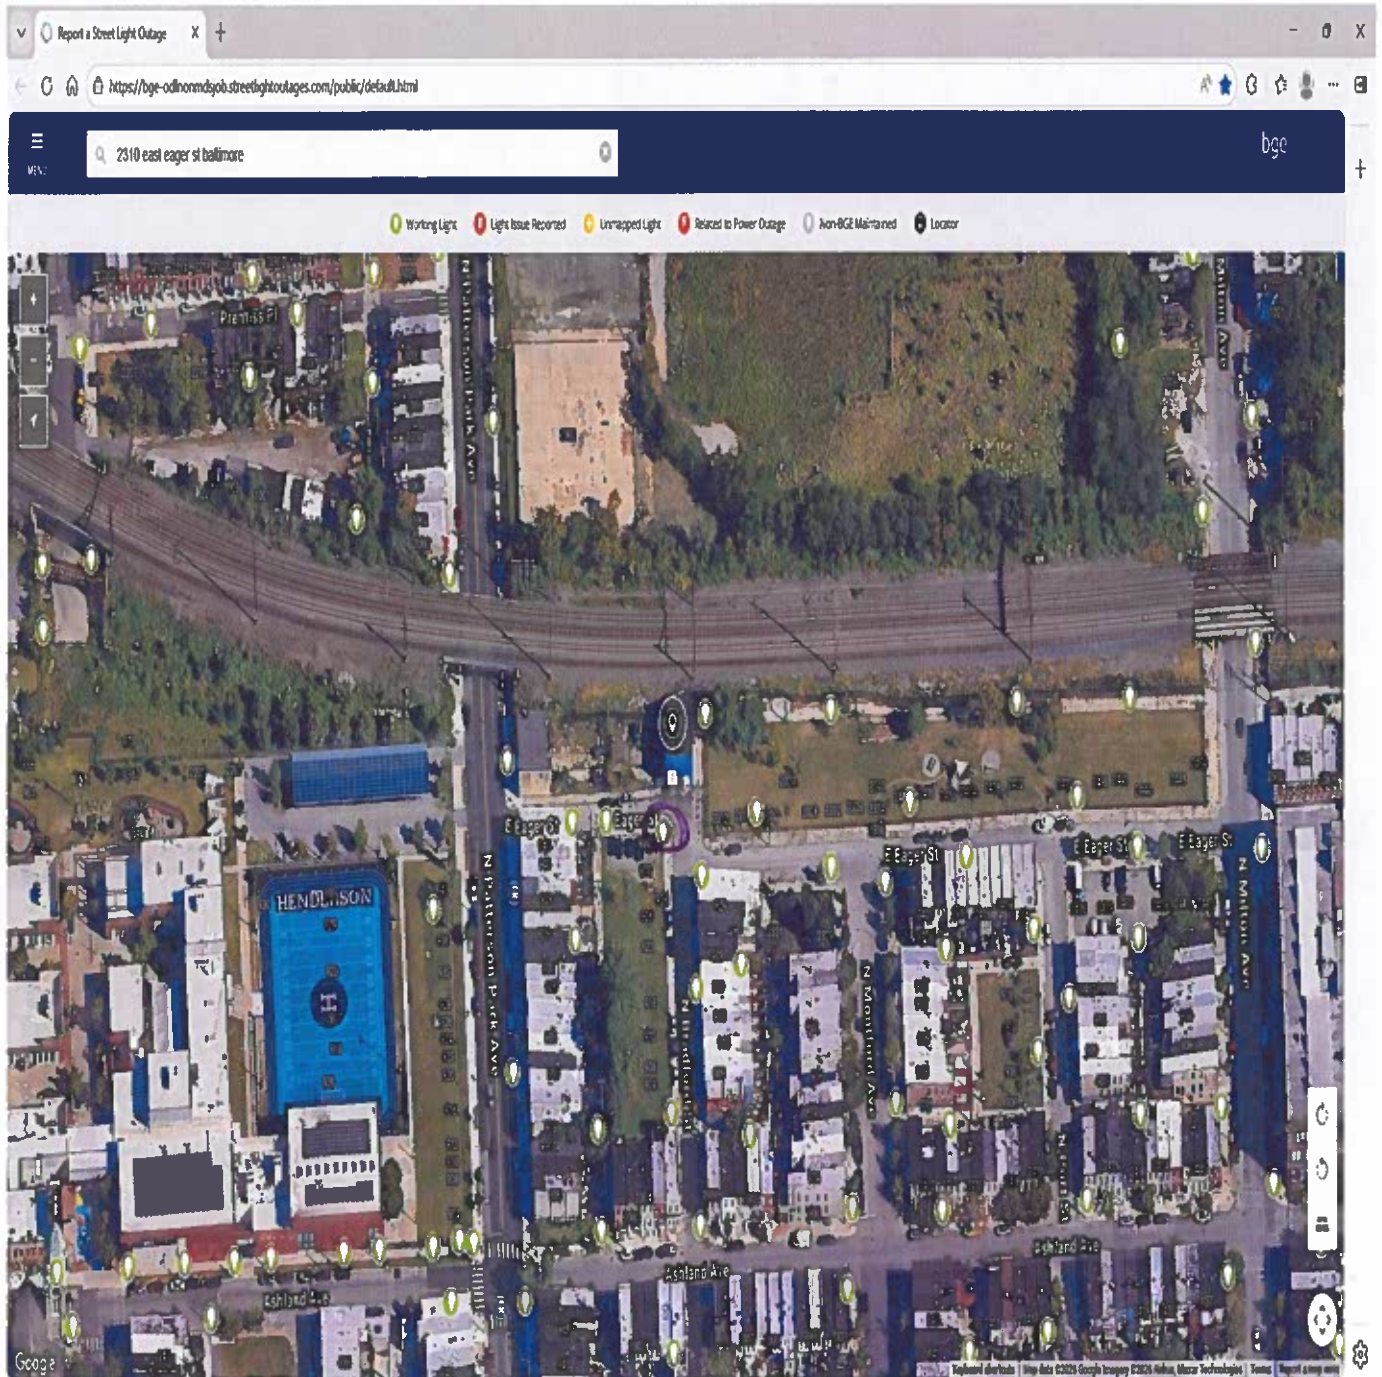
Deteriorated ☒

Missing ☒

**NEED NEW  
BASE**

PMA  
CITY LED
