# Inspections: Damaged Pole Report

Service Request 26-00252599 Sector: \_\_\_\_\_ Gateway: \_\_\_\_\_ Primary: \_\_\_\_\_

Location on Service Request: 400 Pitman PI

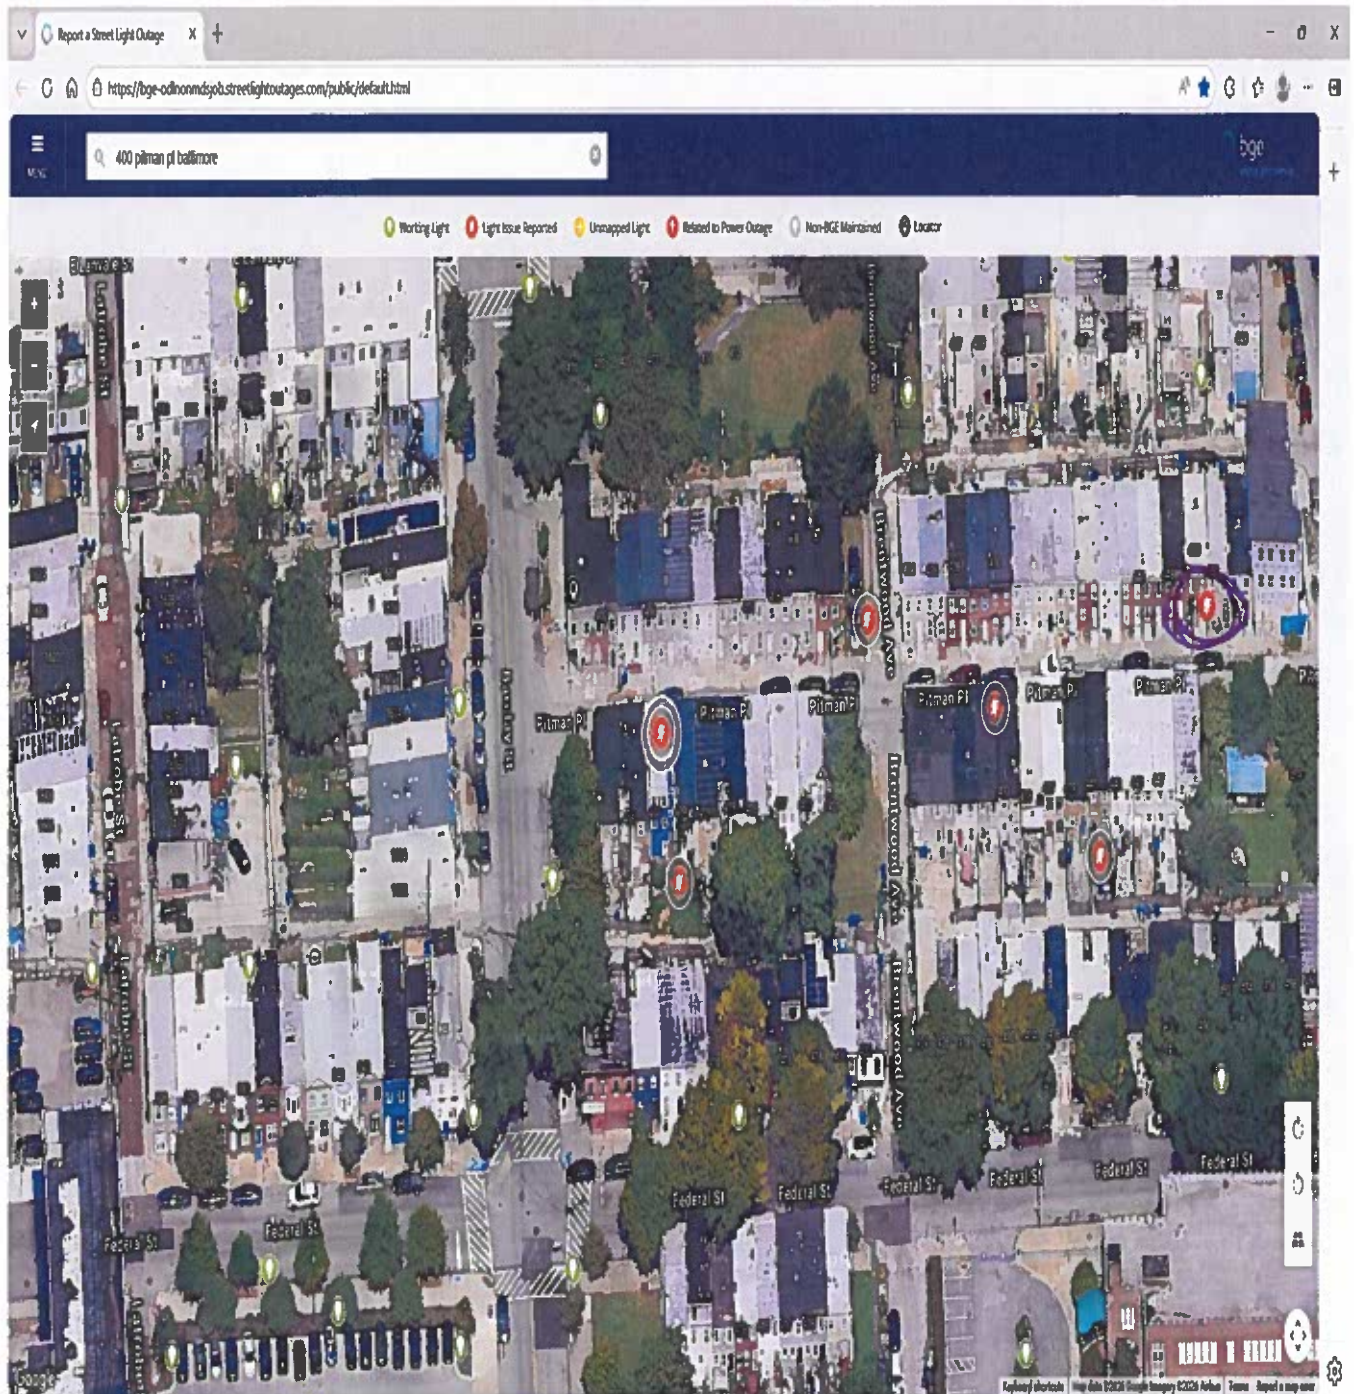
Deteriorated ☒

NEEDS  
NEW  
BASE

25 Foot Aluminum  
pole  
Cobra Hessel  
LED

WORKORDER #  
20873057
