# Inspections: Damaged Pole Report

Service Request 26-00271923 Sector: \_\_\_\_\_ Gateway: \_\_\_\_\_ Primary: \_\_\_\_\_

Location on Service Request: 4219 Orchard Ridge Blvd

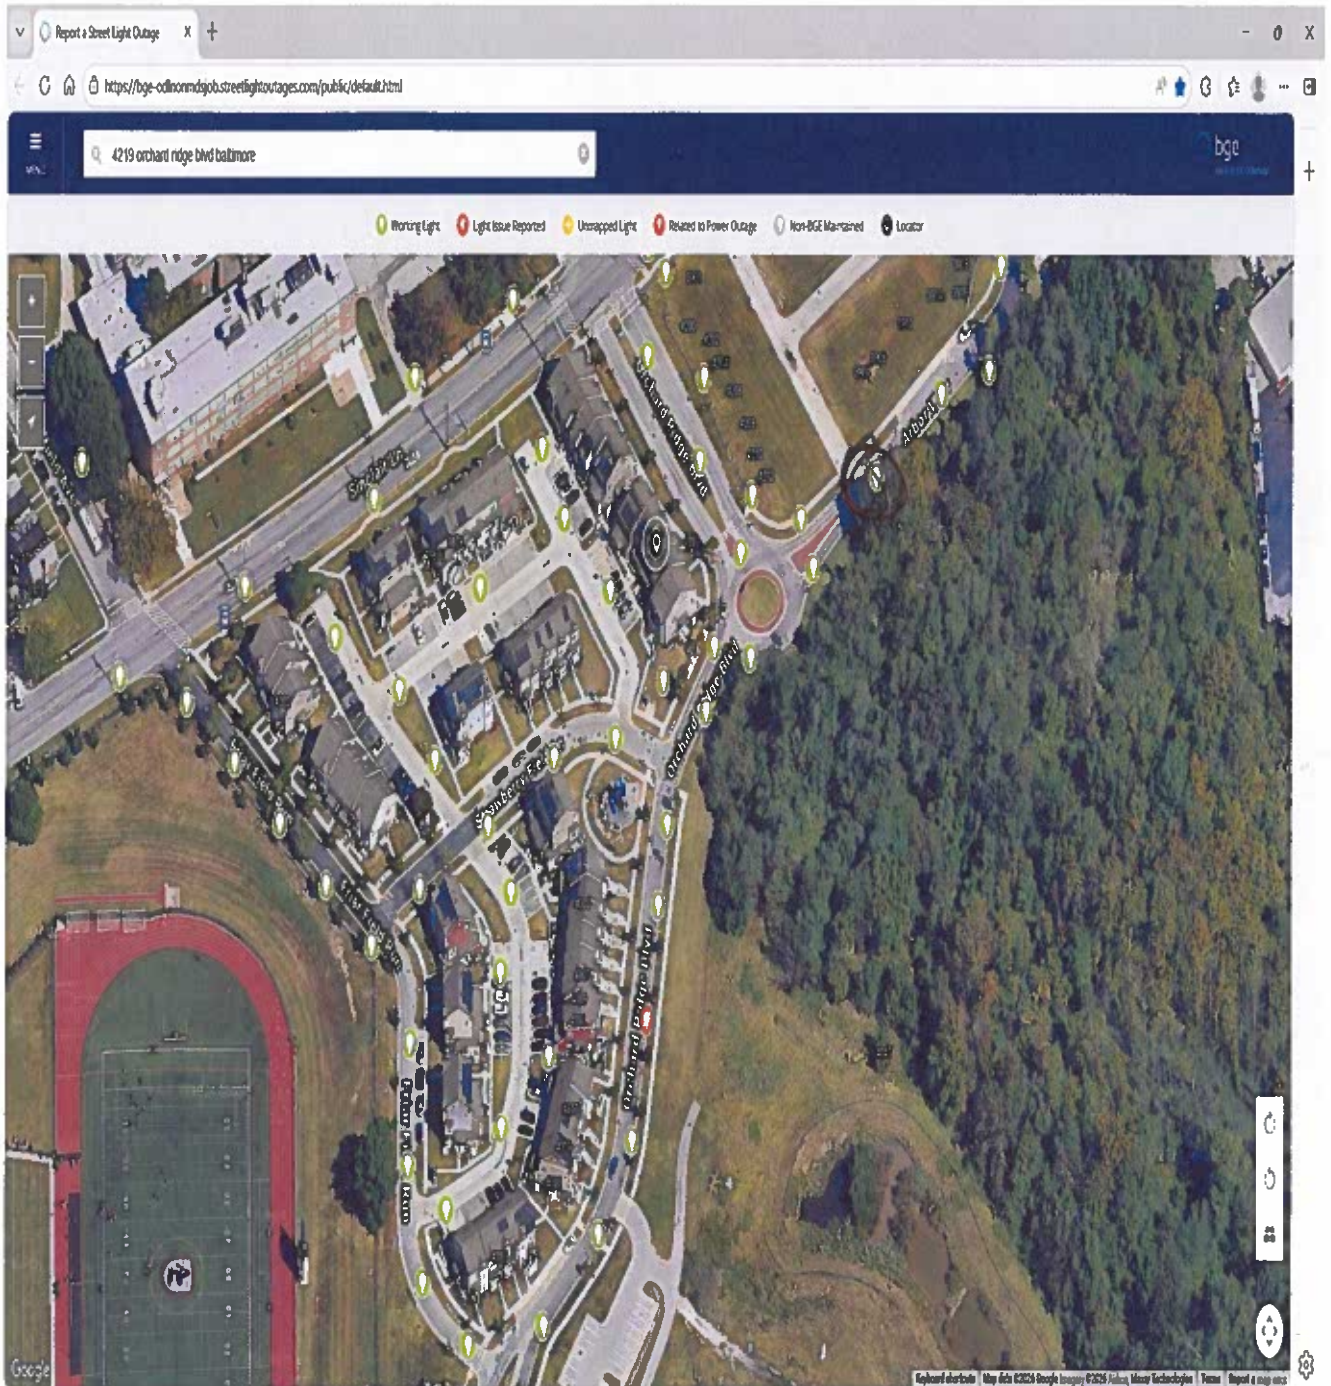
Homeland  
pole  
Acorn Fixture
