# Inspections: Damaged Pole Report

Service Request 26-00282997 Sector: \_\_\_\_\_ Gateway: \_\_\_\_\_ Primary: \_\_\_\_\_

Location on Service Request: 501 N. Calvert St

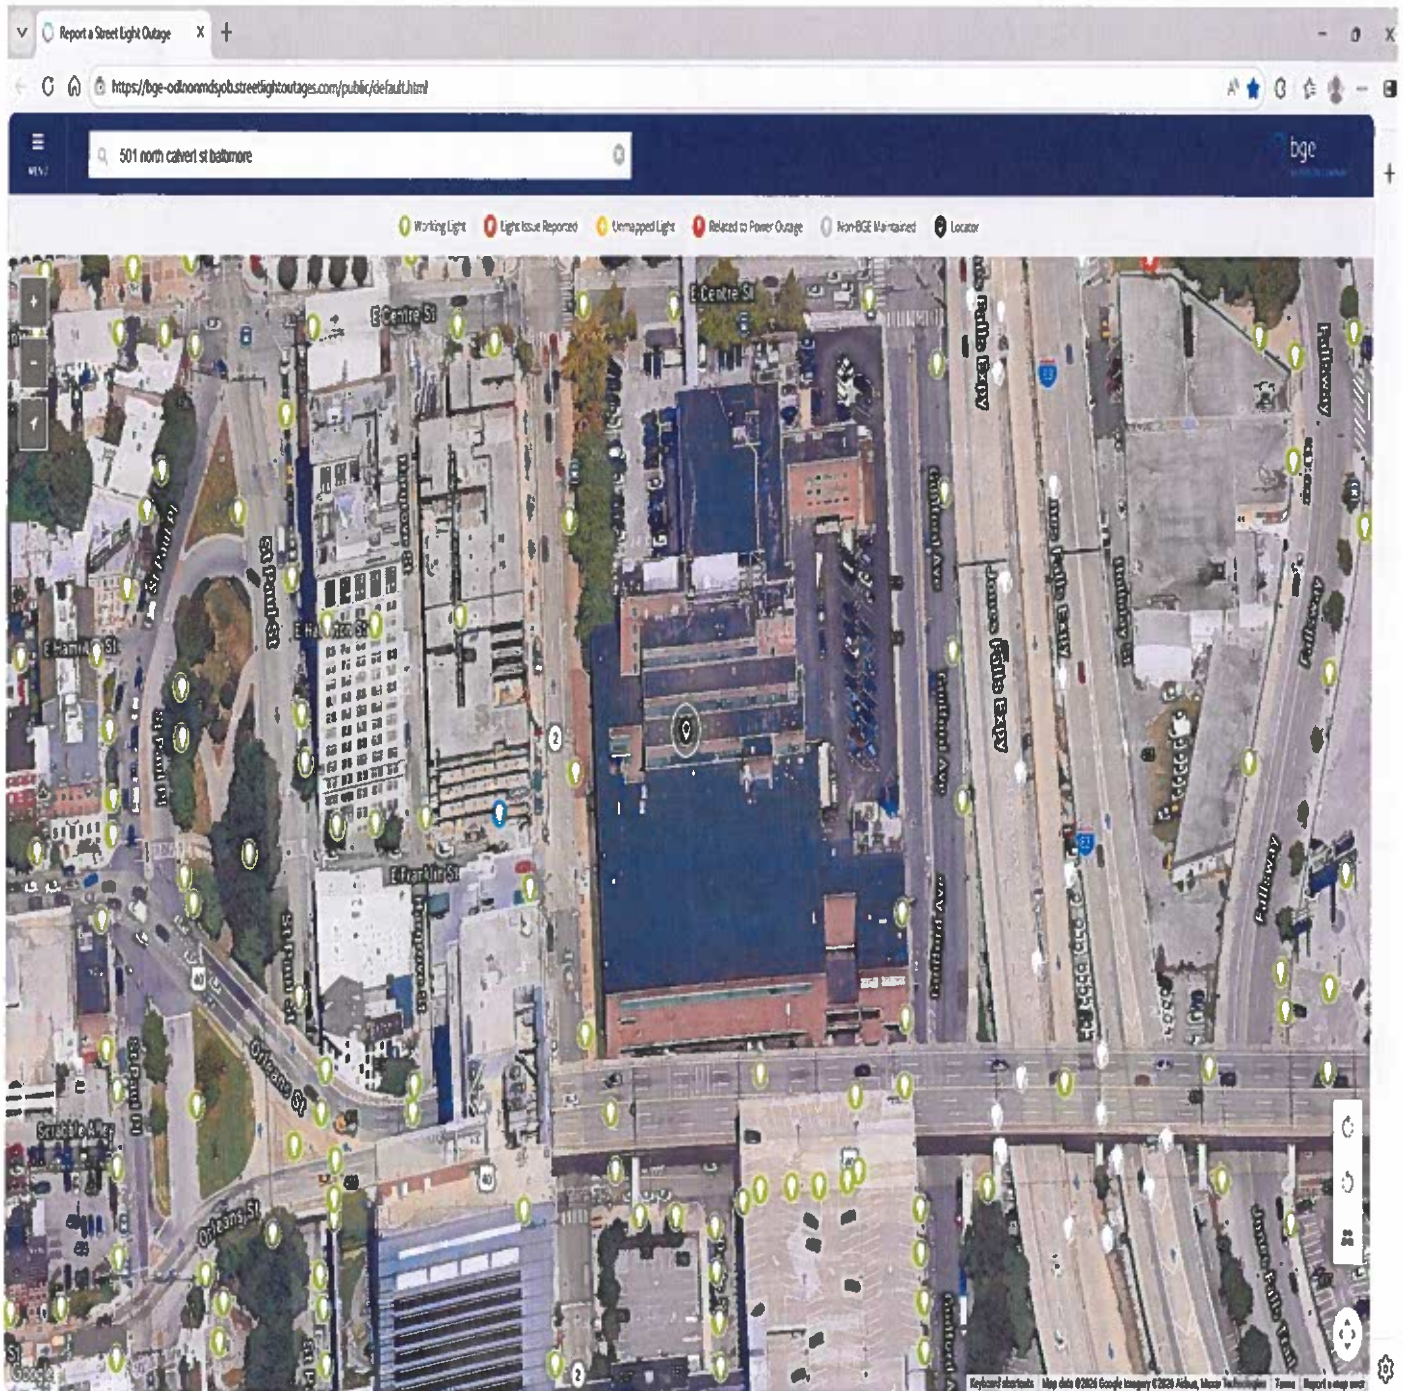
Deteriorated ☒

Missing ☒

30 Foot Aluminum  
pole  
Cove Neck  
LED

NEEDS  
New  
Pedestal  
Base
