Inspections: Damaged Pole Report

Service Request 26-00315231 Sector: \_\_\_\_\_ Gateway: \_\_\_\_\_ Primary: \_\_\_\_\_

Location on Service Request: 5801 PULASKI HWY

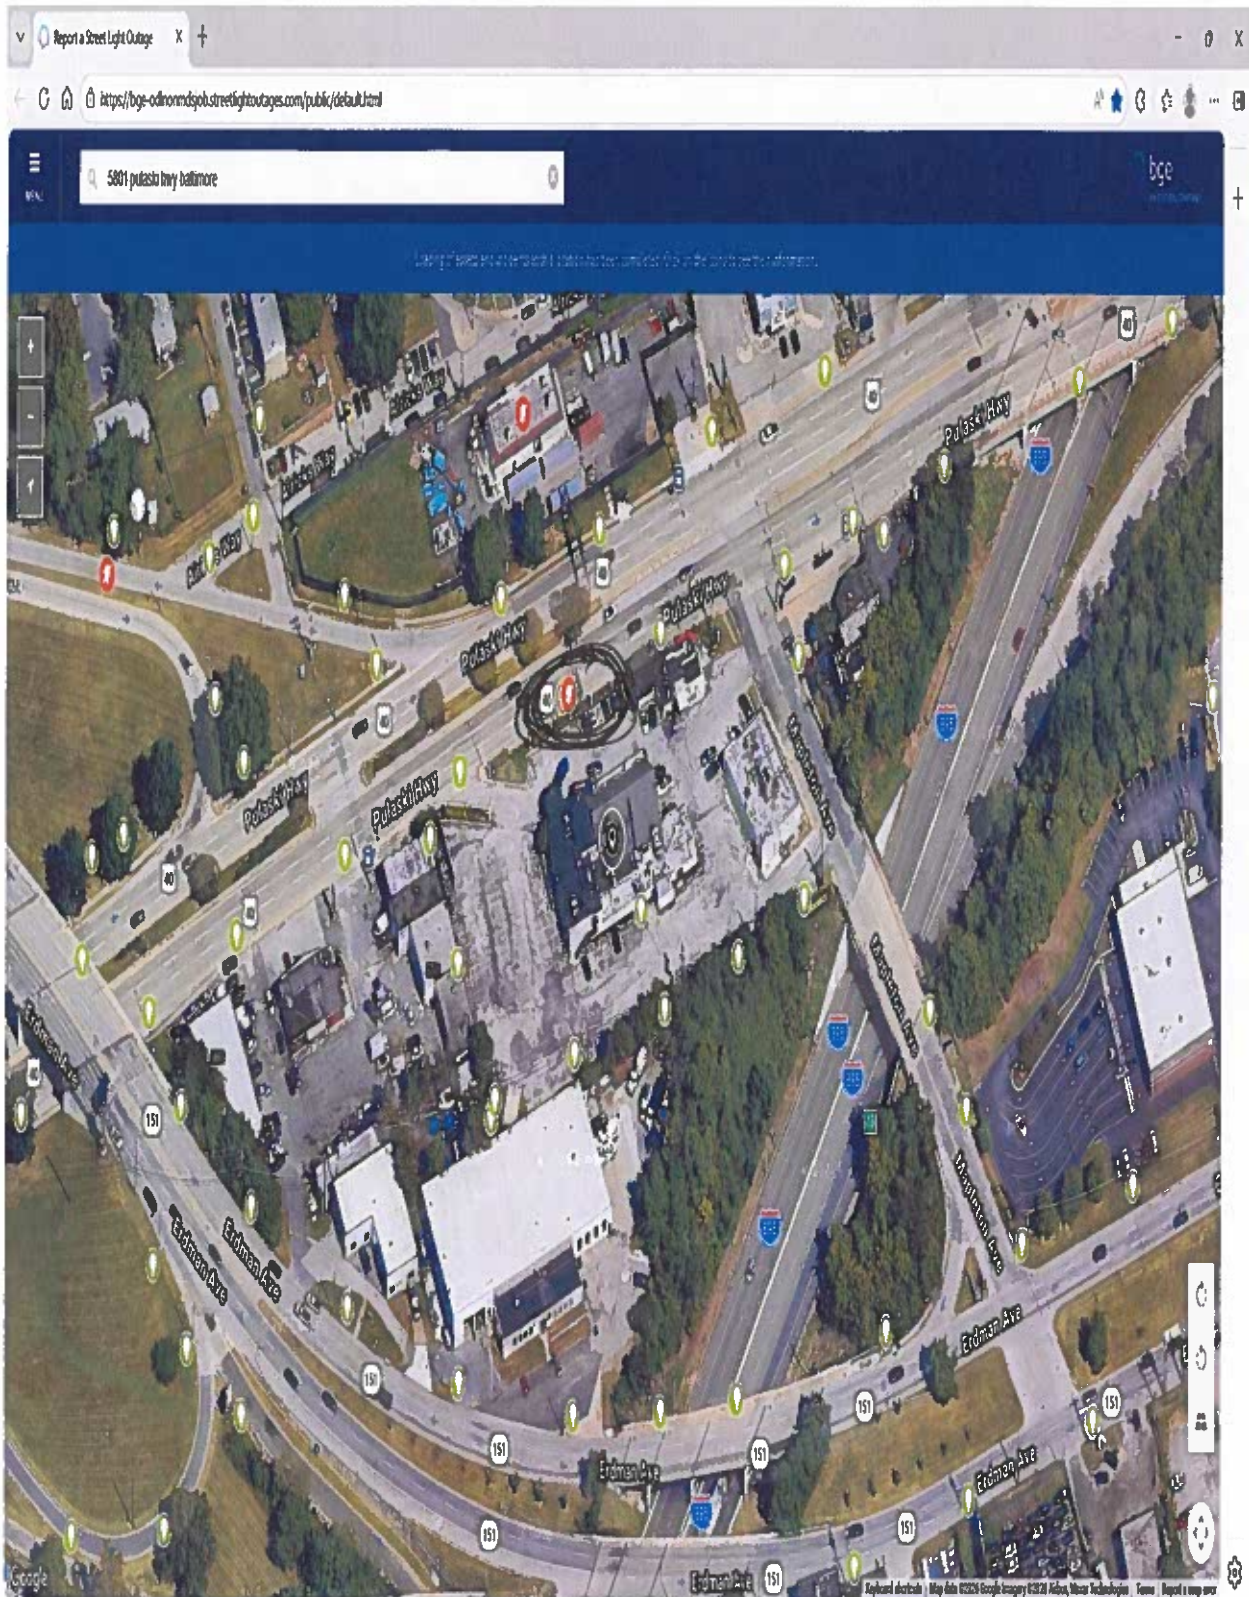
Arm/Fixture Missing ☒

Missing ☒

30 Foot  
Aluminum  
pole  
Cobra Hanel  
LED
