# Inspection Report

**Property Address:**  
2932 Greenmount Ave  
Baltimore MD 21218

**MDHI.com Property Inspectors**

| <b>Date:</b> 4/1/2026 | <b>Time:</b> 10:00:00 AM | <b>Report ID:</b> 040126DB2 |

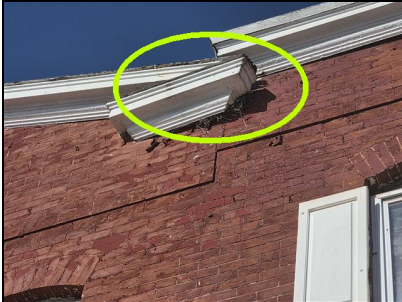
1.3 Item 1(Picture)

**1.3 (1)** The trim is either loose allowing birds to nest.

**Recommendation:** Repair or replace the trim and fix any damage revealed.

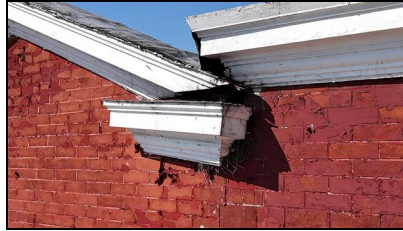
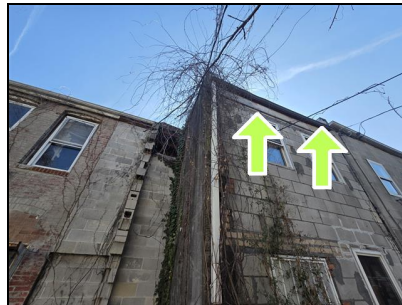
**1.3 (2)** The trim is bare (no paint or stain). Unprotected trim will deteriorate much more rapidly than painted or stained trim.

**RECOMMENDATION:** Paint or stain the trim.

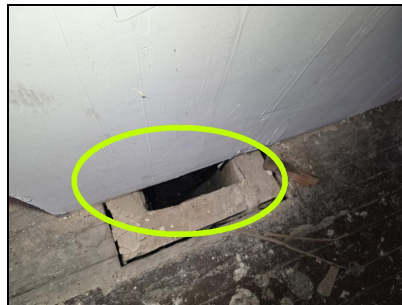
1.4 Item 1(Picture)

**1.4** The chimney has been abandoned and no longer vents any appliance or fixture. As it is no longer serving a functional purpose, the structure provides no active utility and may continue to deteriorate if not properly maintained or sealed.

**Recommendation:** Do not use the chimney. Have a qualified contractor evaluate its condition and make any necessary repairs, including sealing, stabilizing, or modifying the structure as appropriate.

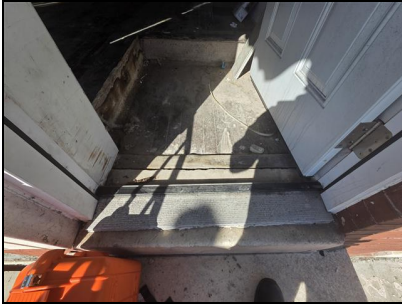
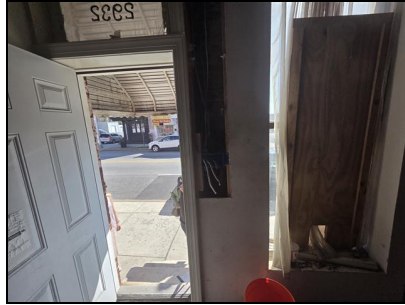
**1.5** The door is not installed square to the structure.

**RECOMMENDATION:** Repair or replace the door.

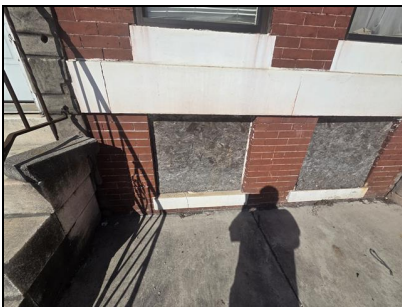
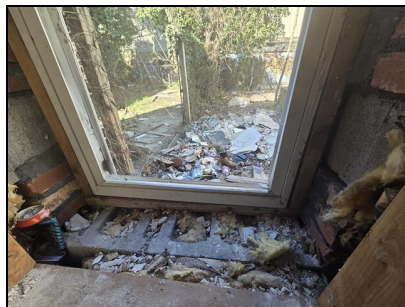
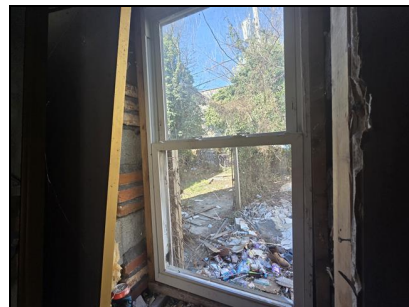
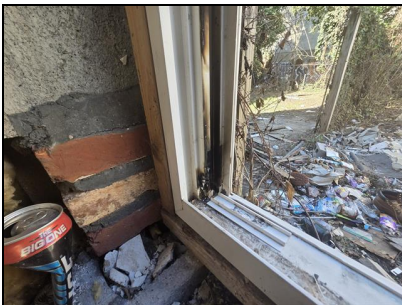
**1.6** The windows are boarded up, damaged, have broken glass or do not function.

Recommendation: Repair or replace the windows as needed.

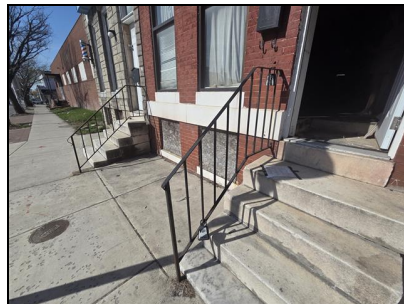
1.7 Item 1(Picture)

**1.7 (1)** The handrail is loose, this is a safety concern.

**Recommendation:** Secure the handrail as needed.

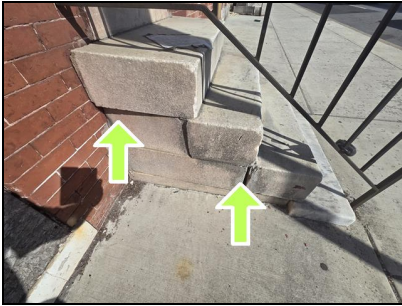
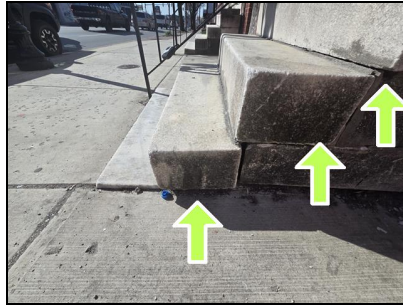
**1.7 (2)** The stair stones have shifted creating gaps.**LOCATION:** Front**RECOMMENDATION:** Repair the steps as needed.

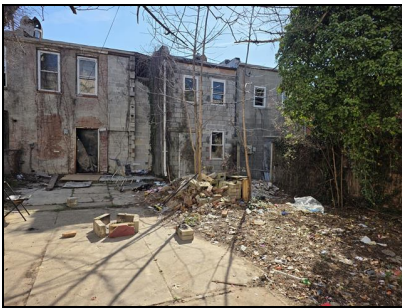
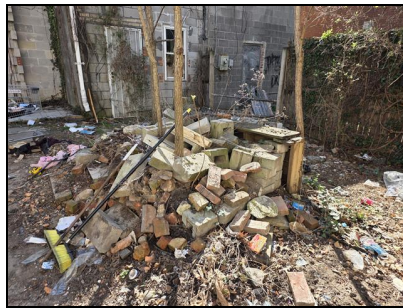
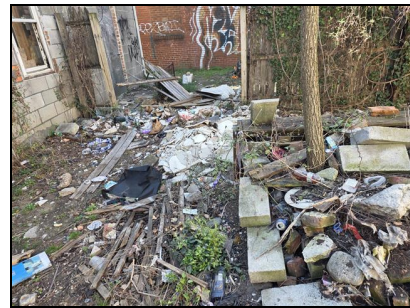
**1.10** There is deterioration at the patio deteriorated.**Location:** Rear**Recommendation:** Repair or replace the patio.

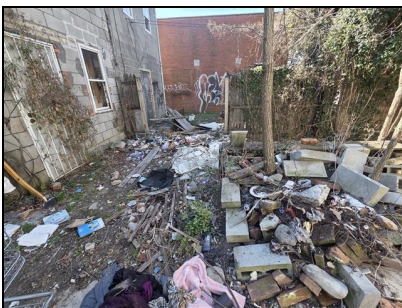
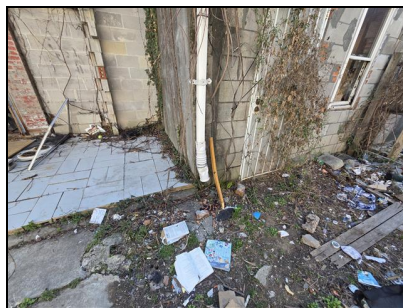
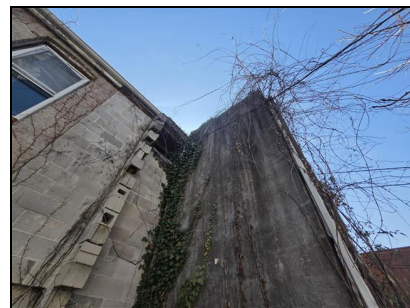
**1.12 Issue:** Vines and ivy are growing up the building.**Impact:** This will draw moisture into the structure and cause deterioration. In some cases, the vegetation will grow into the home, causing mold-conductive conditions and damage.**Location:** Observed in multiple locations.**Recommendation:** Remove the vines/ivy and repair any damage that may be revealed.

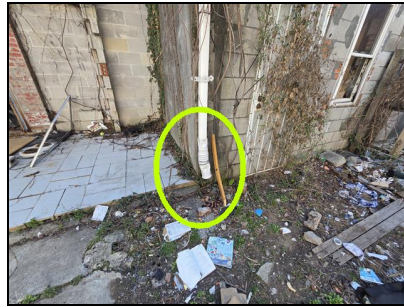
1.13 Item 1(Picture)

**1.13 Issue:** The downspout extensions are either missing or inadequate.

**Impact:** These extensions are essential for directing roof runoff water away from the foundation. Water sitting near or at the properties foundation can have a negative impact, allowing water to seep into the foundation. This is know as efflorescence, in cases were there are penetrations through the foundation or cracks water can enter causing mold conducive conditions.

**Recommendation:** Upgrade or replace the downspout extensions as needed to ensure optimal drainage.

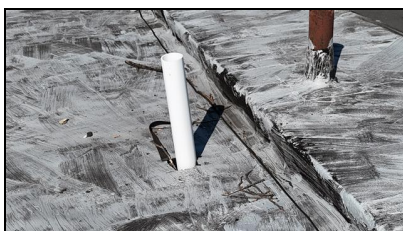
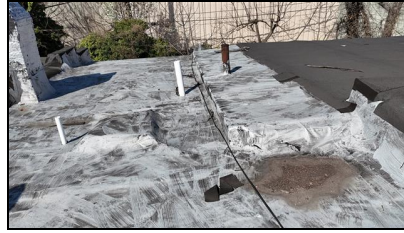
**2.0** The roof covering is older and approaching the end of its service life. While it may continue to perform for a few more years, aging materials are more prone to deterioration, and localized leaks may develop, requiring temporary patching or tar repairs.

RECOMMENDATION: Hire a qualified roofing contractor to evaluate the roof and perform repairs or replacement as needed. Proactive assessment will help address emerging leaks, reduce the risk of moisture intrusion, and plan for full replacement in the near future.

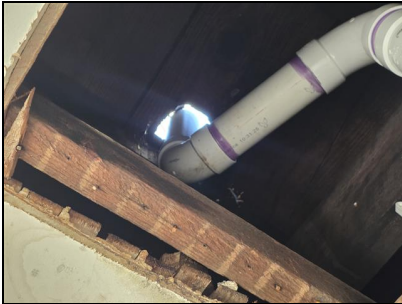
2.1 Item 1(Picture)

**2.1** Flashing is missing in this area of the roof. Missing flashing creates a direct pathway for water penetration and can lead to concealed damage within the roof assembly or adjacent structural components.

RECOMMENDATION: Have a qualified roofing contractor install proper flashing and repair any moisture-related damage uncovered during the work. Correct installation is important to prevent ongoing water intrusion and deterioration.

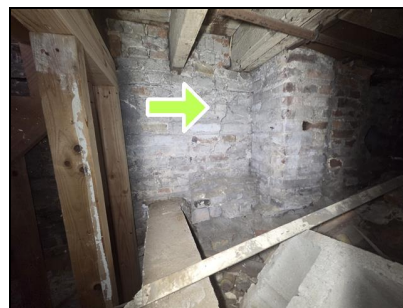
4.0 Item 1(Picture)

**4.0 (1)** Vertical cracks are present in the foundation. Vertical cracking often indicates settlement or ongoing movement and should be evaluated to determine the extent and whether structural concerns are developing.

RECOMMENDATION: Hire a qualified contractor to evaluate the foundation cracks and make any necessary repairs to prevent further movement and maintain structural stability.

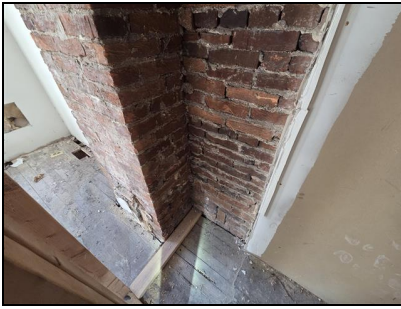
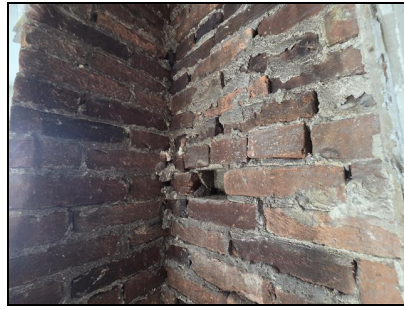
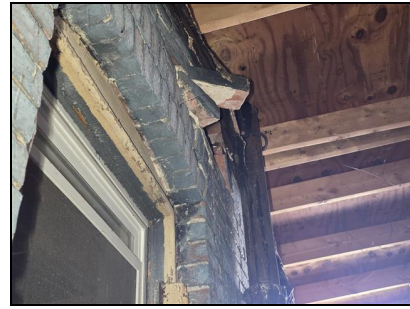
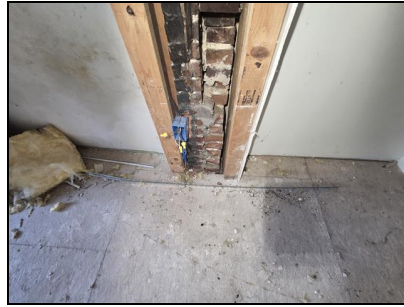
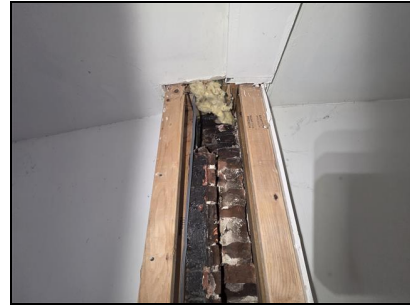
**4.0 (2)** Mortar in the foundation wall is missing or deteriorated. Gaps or weakened mortar joints can allow moisture penetration and may lead to further deterioration of the wall over time.

RECOMMENDATION: Have a qualified contractor repair or repoint the deteriorated mortar to restore proper protection and prevent additional moisture-related damage.

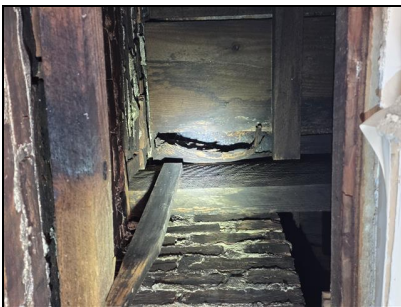
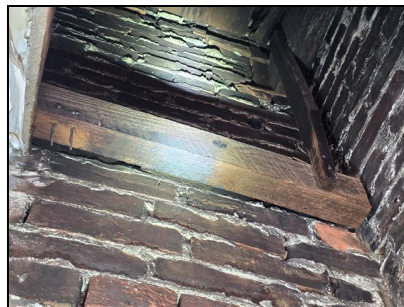
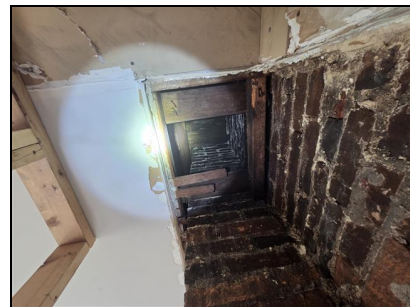
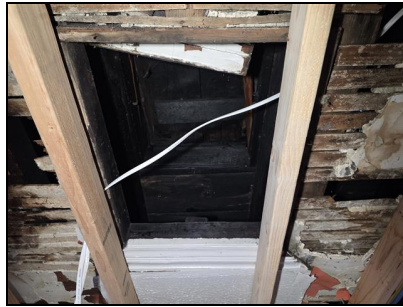
**4.3 (1)** There is evidence of fire damage in the property. The full extent of the damage and the scope of any past repairs cannot be determined during a visual inspection. Fire-related damage may affect structural components, electrical systems, and other concealed areas.

RECOMMENDATION: Ask the property owner for details regarding the fire event and any repairs performed. Records of the incident can typically be obtained from the local fire department, and documentation of repairs—along with any required permits or approvals—can usually be obtained from the municipal building department. Further evaluation by qualified professionals may be necessary depending on the findings.

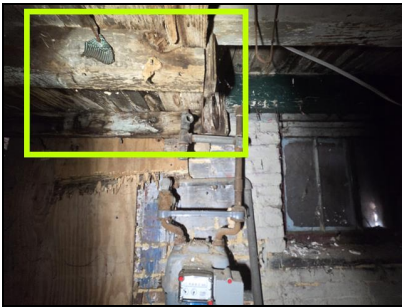
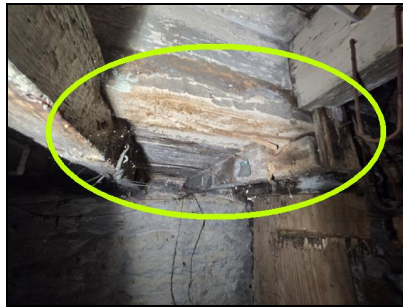
**4.3 (2)** A floor joist is deteriorated. This deterioration can reduce the joist's load-bearing capacity and may indicate an underlying moisture or pest-related issue. The cause of the deterioration should be identified to determine whether additional structural components are affected.

RECOMMENDATION: Hire a qualified contractor to evaluate the deteriorated joist, determine the cause of the damage, and repair or replace the affected structural members as needed.

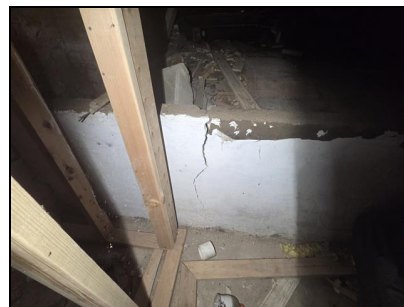
4.4 Item 1(Picture)

**4.4 (1)** There is visible cracking and movement in the retaining wall. Because this wall is supporting soil along the crawlspace, any displacement can compromise stability and may worsen over time. The underlying cause of the cracking and movement should be identified to prevent further structural concerns.

Recommendation: Hire a qualified contractor to evaluate the retaining wall, determine the cause of the cracking and movement, and make any necessary repairs or replacements to ensure the wall remains stable and capable of supporting the adjacent soil.

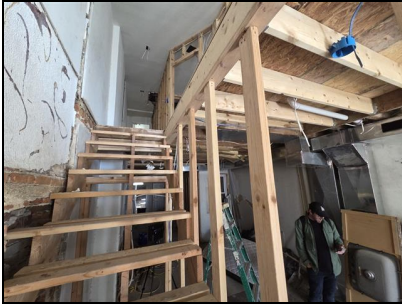
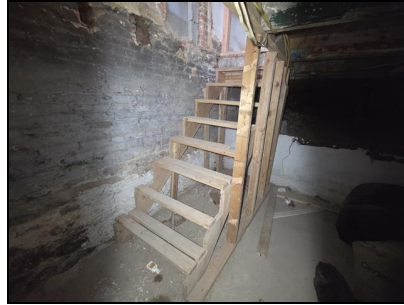
**4.4 (2)** There are no fire stops at the walls. Fire stops at walls adjacent to stairways are essential.

**Recommendation:** Compliance with building codes: Many building codes require fire stops at certain locations, such as around vents, pipes, ducts, cables, and wires at ceiling and floor level.

It is important to consult with a qualified fire safety professional to ensure that fire stops are installed correctly and in compliance with local building codes.

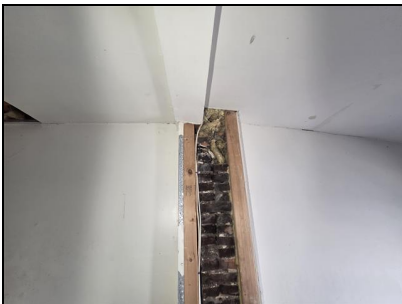
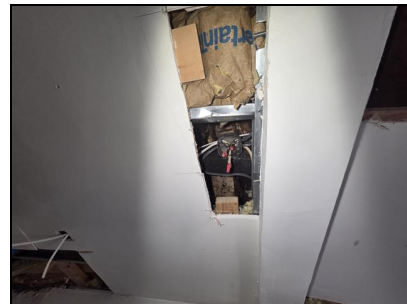
**4.4 (3)** The wall and ceiling do not appear to have appropriate load-bearing supports. When an opening is created in a load-bearing wall, the structural load must be properly transferred down to the foundation or basement through an adequate support system. There is no visible evidence of such a load path in this area.

This condition can lead to structural settlement, deformation, or eventual failure if not corrected.

**Recommendation:** Hire a licensed structural engineer to evaluate the structure and provide detailed recommendations for proper corrective measures. After engineering guidance is obtained, have a qualified contractor perform all required repairs to ensure the load is properly supported.

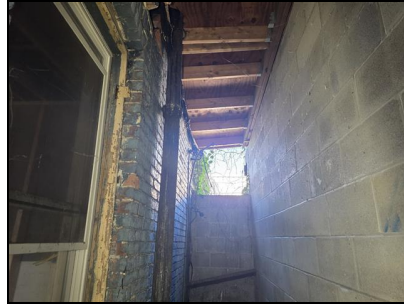
4.5 Item 1(Picture)

**4.5** The roof rafters are exposed to the elements, and some rafters are missing. Structural wood that is not designed for exterior exposure is vulnerable to deterioration when left unprotected. Prolonged exposure can lead to decay, moisture damage, and increased susceptibility to pests.

Recommendation: Have a qualified contractor evaluate the affected area and make all necessary repairs, including replacing missing rafters and properly protecting any exposed structural wood to prevent further deterioration.

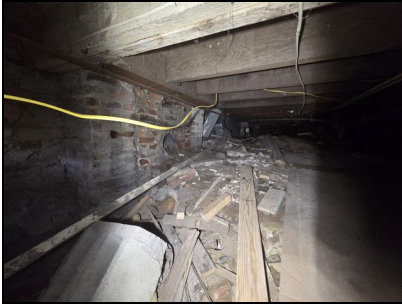
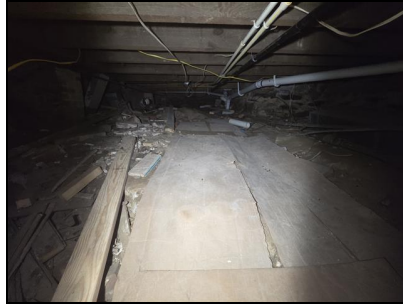
**6.2** Insulation is absent in the crawl space. Missing insulation can reduce energy efficiency and contribute to heat loss, moisture concerns, and overall comfort issues within the property.

**Recommendation:** Install appropriate insulation in accordance with local building guidelines and best practices to improve energy efficiency and help maintain proper thermal performance

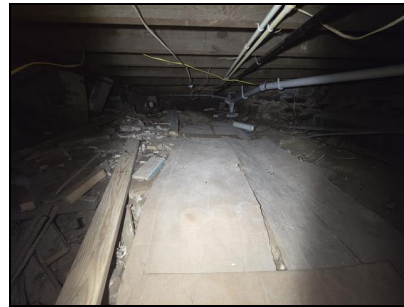
6.4 Item 1(Picture)

**6.4** There is no vapor retarder installed in the crawlspace. Without a proper ground moisture barrier, humidity levels can rise and contribute to condensation, wood deterioration, mold growth, and other moisture-related issues.

**Recommendation:** Install a continuous vapor retarder across all exposed soil areas in accordance with current standards to help control moisture and protect building components.

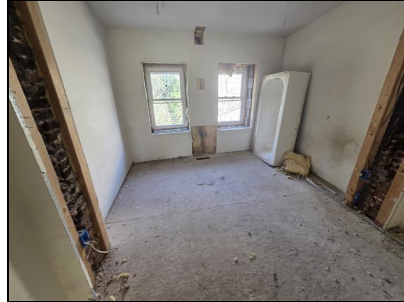
7.1 Item 2(Picture)

**7.1 (2)** The flooring slopes/un-level, there are several possible causes. An evaluation is needed to determine the cause.

RECOMMENDATION: Hire a contractor to determine the cause and make any needed repairs.

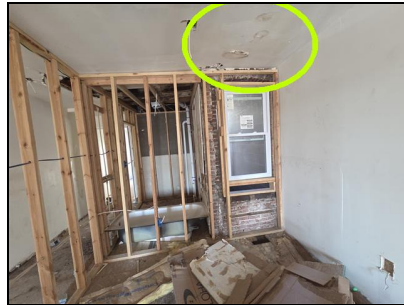
7.3 Item 1(Picture)

**7.3** The ceiling is water-stained or damaged. Moisture meter testing showed high moisture content at the time of inspection, indicating active moisture intrusion. Hidden damage within the ceiling or surrounding materials is possible.

RECOMMENDATION: Have a qualified contractor evaluate the affected area to determine the source of moisture and make all necessary repairs, including addressing any concealed damage uncovered during the work.

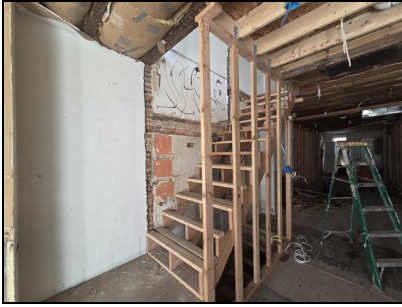
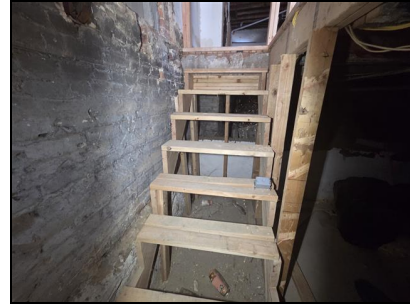
**7.4 (1)** The stairs are installed in a manner that does not align with current building standards. The connection between the stringer end and the floor is vulnerable to failure. While this installation method may have been acceptable at the time of construction, modern practices offer more secure and reliable techniques for stair anchoring.

**Recommendation:** Hire a qualified contractor to assess the stair installation and perform necessary upgrades to meet today's safety and structural standards.

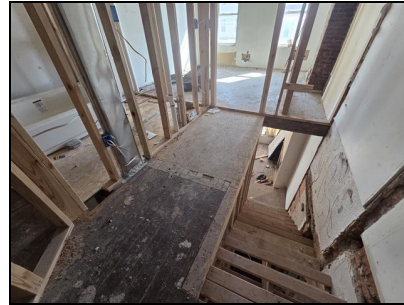
7.4 Item 4(Picture)

**7.4 (2)** A handrail is missing at this location. The absence of a proper handrail creates a safety hazard, increasing the risk of slips, trips, or falls when using the stairs or elevated walking surface.

RECOMMENDATION: Have a qualified contractor install a compliant handrail to restore safe use of the area and meet current safety standards.

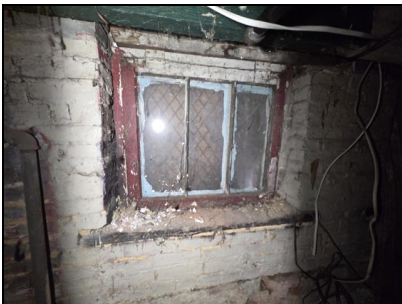
7.8 Item 1(Picture)

**7.8** The window is damaged or inoperative, which affects its ability to function as designed. Depending on the nature of the damage, operation, security, and weather-resistance may be compromised.

RECOMMENDATION: Repair or replace the window to restore proper operation and ensure it functions safely and effectively.

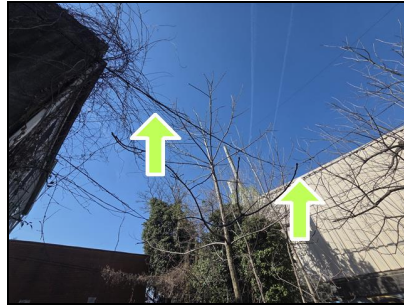
8.0 Item 1(Picture)

**8.0** The entrance cable is in contact with tree limbs. This is a safety hazard.

RECOMMENDATION: Hire a contractor to remove the tree limbs.

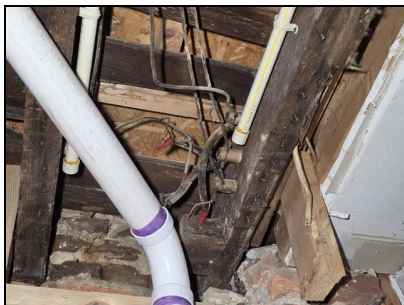
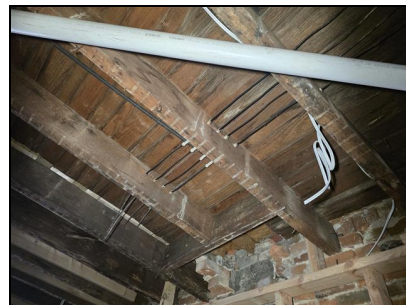
**8.3** Knob-and-tube wiring is present. This older wiring method cannot be grounded and often has brittle, deteriorated, or damaged insulation. These conditions can create safety concerns and may not meet modern electrical standards.

RECOMMENDATION: Hire a licensed electrician to evaluate the condition of the knob-and-tube wiring and make any necessary repairs or replacements to ensure the system is safe and compliant with current electrical requirements.

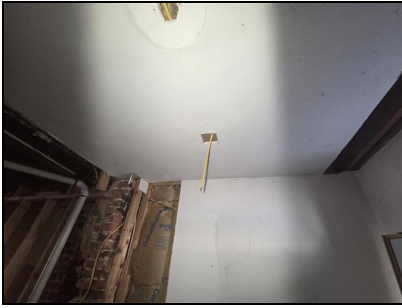
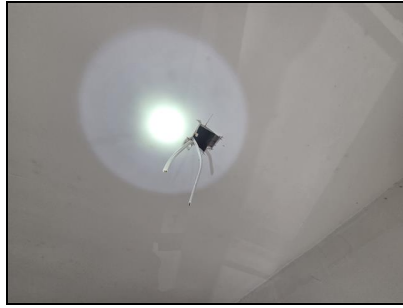
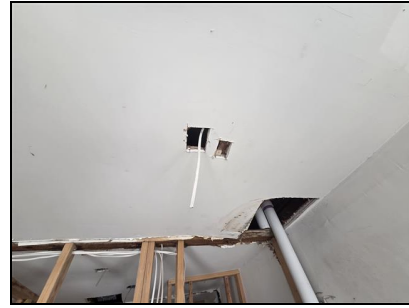
**8.7** Some light fixtures appear to require a junction box for proper installation. Several fixtures are installed in areas where a junction box may be missing or where the fixture may not be rated for direct contact with insulation.

RECOMMENDATION: Have a qualified electrician verify that each fixture is properly installed with an approved junction box where required. Confirm that all lighting is rated for the installation conditions, including proximity to insulation (IC rated where applicable) and compliance with manufacturer specifications.

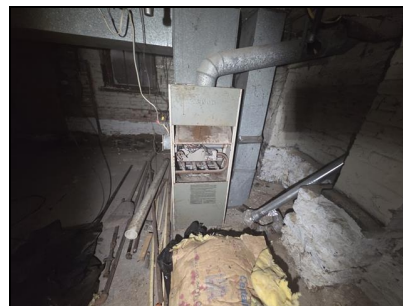
9.0 Item 1(Picture)

**9.0** The furnace is old and was not connected at time of inspection. The unit should be replaced.

Recommendation: Replace the HVAC unit and complete the installation of all the duck work.

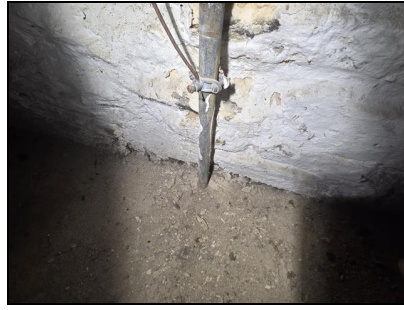
10.0 Item 1(Picture)

Longevity varies based on water quality, electrical grounding conditions, and the thickness of the original zinc coating.

Recommendation: Hire a licensed plumber to evaluate the condition of the galvanized piping and repair or replace sections as needed to ensure proper function and reduce the risk of future leaks or failures.
