# Inspections: Damaged Pole Report

Service Request: 26-00328022 Sector: \_\_\_\_\_ Gateway: \_\_\_\_\_ Primary: \_\_\_\_\_

Location on Service Request: 306 Eo 23rd St

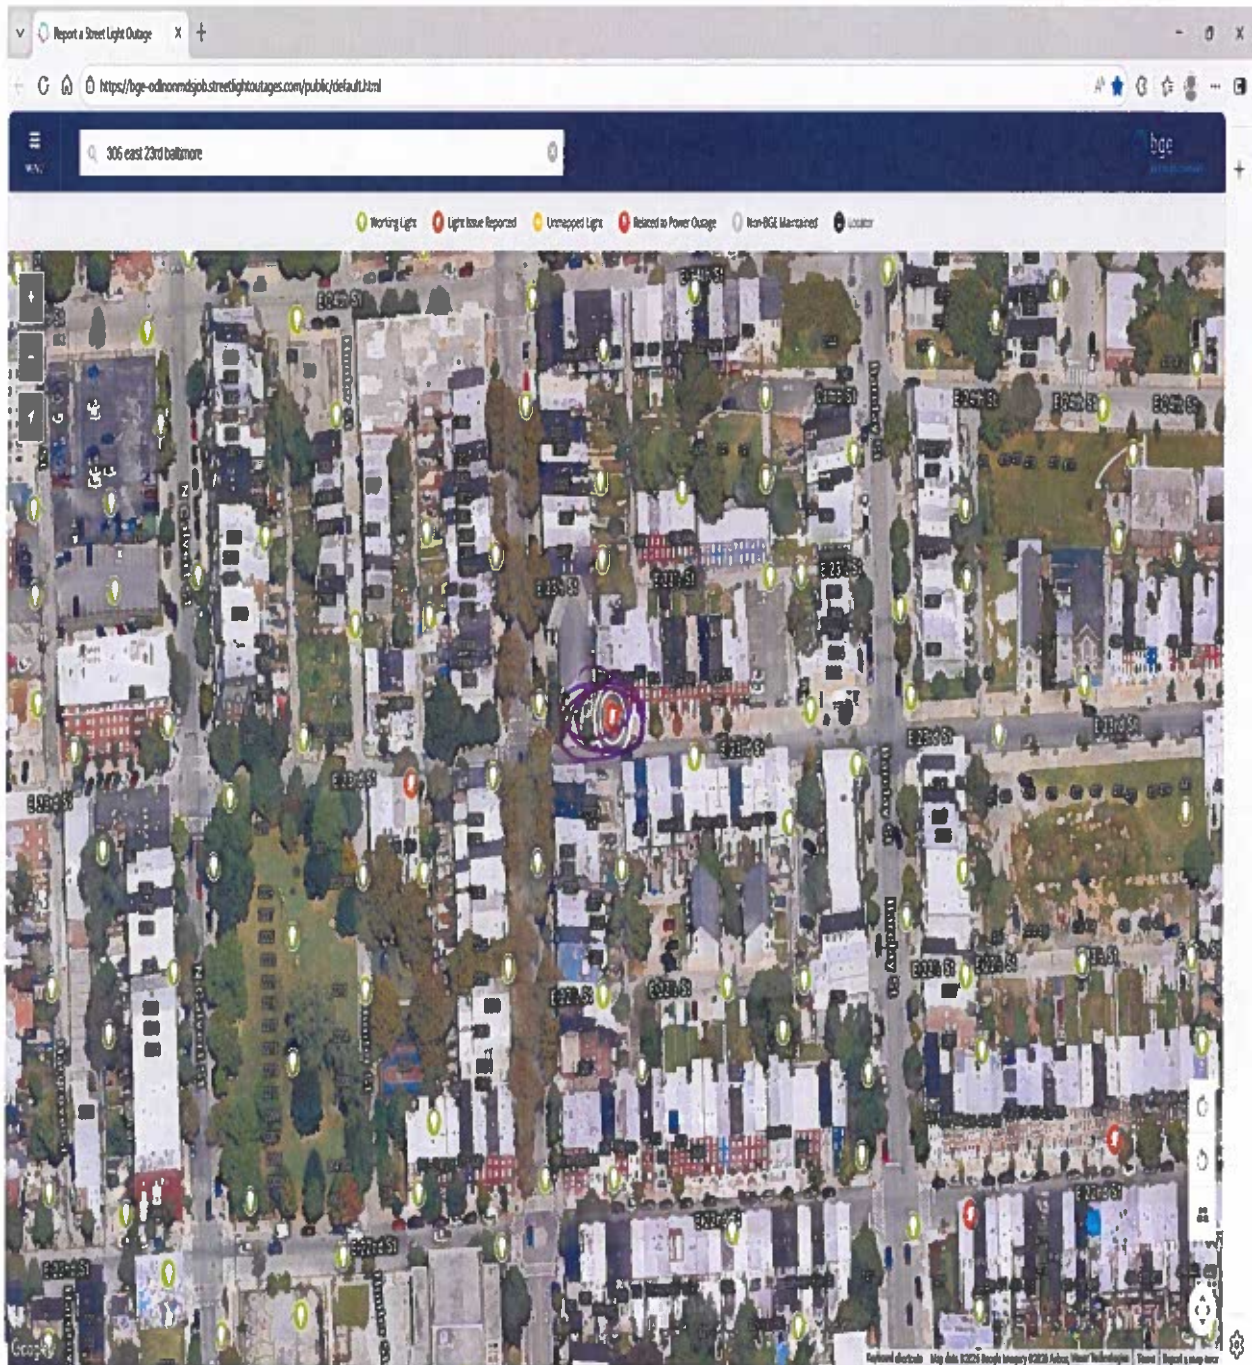
Deteriorated ☒

Missing ☒

25 Foot Aluminum pole  
Cobra Head  
LED
