# Inspections: Damaged Pole Report

Service Request: 26-00339095 Sector: \_\_\_\_\_ Gateway: \_\_\_\_\_ Primary: \_\_\_\_\_

Location on Service Request: 1430 Lawrence St

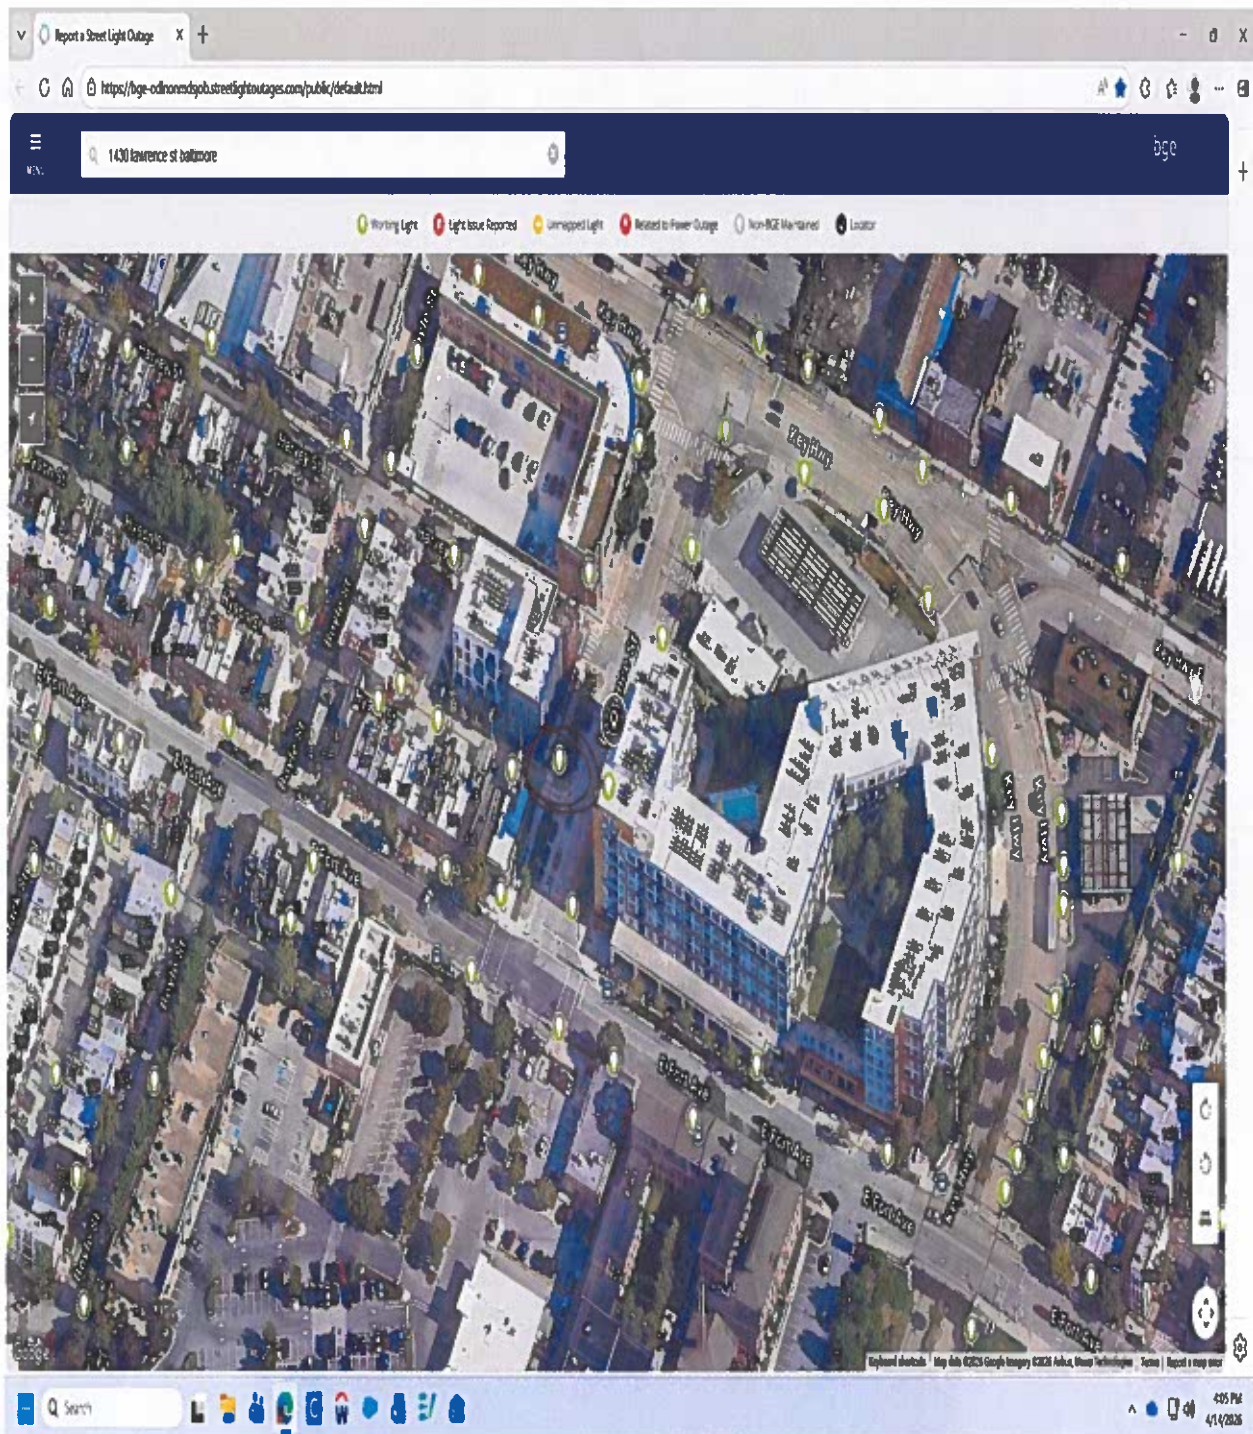
Deteriorated ☒

Missing ☒

30 Foot Aluminum  
pole  
Color A Head  
LED
