# Inspections: Damaged Pole Report

Service Request 26-00348225 Sector            Gateway:            Primary:

Location on Service Request: 5700 Eastern Ave

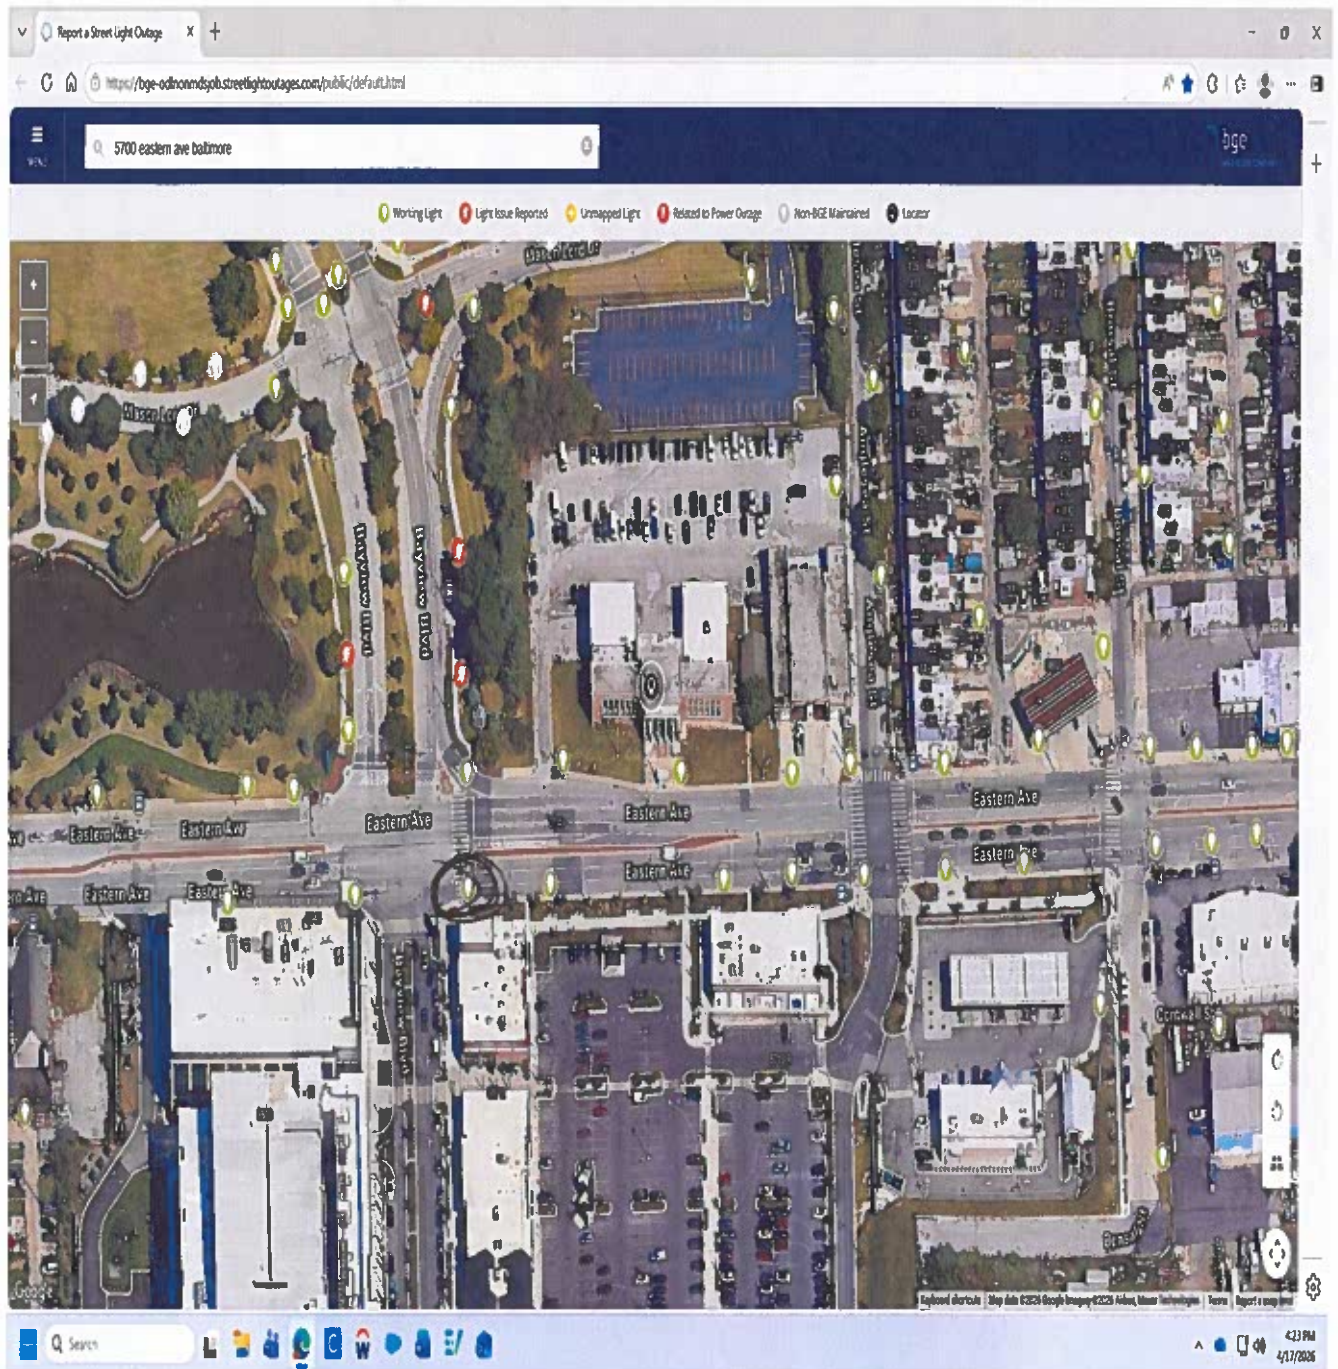
30 Foot  
Aluminum  
pole  
Cobra Head  
LED
