# Inspection Report

**Property Address:**  
2607- 2609 Greenmount Ave  
Baltimore MD 21218

**MDHI.com Property Inspectors**

| <b>Date:</b> 4/16/2026 | <b>Time:</b> 10:00:00 AM | <b>Report ID:</b> 041626DB1-2 |

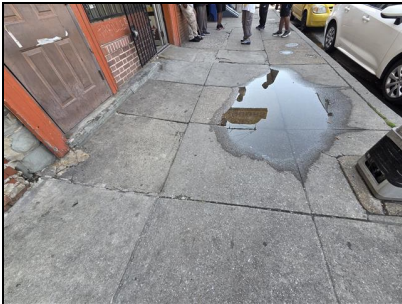
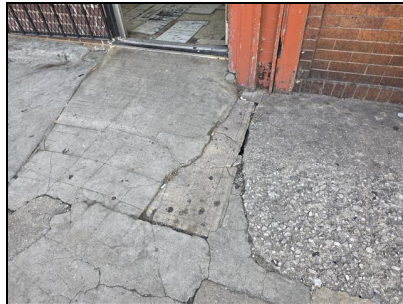
**1.1 (1)** The walk has cracked and settled/heaved. Cracks permit moisture to enter, which can cause further damage. Uneven walking surfaces are trip hazard.

LOCATION: Front

RECOMMENDATION: Repair the walk.

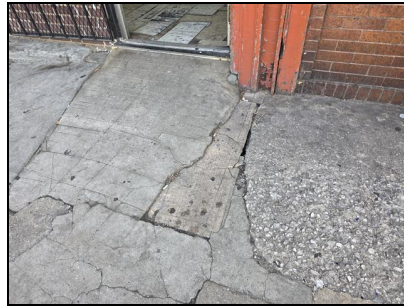
1.1 Item 3(Picture)

**1.1 (2)** There is a gap at the walk near the building. This may permit water to penetrate the foundation.

LOCATION: Front

RECOMMENDATION: Fill and seal the gap.

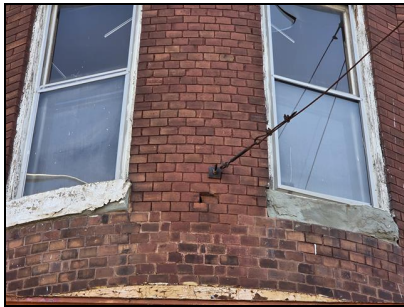
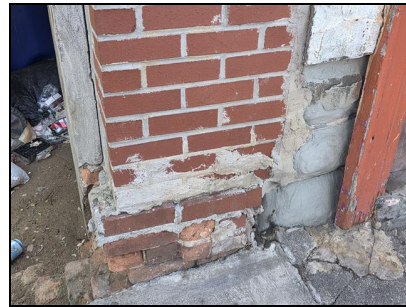
**1.2 (1)** There are deteriorated mortar joints in the siding. This permits moisture penetration and will cause further damage.

LOCATION: Front

RECOMMENDATION: Repair the mortar joints.

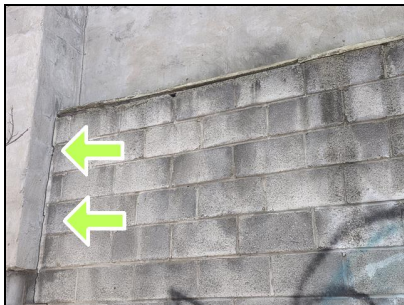
1.2 Item 4(Picture)

**1.2 (2)** There are gaps or unsealed areas side of the building and the pilasters. This will allow moisture into the structure and can lead to preventable deterioration.

Location: Left side

Recommendation: Hire a contractor to repair the gap as needed.

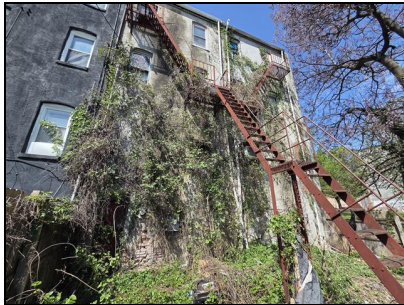
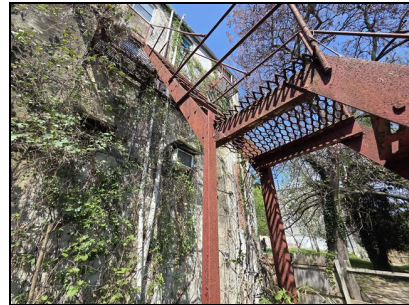
**Impact:** This will draw moisture into the structure and cause deterioration. In some cases, the vegetation will grow into the home, causing mold-conducive conditions and damage.

**Location:** Multiple Locations

**Recommendation:** Remove the vines/ivy and repair any damage that may be revealed.

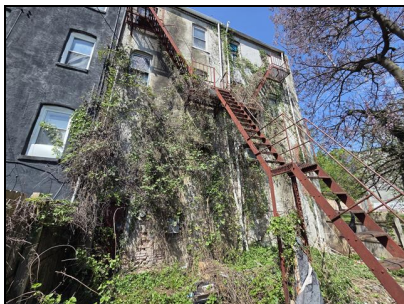
1.20 Item 1(Picture)

**1.20** Vegetation and organic growth are covering portions of the fire escape, limiting visibility and restricting a full inspection. Several welds are visibly failed or deteriorated, rendering the fire escape unsafe for use. A compromised fire escape poses a serious life-safety hazard.

**Location:** Rear

**Recommendation:** Have a qualified contractor or structural steel specialist evaluate the entire fire escape system, remove obstructing growth, and perform all necessary repairs or replacements to restore safe, functional, and code-compliant emergency egress.

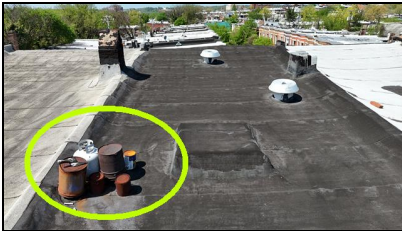
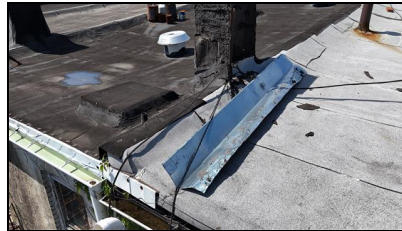
**2.0 (1)** There is debris on the roof. This can damage roofing and permit water penetration.

LOCATION: In multiple locations.

RECOMMENDATION: Clean the debris off the roof.

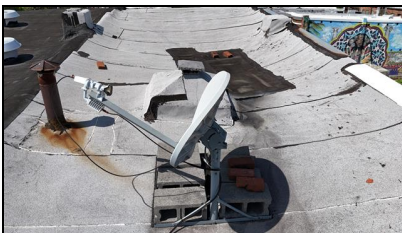
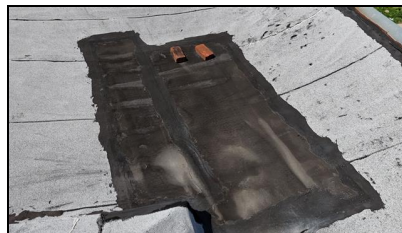
**2.0 (2)** Repairs have been made to the roof covering in the rear area. The original cause and full extent of the prior damage could not be determined based on visible conditions. At the time of inspection, no active leaks were observed.

**Location:** Left Side

**Recommendation:** Continue to monitor the repaired area for signs of deterioration or water intrusion. Perform maintenance as needed to preserve roof integrity and prevent future issues.

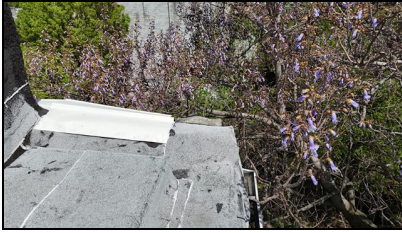
2.1 Item 1(Picture)

**2.1** The cap is damaged or missing and some areas are covered with rolled roofing material. This should be capped with metal flashing/cap. This can allow interior leaking and damage.

LOCATION: In multiple locations.

RECOMMENDATION: Replace with metal flashing and repair any damage which may be revealed.

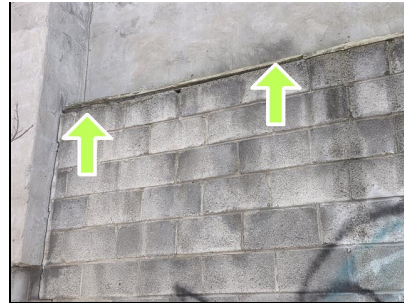
4.0 Item 1(Picture)

**4.0 (1)** The mortar at the top of the foundation wall is deteriorated. Gaps or weakened mortar joints can allow moisture penetration and may lead to further deterioration of the wall over time.

LOCATION: Left side

RECOMMENDATION: Have a qualified contractor repair or repoint the deteriorated mortar to restore proper protection and prevent additional moisture-related damage.

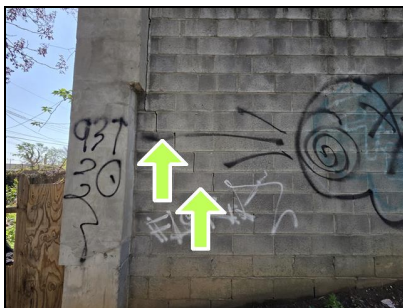
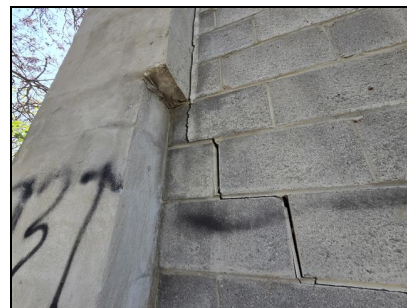
**4.0 (2)** There are step cracks in the foundation wall. Step cracks indicate that the foundation has settled or is settling.

LOCATION: Left side

RECOMMENDATION: Hire a contractor to evaluate the cracks and provide repairs as needed.

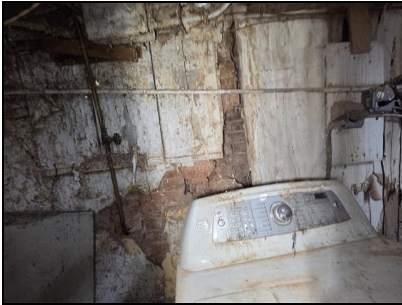
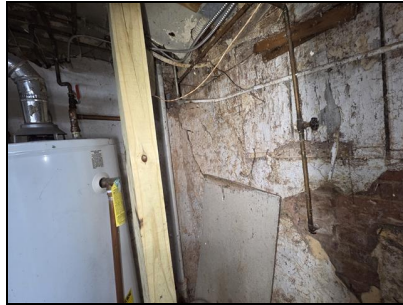
**4.0 (3)** Mortar in the foundation wall is missing or deteriorated. Gaps or weakened mortar joints can allow moisture penetration and may lead to further deterioration of the wall over time.

LOCATION: Basement

RECOMMENDATION: Have a qualified contractor repair or repoint the deteriorated mortar to restore proper protection and prevent additional moisture-related damage.

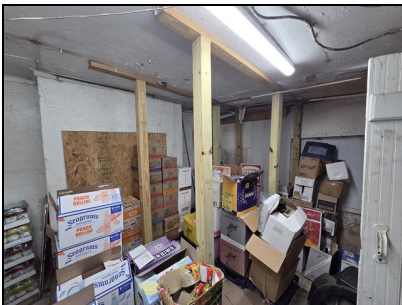
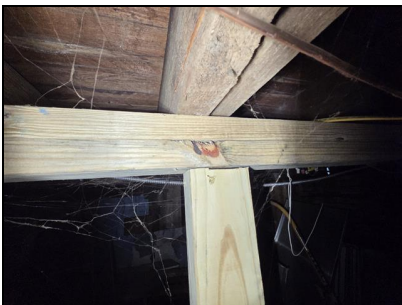
**4.2 (1)** The support column beams are 4 X 4's and 2 x 4's, this is not recommend for load bearing support of a building. Although your property is older and predates current standards. This may pose an issue with settlement.

LOCATION: Basement Multiple Locations

RECOMMENDATION: Hire a contractor to evaluate the columns and beam connection and make any repairs needed.

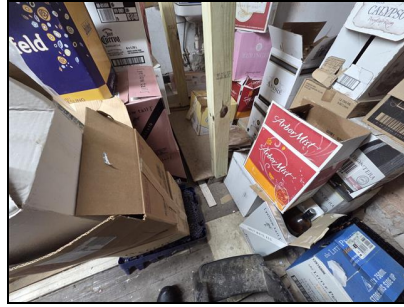
4.2 Item 5(Picture)

**4.2 (2)** The pier does not have a footing that extends below the frost line. This can affect its load carrying ability. Surface block are not adequate.

LOCATION: Basement

RECOMMENDATION: Hire a contractor to evaluate and repair or replace as needed.

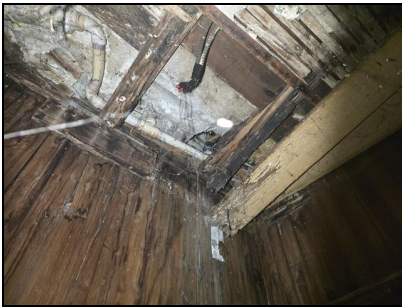
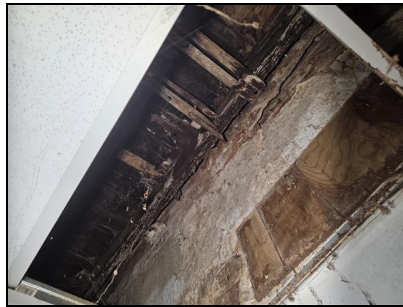
**4.3 (1)** The sub-floor is deteriorated from moisture penetration. This weakens the floor structure.

LOCATION: 2nd floor

RECOMMENDATION: Hire a contractor to evaluate and repair or replace as needed.

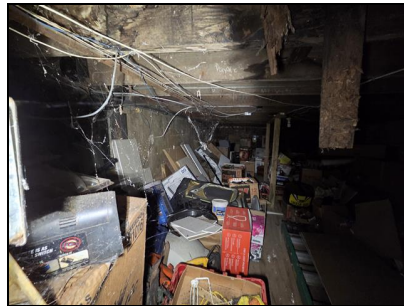
4.3 Item 3(Picture)

**4.3 (2)** Moisture staining is present on the joists or subfloor. A moisture meter was used during the inspection, and the affected areas showed low (dry) moisture levels, indicating that the leak was from a prior event and has since been repaired. No active moisture was detected at the time of the inspection.

LOCATION: Multiple locations throughout the property. Basement

RECOMMENDATION: Ensure all plumbing fixtures, appliances, and other water-related components remain in good working condition. If any new moisture or leakage is discovered in the future, hire a qualified contractor to identify and repair the source and complete any necessary repairs to the affected building materials promptly.

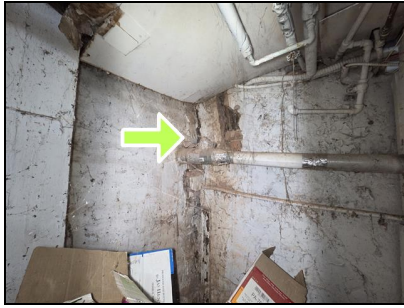
4.4 Item 1(Picture)

**4.4** The bearing wall is bowing. This indicates a structural failure. The cause for this should be identified.

LOCATION: Rear

RECOMMENDATION: Hire a contractor for an evaluation and provide repairs as needed.

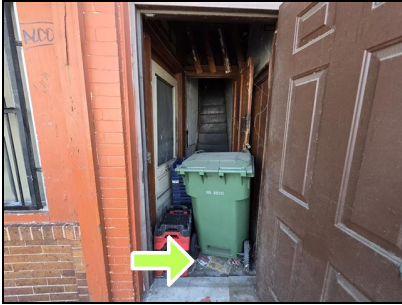
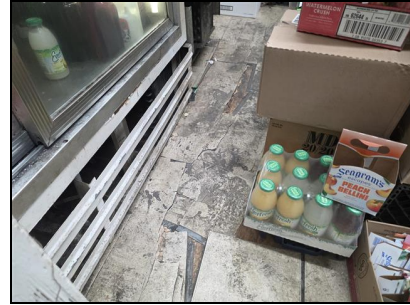
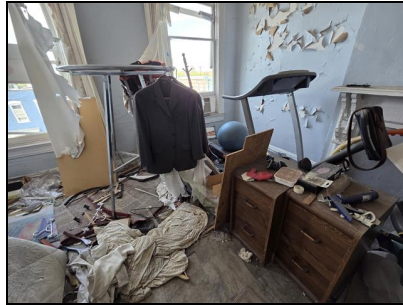
7.1 (1) The flooring is damaged.

LOCATION: Multiple locations throughout the property.

RECOMMENDATION: Repair or replace the flooring.

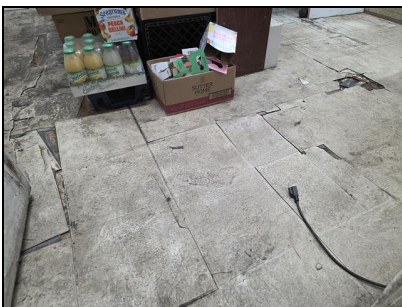
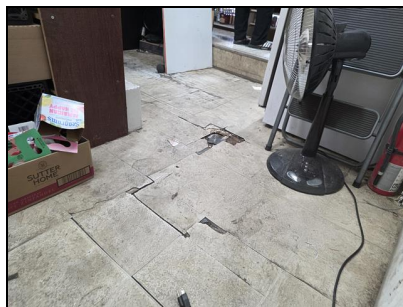
**7.1 (2)** The flooring slopes/un-level, there are several possible causes. An evaluation is needed to determine the cause.

LOCATION: Multiple locations throughout the property.

RECOMMENDATION: Hire a contractor to determine the cause and make any needed repairs.

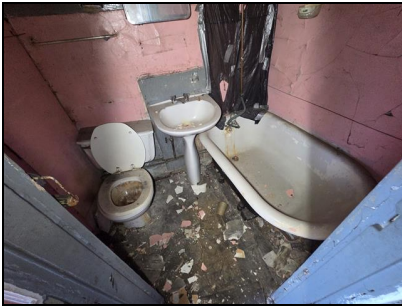
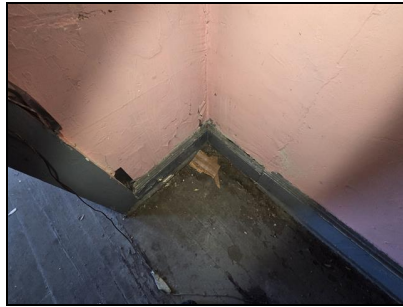
**7.1 (3)** The flooring is water damaged. The source of moisture, and weather this is an ongoing problem, cannot be determined.

LOCATION: Multiple locations throughout the property.

RECOMMENDATION: Hire a contractor for an evaluation and make repairs as needed.

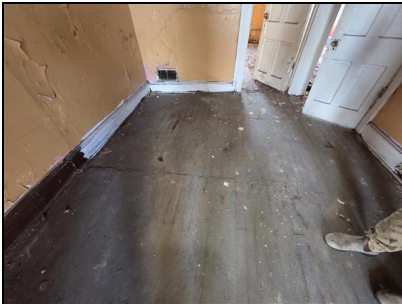
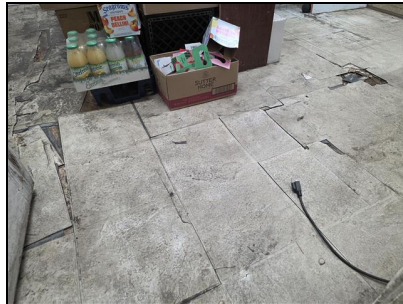
**7.1 (4)** The floor tiles are un-even. This can be a tripping hazard for some people. The variation is beyond the acceptable standards.

LOCATION: Multiple locations throughout the property.

RECOMMENDATION: Repair the floor as needed.

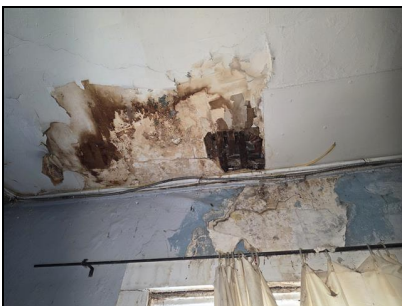
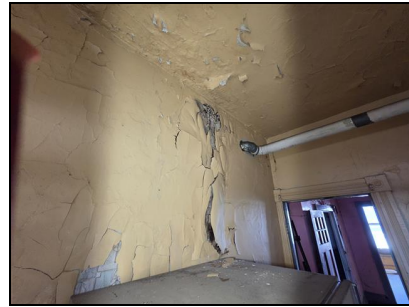
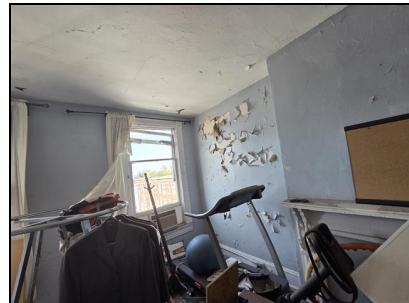
**7.2 (1)** The interior wall is water damaged. Testing with a moisture meter indicates low moisture content (dry) at the time of this inspection. This may be from a previous water issue, which has been resolved.

LOCATION: Multiple Locations

RECOMMENDATION: Hire a contractor for an evaluation and to make needed repairs.

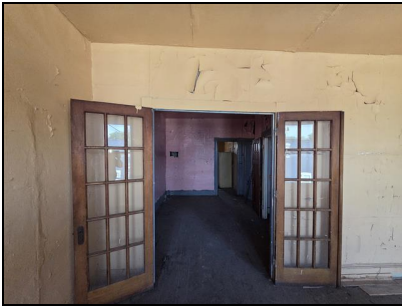
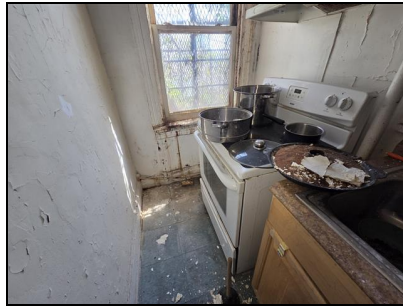
**7.2 (2)** The wall is damaged or unfinished.

LOCATION: Multiple locations throughout the property.

RECOMMENDATION: Hire a contractor to make repairs as needed.

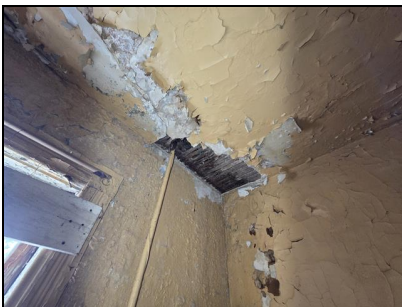
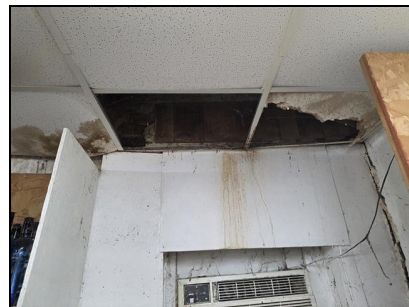
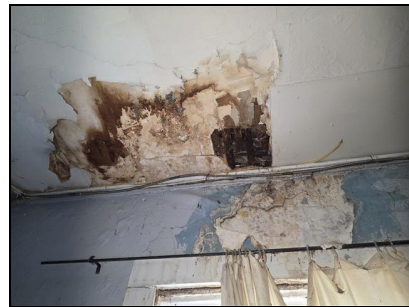
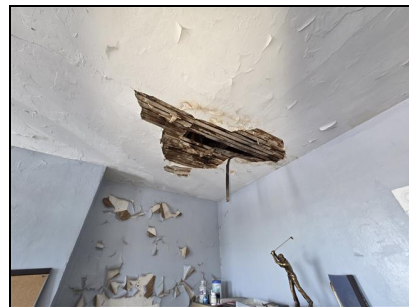
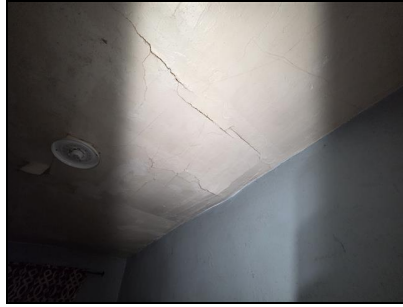
**7.3** The ceiling is water damaged or in need of repair.

LOCATION: Multiple locations throughout the property.

RECOMMENDATION: Hire a contractor for an evaluation and to make repairs as needed.

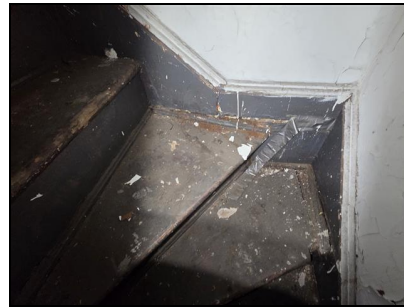
7.4 Item 1(Picture)

**7.4** The step(s) treads are loose or deteriorated. This is a safety concern.

LOCATION: Stairway

RECOMMENDATION: Hire a contractor to repair the stairs as needed.

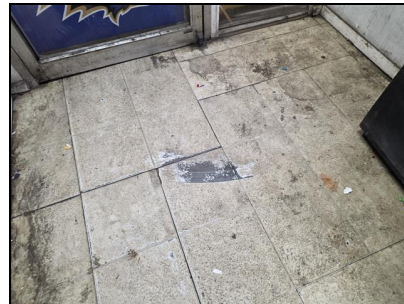
7.7 Item 1(Picture)

**7.7** The door rubs on the carpet or floor.

LOCATION: Store

RECOMMENDATION: Hire a contractor to determine the cause and make needed repairs.

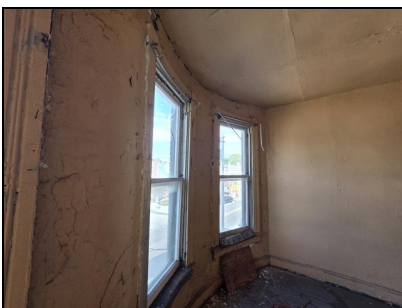
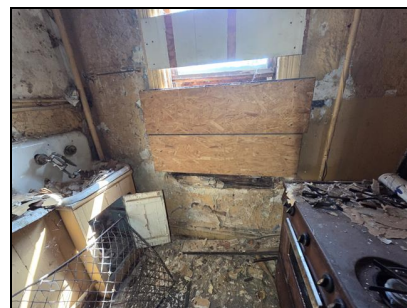
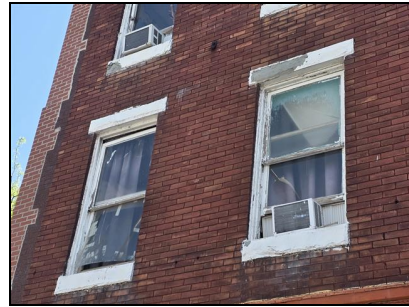
**7.8** The window is damaged or inoperative. This affects the proper function.

LOCATION: Multiple locations throughout the property.

RECOMMENDATION: Repair or replace the window.

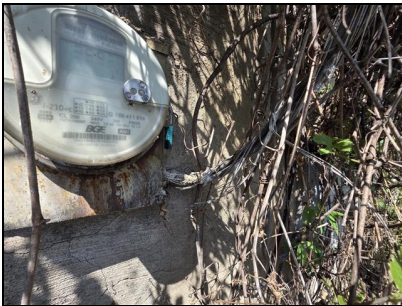
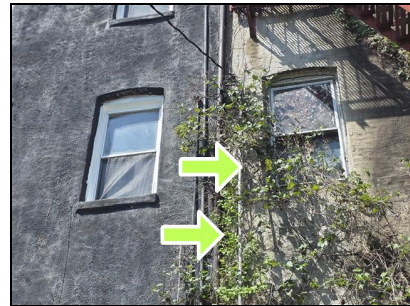
**8.0** There is deteriorated insulation on the service entrance cable. This is a safety hazard.

LOCATION: Rear

RECOMMENDATION: Hire an electrician to replace the insulation or the cable as needed.

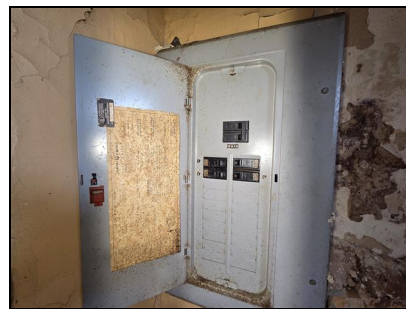
8.1 Item 1(Picture)

**8.1** The panel is not energized.

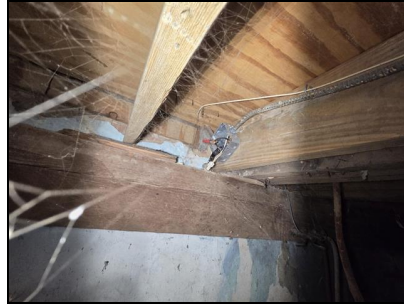
8.3 Item 1(Picture)

**8.3** There is unprotected exposed wiring and branch circuit ends present. All wire terminations and splices should be enclosed in an approved junction box that remains permanently accessible and has a cover for safety. This situation poses a safety hazard.

**Location:** Basement

**Recommendation:** Hire an electrician to perform the necessary repairs.

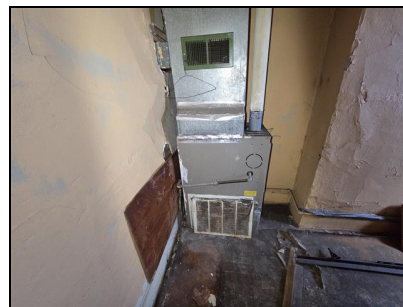
9.0 Item 1(Picture)

**Location:** HVAC unit

**Recommendation:** Hire an HVAC contractor to evaluate the system and make required repairs.

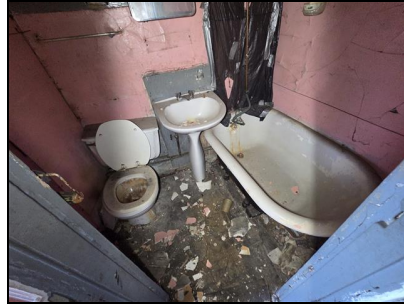
10.4 Item 1(Picture)

**10.4** The toilets, sinks and tubs will need replacement and plumbing repairs throughout the property. They are in non working condition.

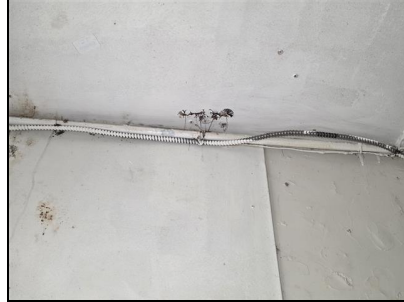
12.7 Item 1(Picture)

**12.7** Suspected mold or fungus buildup has been identified. This growth may lead to the deterioration of structural components and could pose health and safety risks.

LOCATION: Multiple locations throughout the property.

RECOMMENDATION: Hire an environmental specialist to assess the suspected mold and carry out any necessary repairs.

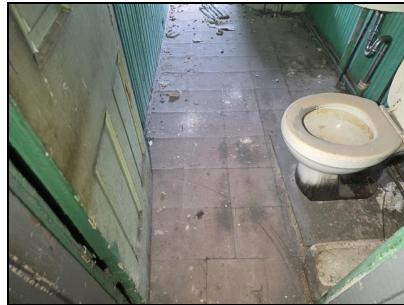
12.9 Item 1(Picture)

**12.9** Materials are present which possibly contain asbestos. This is a potential health and safety hazard.

LOCATION: Bathroom

RECOMMENDATION: Asbestos content can be confirmed only by laboratory analysis higher and environmental specialist to evaluate the suspected asbestos and to make required repairs as needed.
