# Inspections: Damaged Pole Report

Service Request 26-00410877 Sector \_\_\_\_\_ Gateway: Primary

Location on Service Request: 4825 Eastern Ave

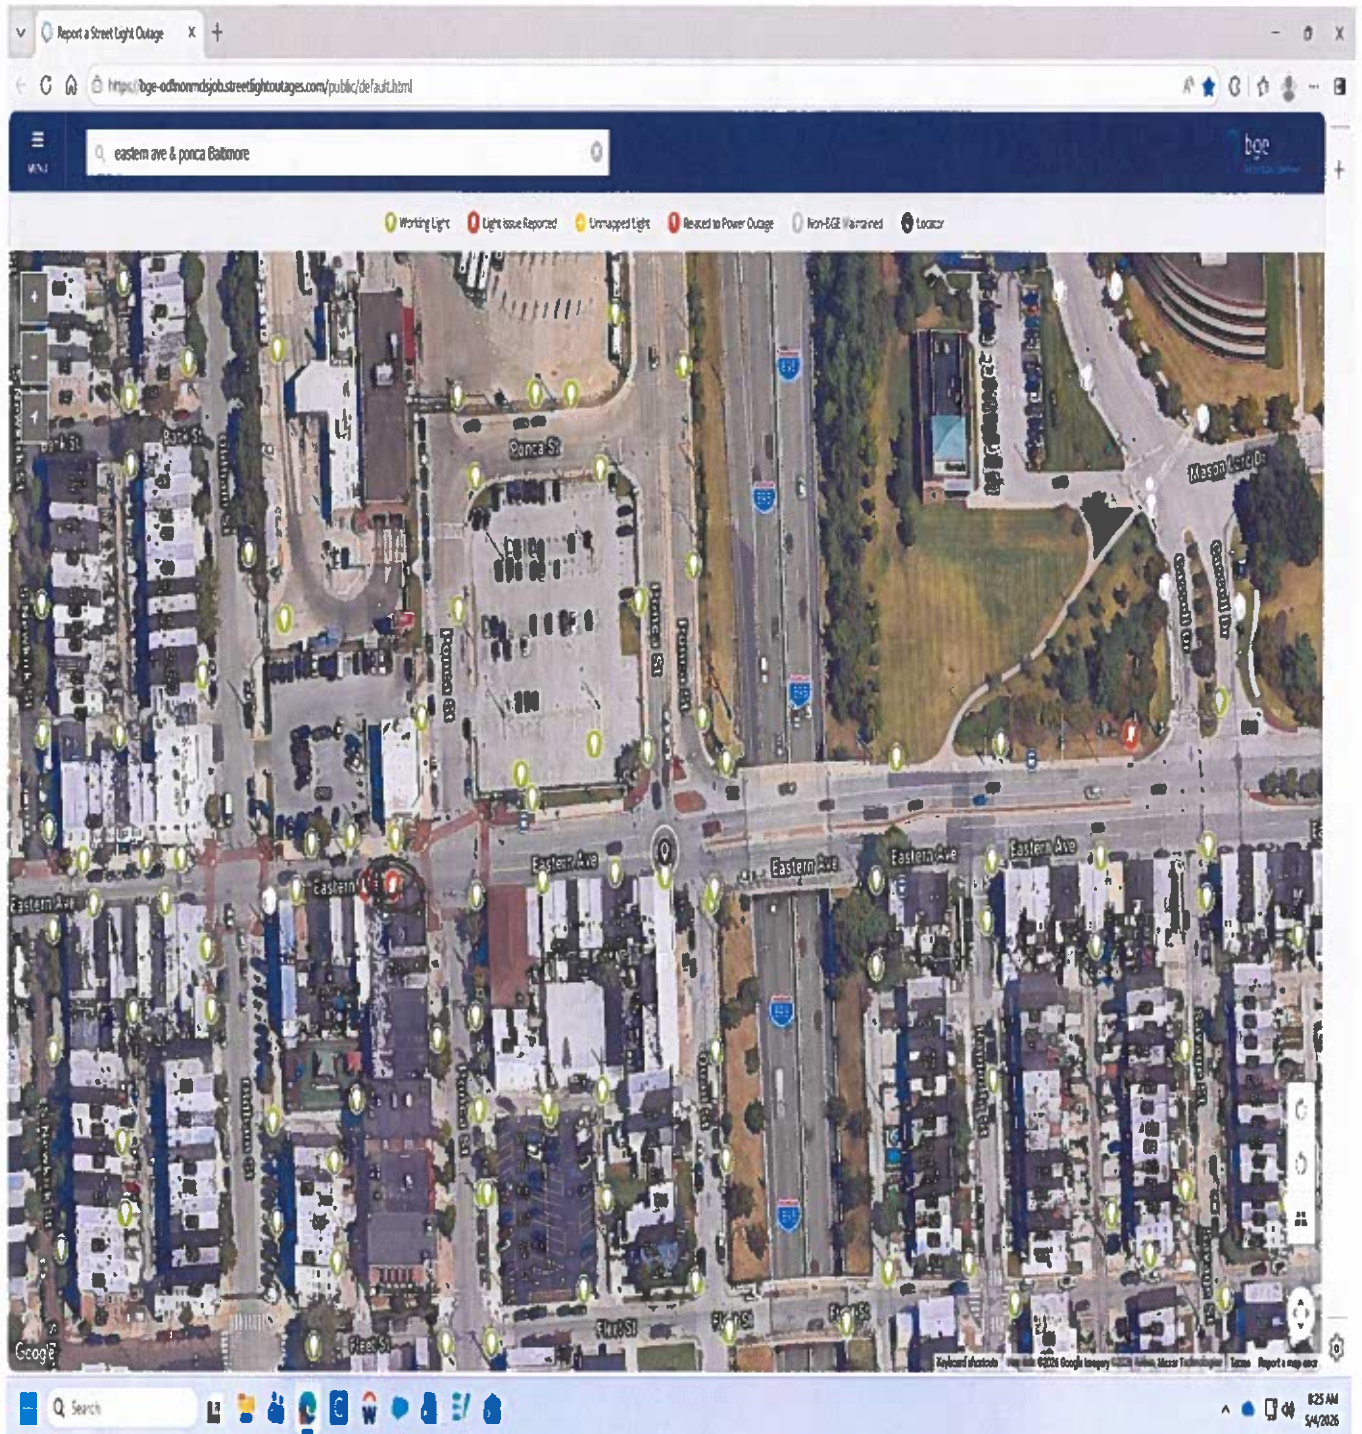
Deteriorated ☒

Missing ☒

HomeLand pole  
Acorn Fixture
