# Inspections: Damaged Pole Report

Service Request 26-00422848 Sector: \_\_\_\_\_ Gateway: \_\_\_\_\_ Primary: \_\_\_\_\_

Location on Service Request: 4100 Belvoir Rd

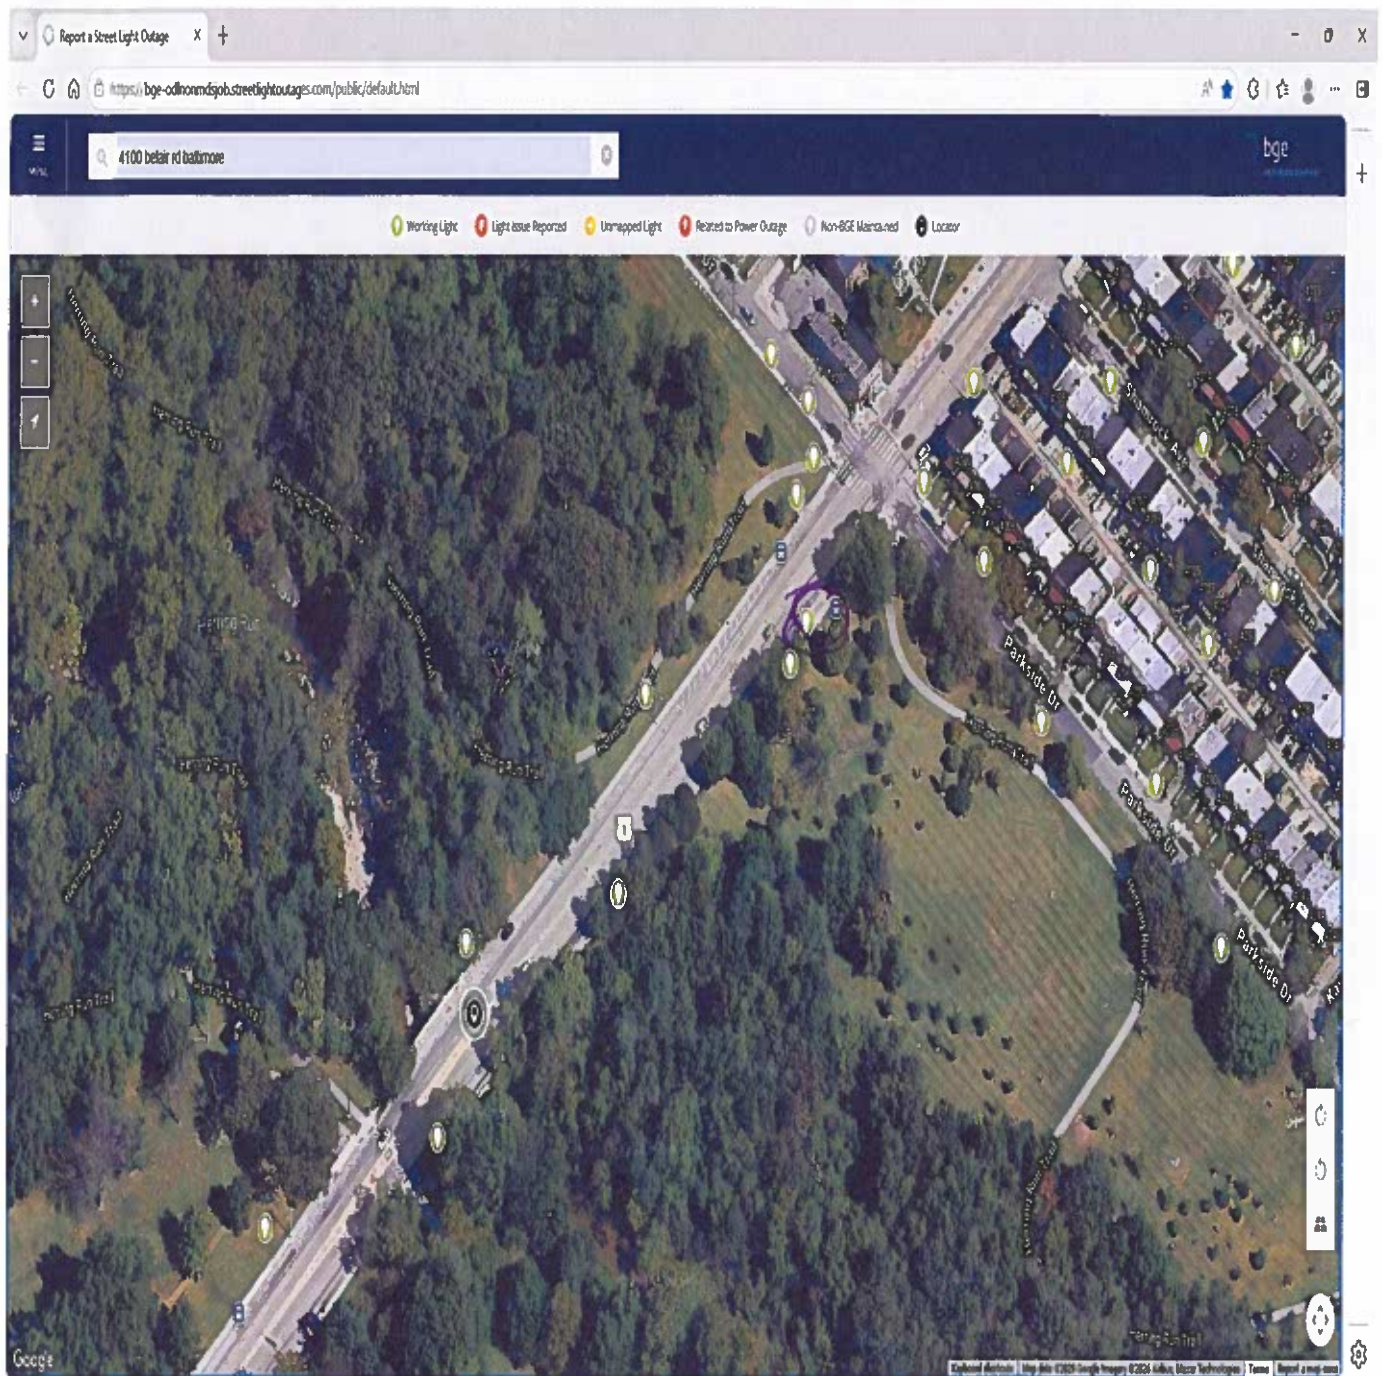
Missing ☒

NEEDS  
New  
Pedestal  
Base

30 Foot Aluminum  
pole  
Cobra Head  
LED
