Inspections: Damaged Pole Report

Service Request 26-00423981 Sector: \_\_\_\_\_ Gateway: \_\_\_\_\_ Primary: \_\_\_\_\_

Location on Service Request: 2828 Fleetwood Ave

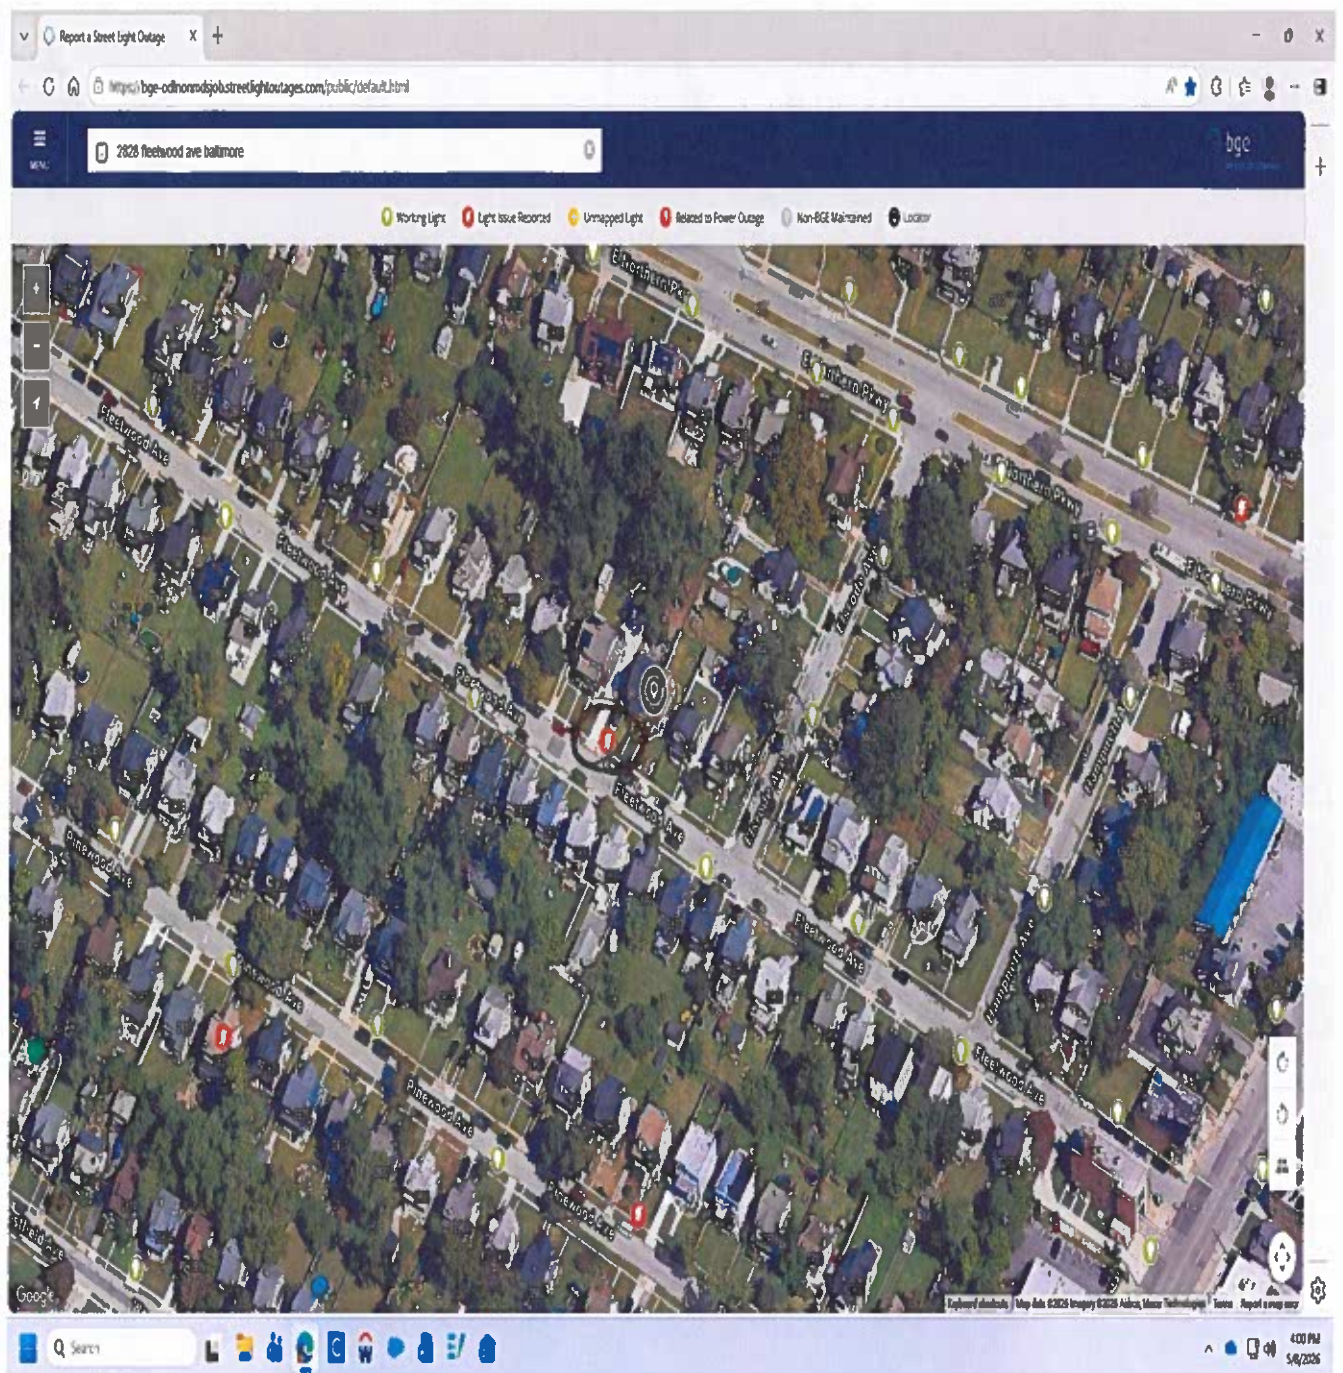
Deteriorated \_\_\_\_\_  
Missing ☒  
Damaged \_\_\_\_\_  
Arm/Fixture Missing \_\_\_\_\_  
Other \_\_\_\_\_

NEEDS  
New  
Base

25 Foot  
steel  
pole  
Cobra Head  
LED

work order #  
20805971
