# Inspections: Damaged Pole Report

Service Request: 26-00435240 Sector: \_\_\_\_\_ Gateway: \_\_\_\_\_ Primary: \_\_\_\_\_

Location on Service Request: 1228 Eo Baltimore St

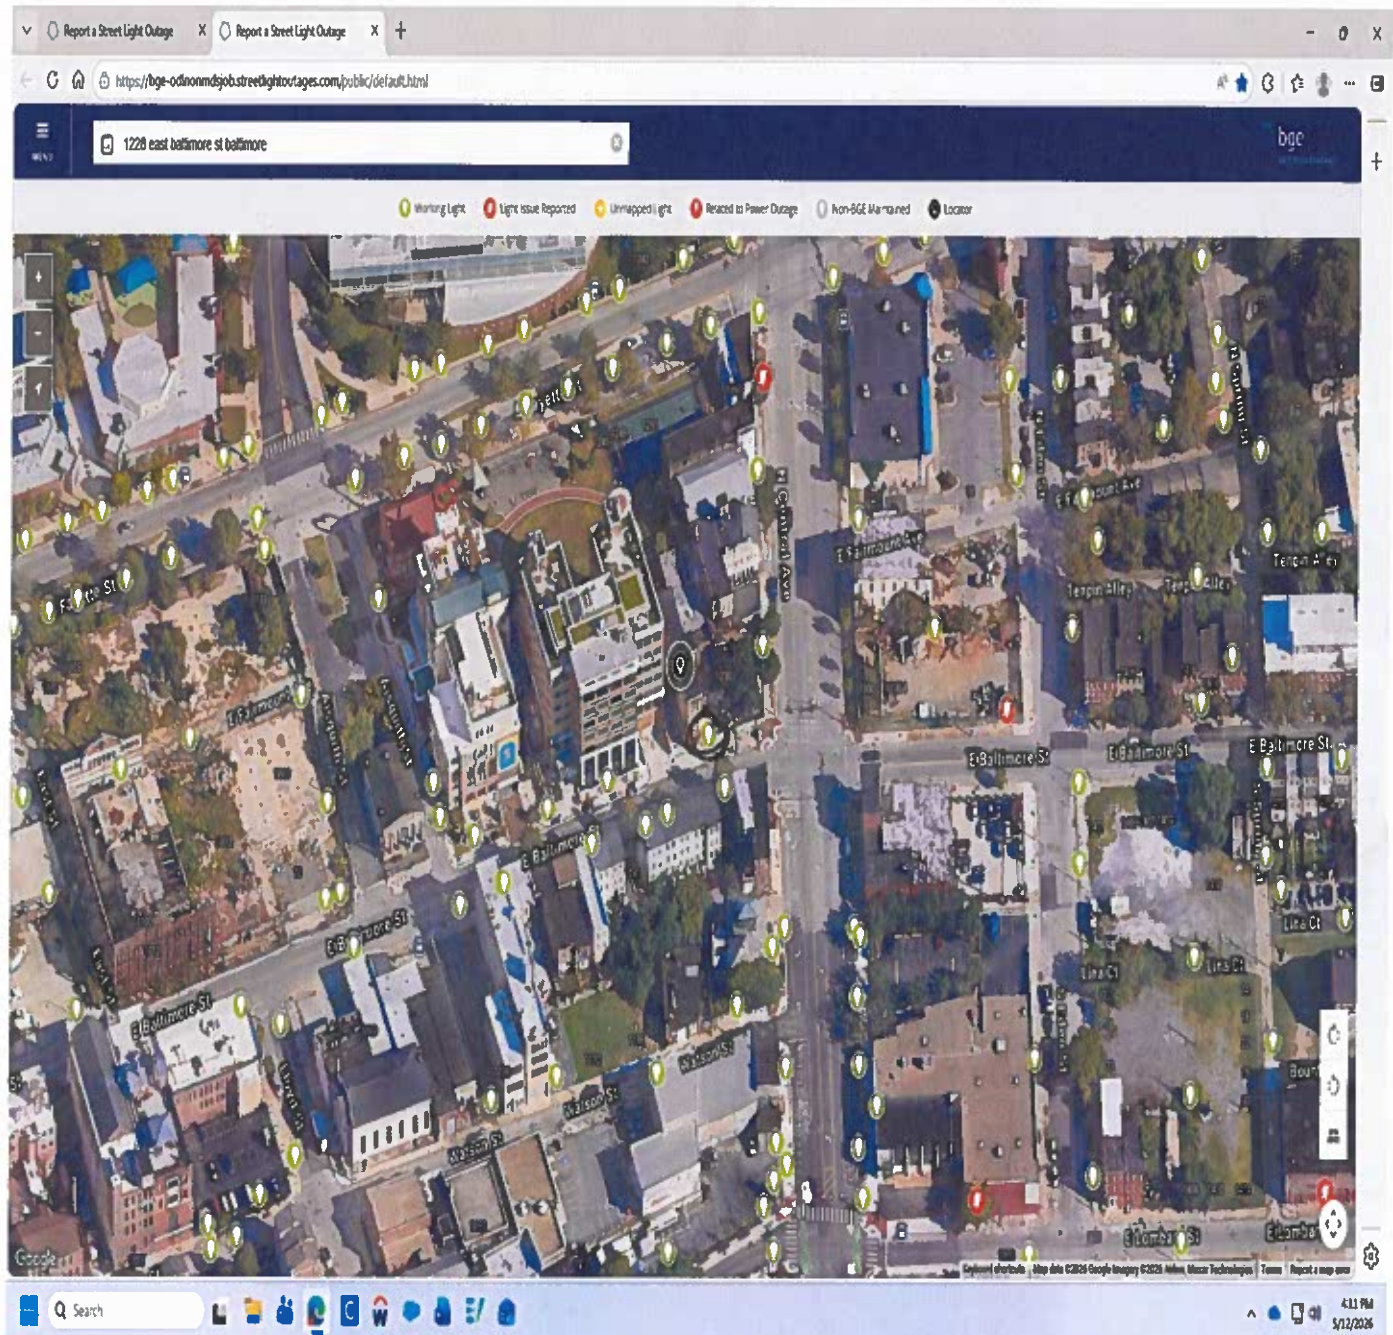
Missing ☒

Good ☒  
Bad: ☐  
Bolts ☒  
Wires ☒  
Conduit ☒

Home Inwd  
Acorn Fixture
