# Inspections: Damaged Pole Report

Service Request 26-00465223 Sector: \_\_\_\_\_ Gateway: \_\_\_\_\_ Primary: \_\_\_\_\_

Location on Service Request: 2900 Clifton Park Ter

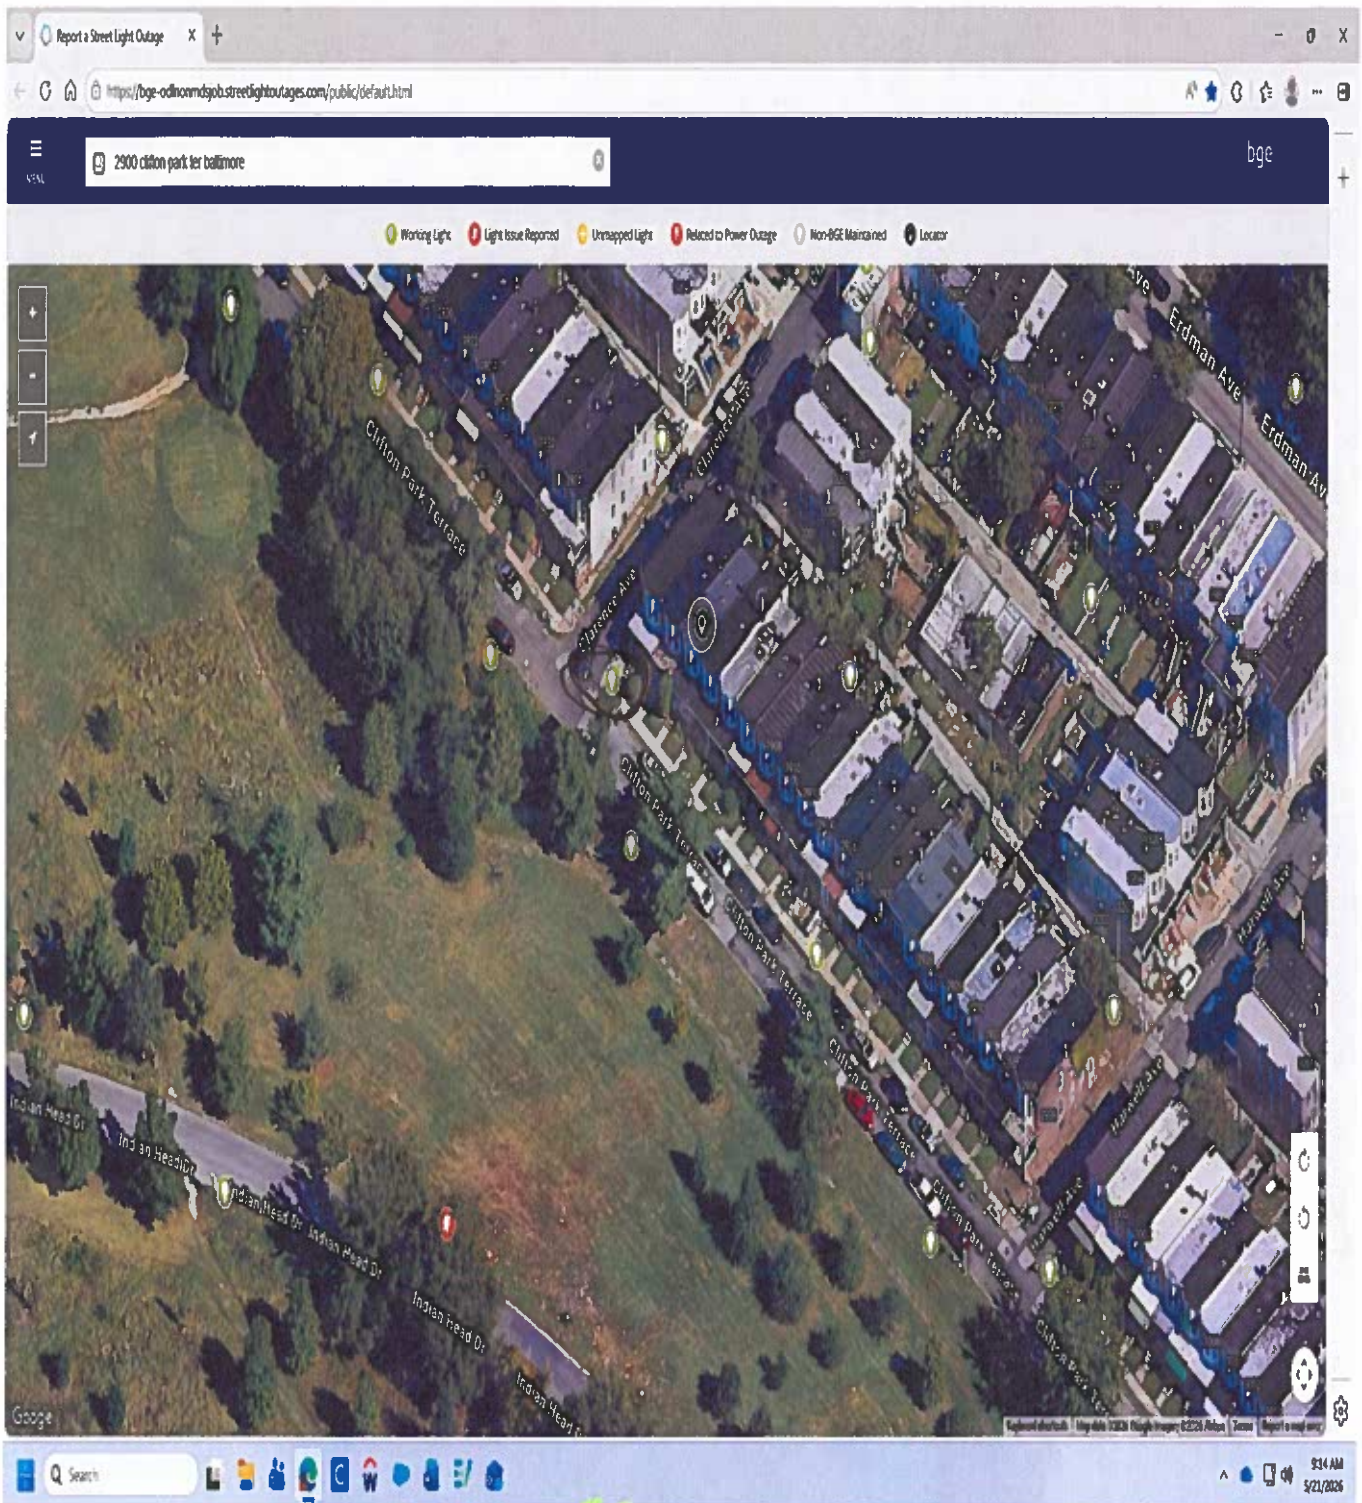
Deteriorated \_\_\_\_\_  
Missing ☒  
Damaged \_\_\_\_\_  
Arm/Fixture Missing \_\_\_\_\_  
Other \_\_\_\_\_

Good ☒  
Bad: ☒  
Bolts ☒  
Wires ☒  
Conduit ☒

PMA  
HPS

NEEDS  
New  
Base
